**H0258.04-303-11-R2  
ACOUSTICAL PERFORMANCE TEST REPORT  
ASTM E90**

**CR LAURENCE CO., INC.**

**Series/Model: 487-AR**

**Type: Office Partition**

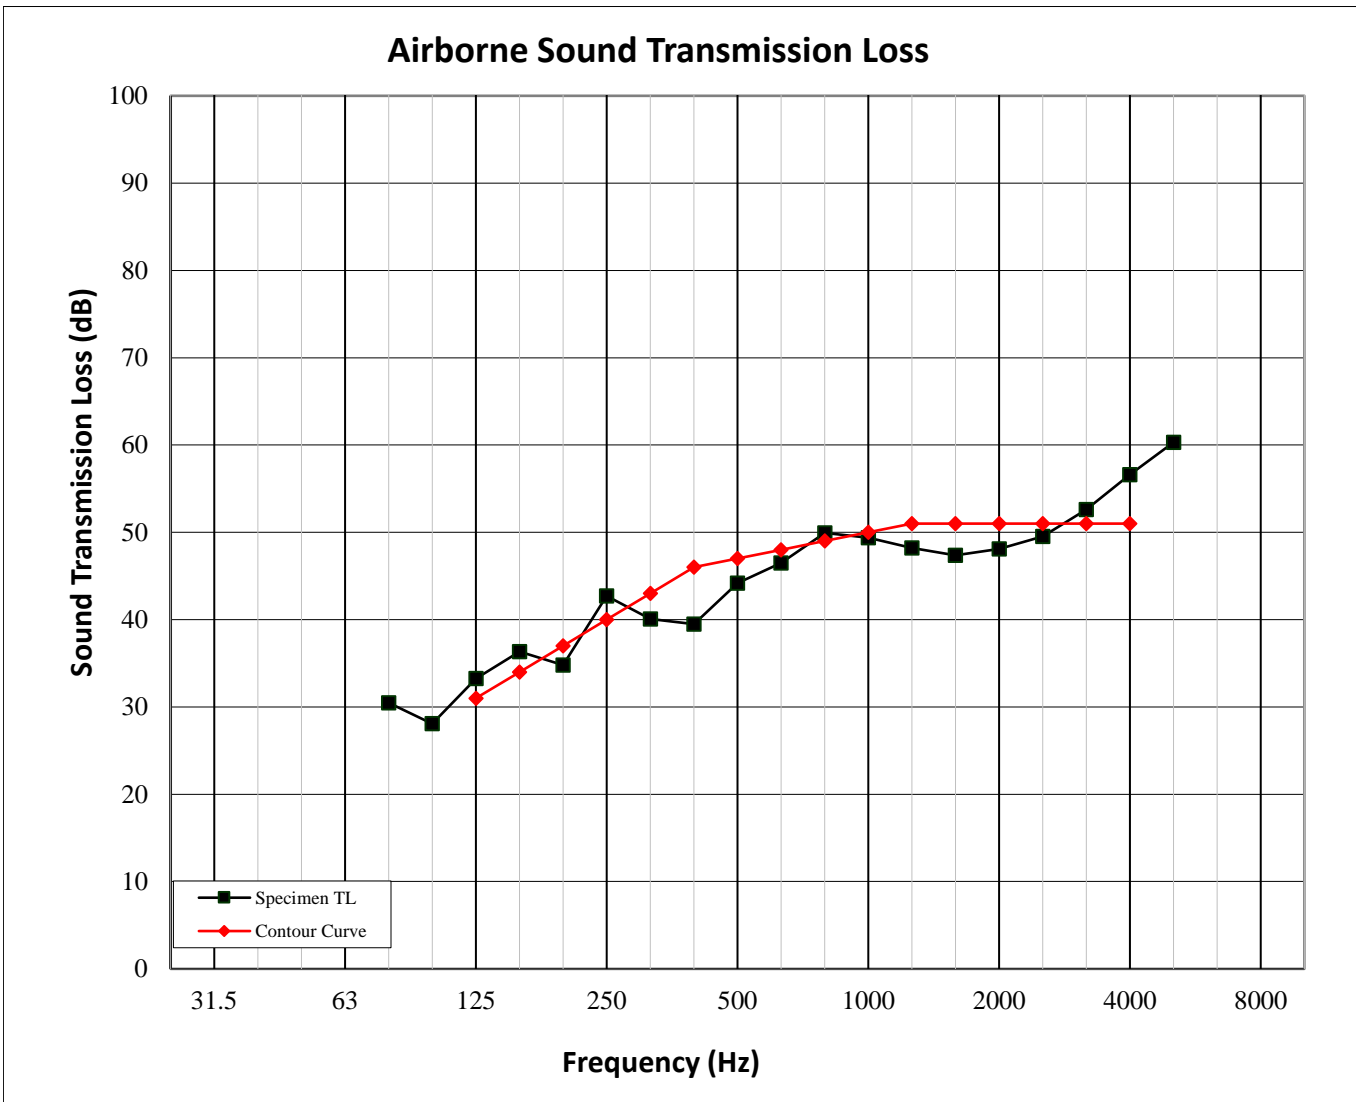
**AIRBORNE SOUND TRANSMISSION LOSS**  
ASTM E 90

**STC Rating**      **47**      *(Sound Transmission Class)*  
**Deficiencies**      **29**      *(Sum of Deficiencies)*  
**OITC Rating**      **40**      *(Outdoor-Indoor Transmission Class)*

<b>Test Date</b>	04/19/17					
<b>Data File No.</b>	H0258.04					
<b>Client</b>	CR Laurence Co., Inc.					
<b>Description</b>	Series/Model: 487-AR Aluminum Office Wall with 1/4" laminate, 3-1/2" air space, 3/8" laminate					
<b>Specimen Area</b>	4.12 m <sup>2</sup>	Receive Temp.	22.8 °C		Source Temp.	22.2 °C
<b>Technician</b>	Bradlay Hunt	Receive Humidity	54%		Source Humidity	56%

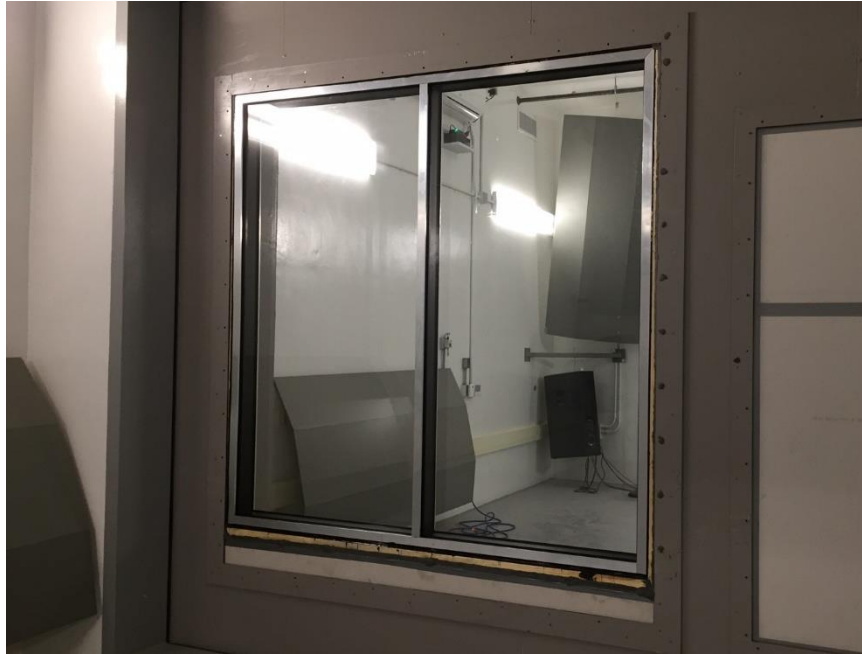
**Receive Room View of Installed Specimen**

A sound transmission loss test was initially performed on a filler wall. The specimen plug was removed from the filler wall assembly. The specimen was placed on a foam isolation pad in the test opening. Duct seal was used to seal the perimeter of the specimen to the test opening on both sides. The interior side of the specimen, when installed, was approximately 1/4" from being flush with the receive room side of the filler wall. A stethoscope was used to check for any abnormal air leaks around the test specimen prior to testing. Operable portions of the test specimen, if any, were cycled at least five times prior to testing.

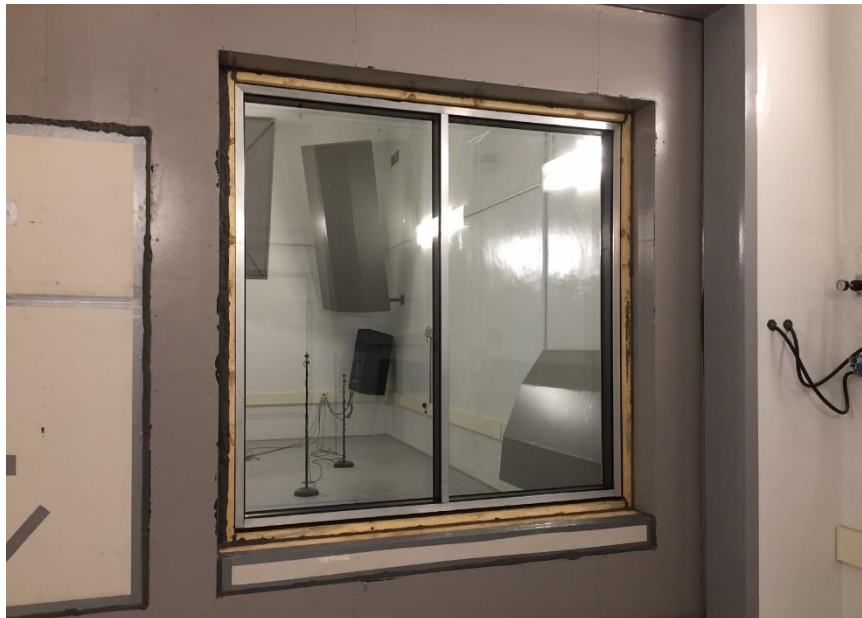
**Source Room View of Installed Specimen**

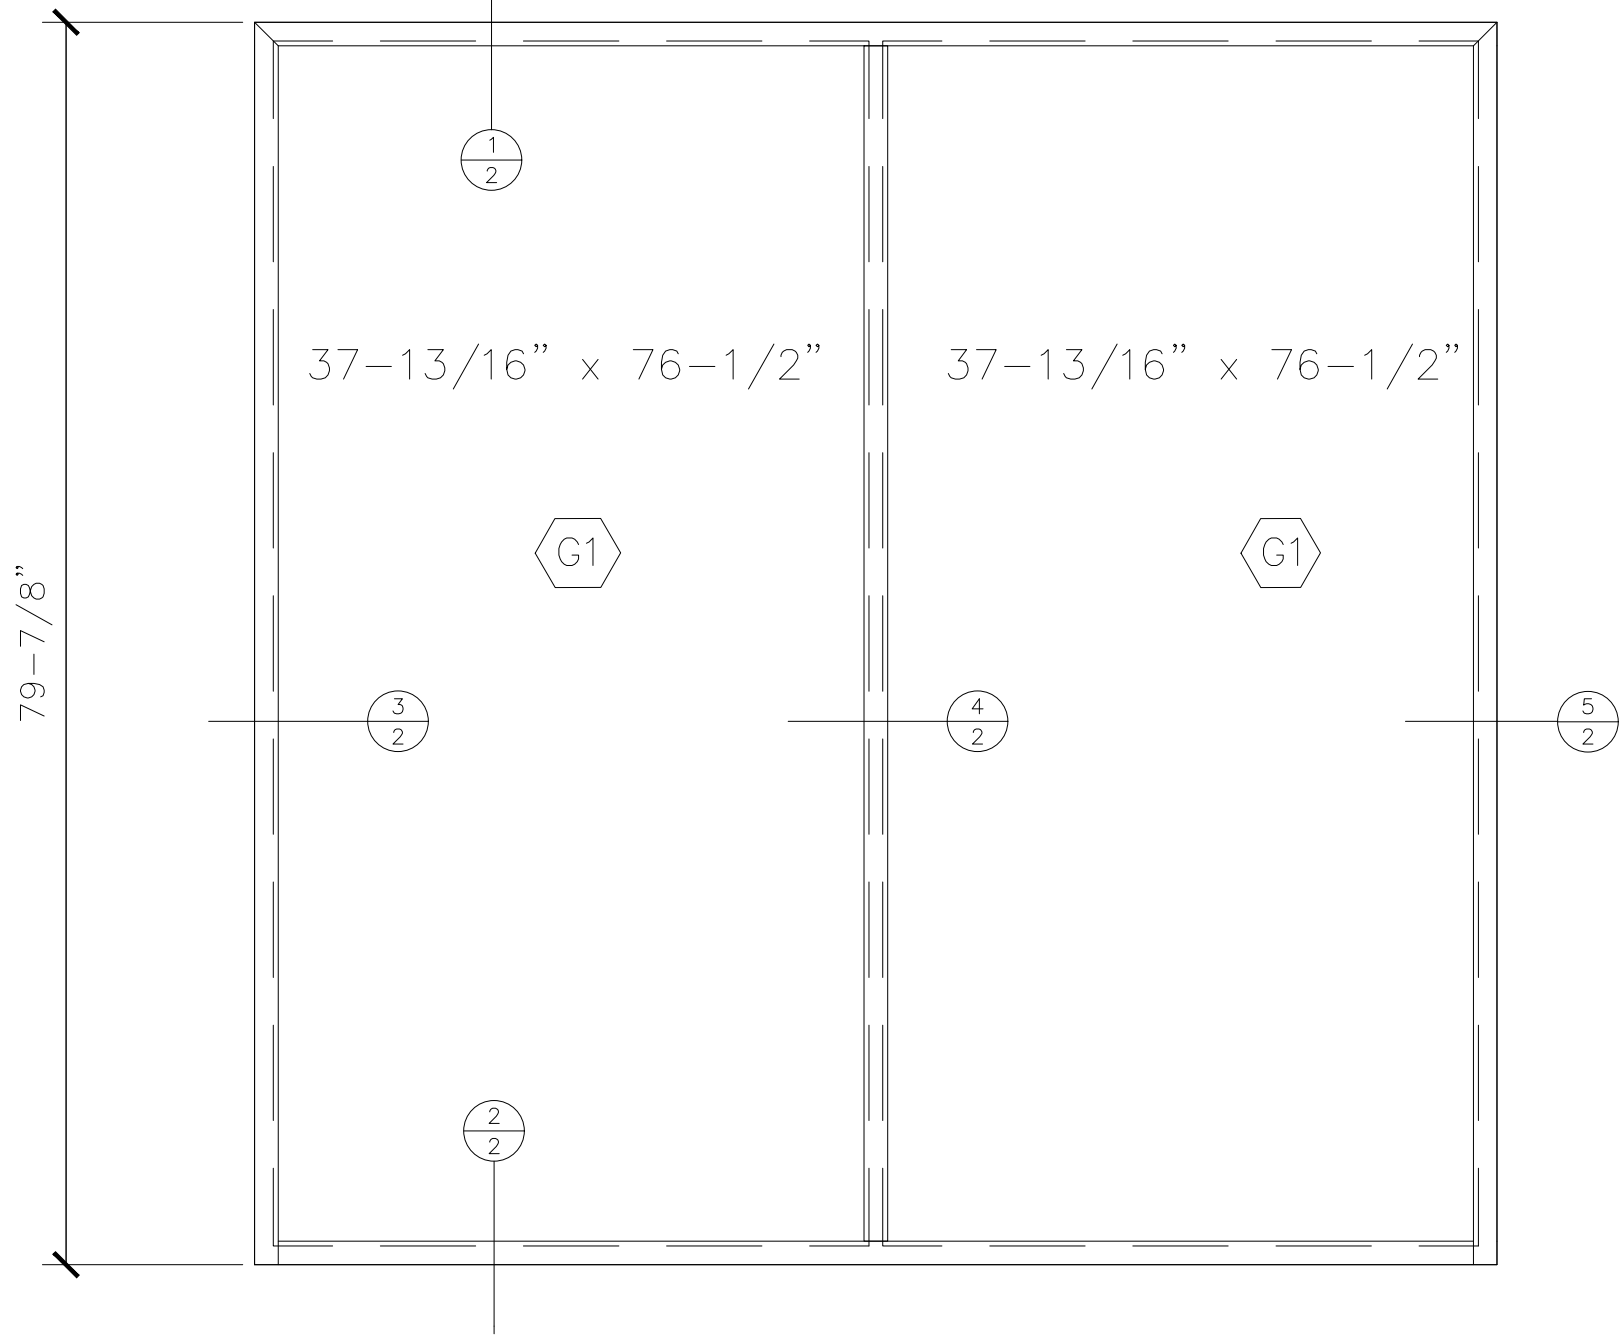
SHT 1 OF 3

C1	FRAME	487X201	487 HEAD, JAMB, SILL MULLIONS
C2		487X203	487 VERTICAL/HORIZONTAL MULLIONS
C3		487X202	487 FLOOR TRACK
C4		487X215	487 FACE CAP- 1-1/2"
C6		487X214	487 GLAZING ADAPTOR
F1	FASTENERS	20061601	# 6-20X1/2 P.H.P. TEK SCREWS
F2		-----	# 8 X 2-1/2 DRY WALL SCREWS
W1	WTHR STRIP	NP718	INTERIOR SPONGE GASKET
W2		NP225	VINYL GLAZING GASKET
G1	GLASS		1/4" LAMINATED GLASS
G2		SB514	NEOPRENE SETTING BLOCK
H1	HARDWARE	487C1	487 SERIES 90 DEG. CLIP
H2		487C2	487 SERIES "T" CLIP
H3		TCI-93170X330	TREMCO ACOUSTICAL CURTAINWALL SEALANT

Job Name:  
 487 SERIES  
 OFFICE PARTITION  
 ACOUSTIC CONTROL SYSTEM
