CR LAURENCE CO, INC.

ACOUSTICAL PERFORMANCE TEST REPORT

AAMA 1801 TESTING ON IT451, STOREFRONT WINDOW

H7645.03-303-11 R0

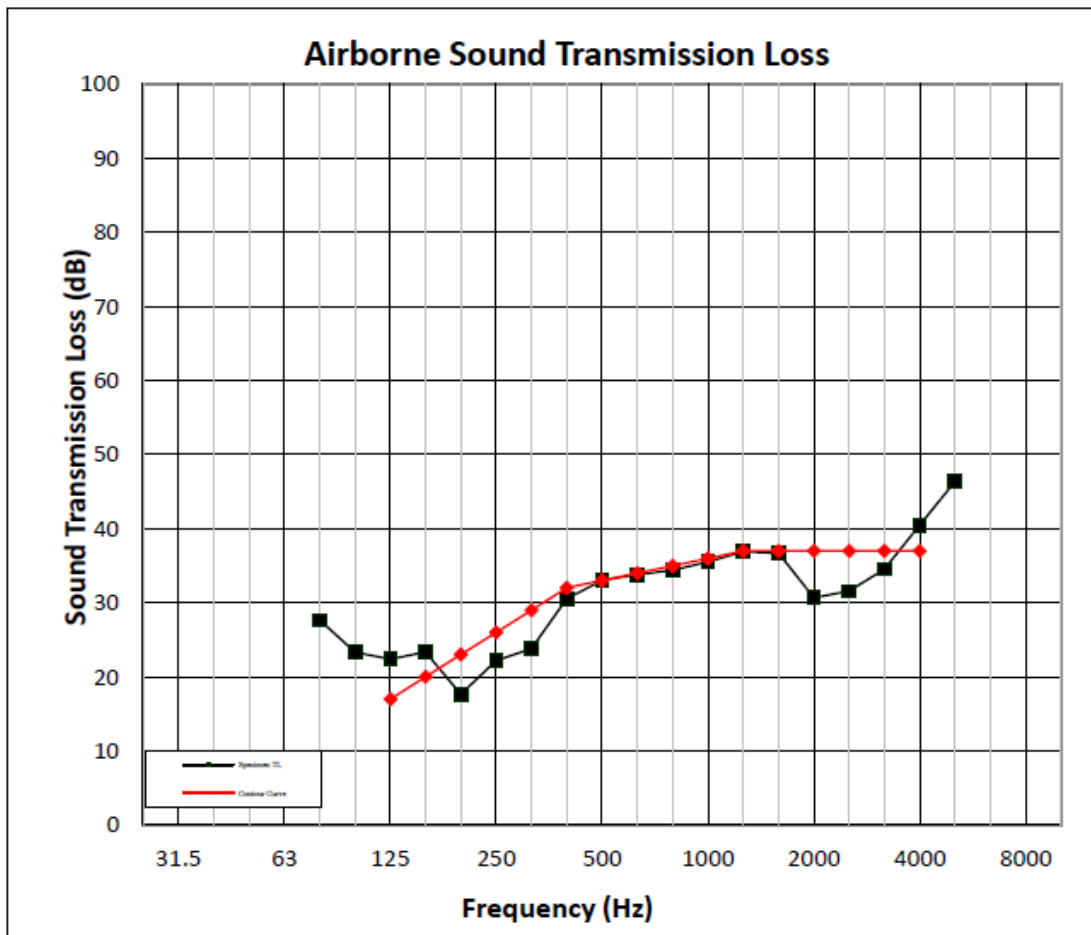
RESULTS GRAPH

ASTM E90 AIRBORNE SOUND TRANSMISSION LOSS

DATA FILE NO.	H7645.01C					
CLIENT	CR Laurence Co., Inc.					
DESCRIPTION	Series/Model: IT451 Storefront with 1" IG (1/4" tempered interior, 1/2" air space, 1/4" tempered exterior)					
SPECIMEN AREA	4.03 m ²	RECEIVE TEMP.	19.2 °C	SOURCE TEMP	19.4 °C	
TECHNICIAN	Leeland S. Ho	RECEIVE HUMIDITY	57%	SOURCE HUMIDITY	59%

To obtain the Sound Transmission Class (STC), read the TL of the contour curve at 500 Hz. The sum of the deficiencies below the contour curve must not exceed 32. The maximum deficiency at any one frequency must not exceed 8.

FREQ (Hz)	BACKGROUND SPL (dB)	ABSORPTION (m ²)	SOURCE SPL (dB)	RECEIVE SPL (dB)	SPECIMEN TL (dB)	95% CONFIDENCE LIMIT	NUMBER OF DEFICIENCIES
80	45.0	4.0	104	78	28	1.52	-
100	34.5	4.2	105	82	23	2.16	-
125	37.4	5.3	105	82	22	1.73	0
160	43.2	5.2	104	80	23	0.97	0
200	35.7	6.5	105	85	18	0.62	5
250	23.7	7.0	106	81	22	0.62	4
315	16.9	6.7	106	80	24	0.73	5
400	18.5	5.9	105	73	31	0.50	1
500	16.4	5.3	105	71	33	0.39	0
630	19.9	5.7	106	71	34	0.41	0
800	21.0	5.7	106	70	34	0.20	1
1000	9.8	5.9	107	70	36	0.42	0
1250	7.4	6.1	105	66	37	0.13	0
1600	6.7	6.6	104	65	37	0.20	0
2000	6.8	7.6	101	68	31	0.20	6
2500	5.9	8.4	101	66	32	0.25	5
3150	5.9	9.6	101	62	35	0.22	2
4000	6.1	11.8	99	54	40	0.35	0
5000	6.5	14.7	98	46	46	0.34	-
STC RATING	33 (Sound Transmission Class)						
DEFICIENCIES	29 (Sum of Deficiencies)						
OITC RATING	27 (Outdoor-Indoor Transmission Class)

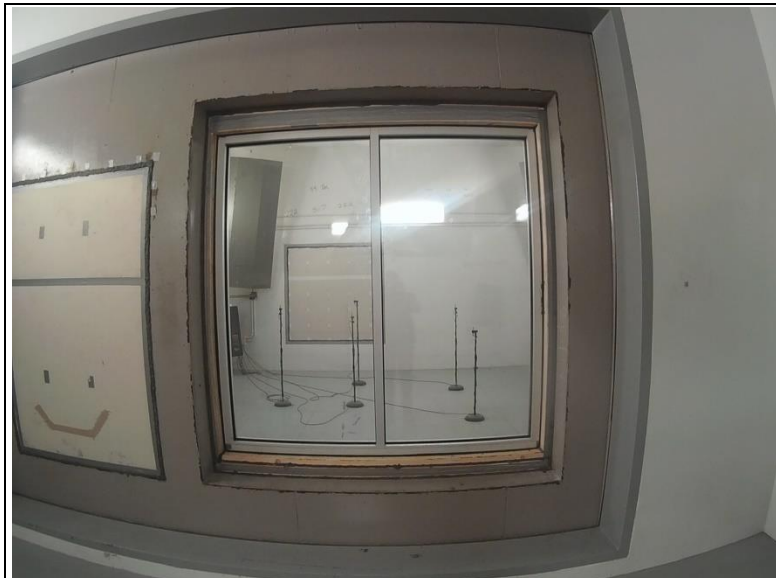
Receive Room View of Test Specimen

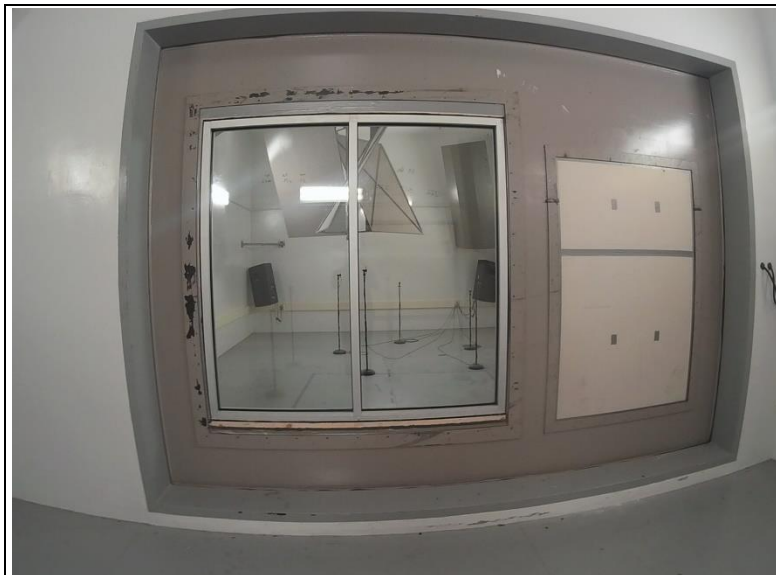
Source Room View of Test Specimen
