**ASTM F 1642-04/GSA TS01  
TEST REPORT**

**UNITED STATES ALUMINUM**

**SERIES/MODEL: BW3250**

**PRODUCT TYPE: Aluminum Combination Fixed Window**

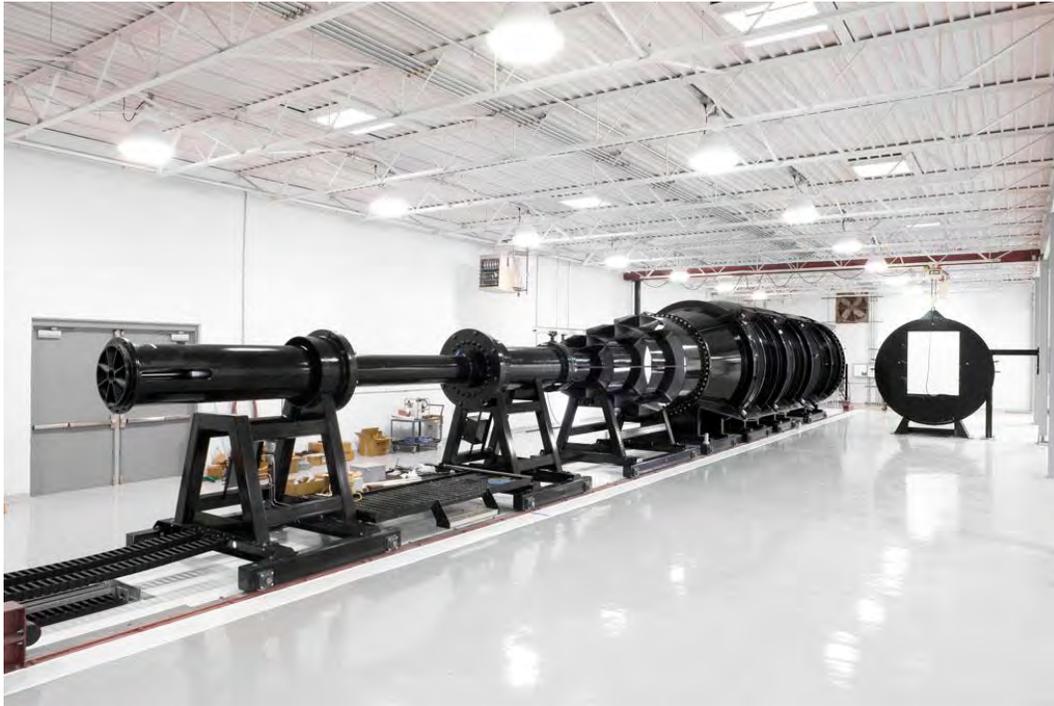
**Figure #1**  
Shock Tube and Test Facility

**Test Facility:** Architectural Testing, Inc.'s shock tube is housed in a 10,000 square foot state-of-the-art test facility located in York, Pennsylvania. Blast loadings are produced on the specimen to simulate the effects of a high explosive charge at a specified standoff distance. Shock waves are generated by the sudden rupturing of a thin aluminum membrane. The shock wave expands as it travels down the tube and impacts the target with a specific positive pressure and impulse. A photograph of the shock tube is provided in Figure #1 of Appendix A.

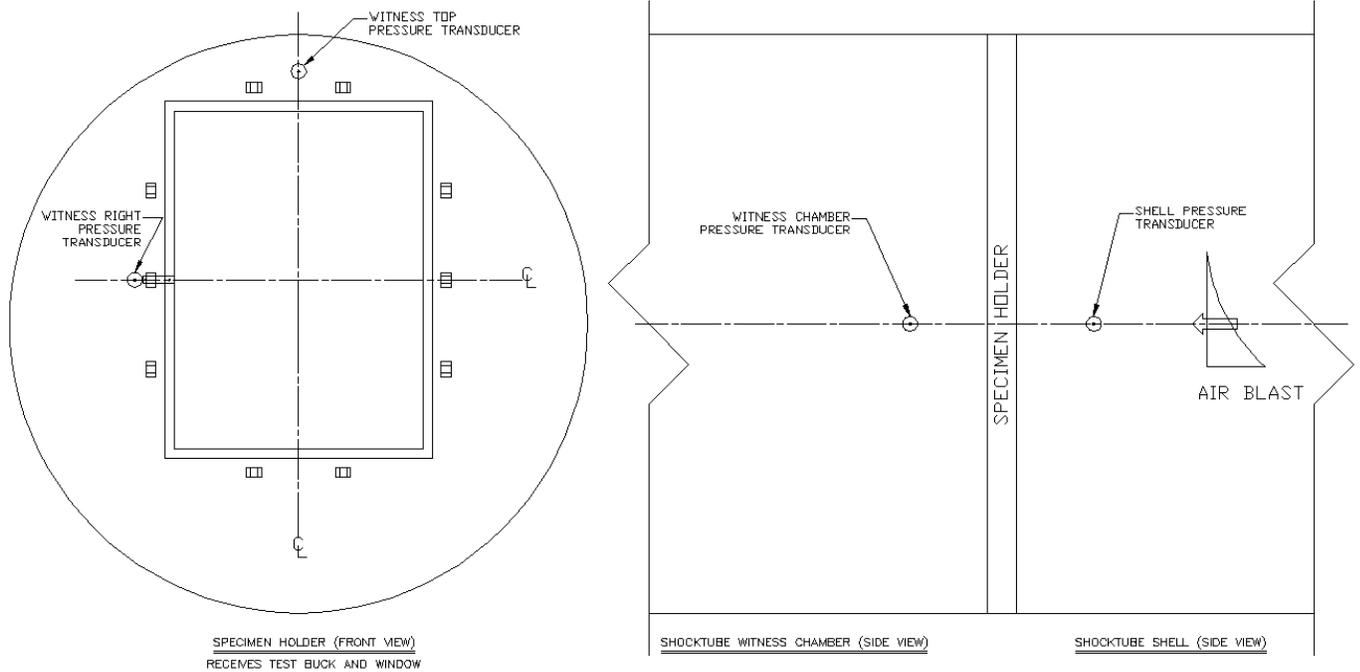
**Figure #2**  
Pressure Sensor Locations

**Data Acquisition:** In accordance with ASTM F 1642-04 and GSA TS01, four reflective pressure transducers are utilized to record data at a 1MHz sample rate. Two reflective pressure transducers are located on the specimen holder at the top and right side (when viewed from the interior). A third pressure transducer is located on the shell to the exterior of the specimen, and a fourth is located in the witness chamber, directly to the interior of the specimen holder. A sketch of the specimen holder and corresponding reflective pressure sensor locations are provided in Figure #2 of Appendix A.

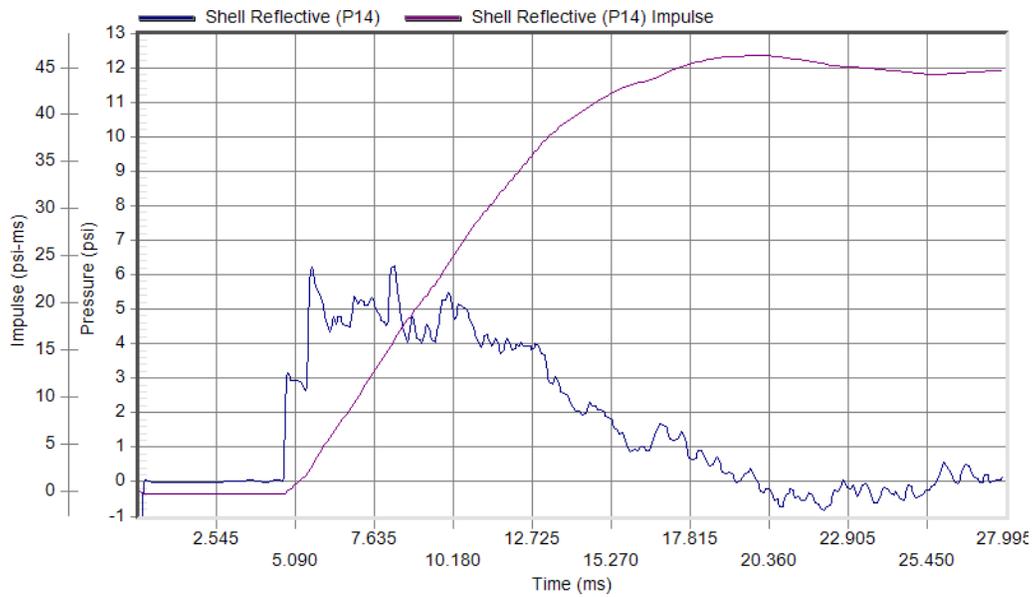
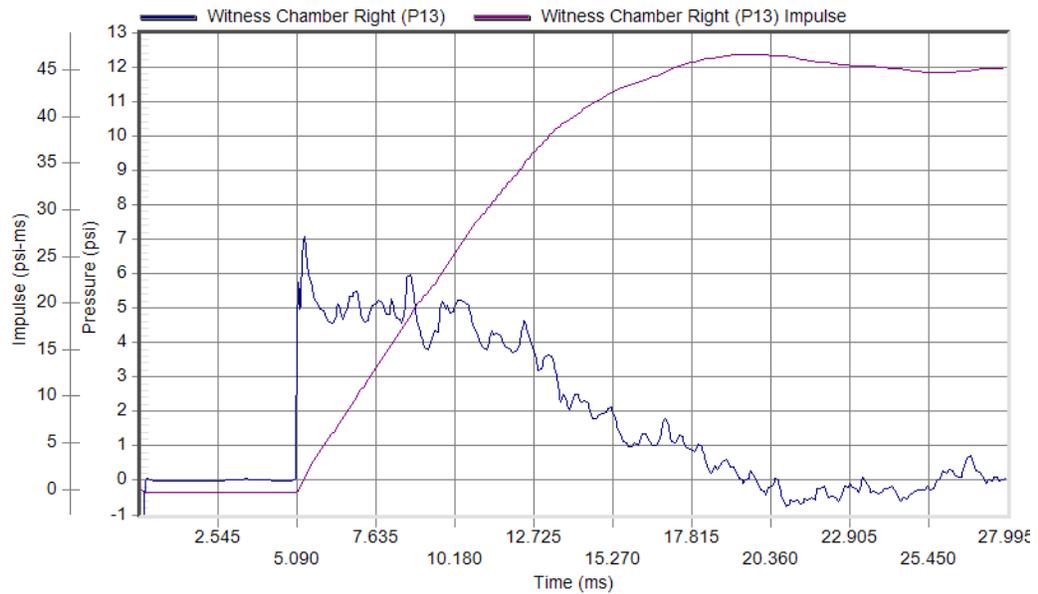
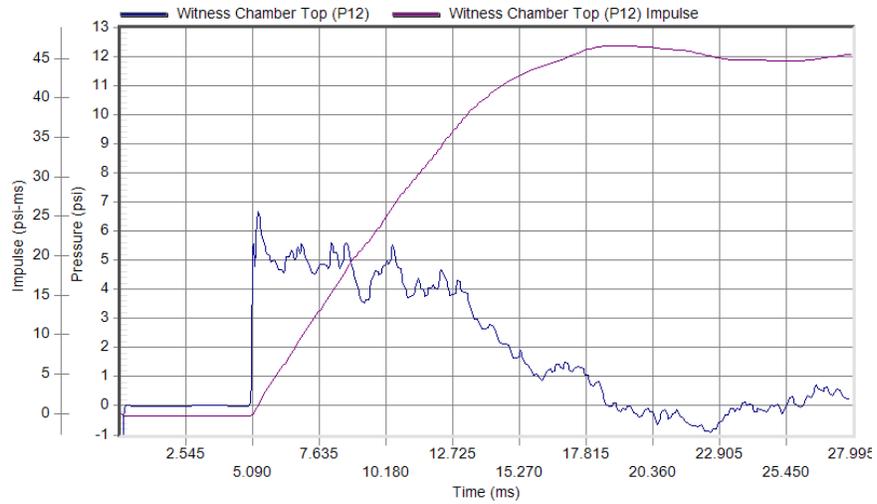
### Specimen #1

Peak Pressure: 6.28 psi at 8.26 ms  
Duration: 10.99 ms

Peak Pressure: 7.07 psi at 5.32 ms  
Duration: 14.04 ms

Peak Pressure: 6.69 psi at 5.30 ms  
Duration: 13.25 ms

<u>Description</u>	<u>Results</u>
Ambient Temperature	63°F
Glazing Temperature	66°F
Peak Positive Pressure	
Top Pressure	6.7 psi
Right Pressure	7.1 psi
Shell Pressure	6.3 psi
Average Pressure	6.7 psi
Positive Phase Duration	
Top Duration	13 msec
Right Duration	14 msec
Shell Duration	11 msec
Average Duration	13 msec
Positive Phase Impulse	
Top Impulse	47 psi-msec
Right Impulse	47 psi-msec
Shell Impulse	46 psi-msec
Average Impulse	47 psi-msec

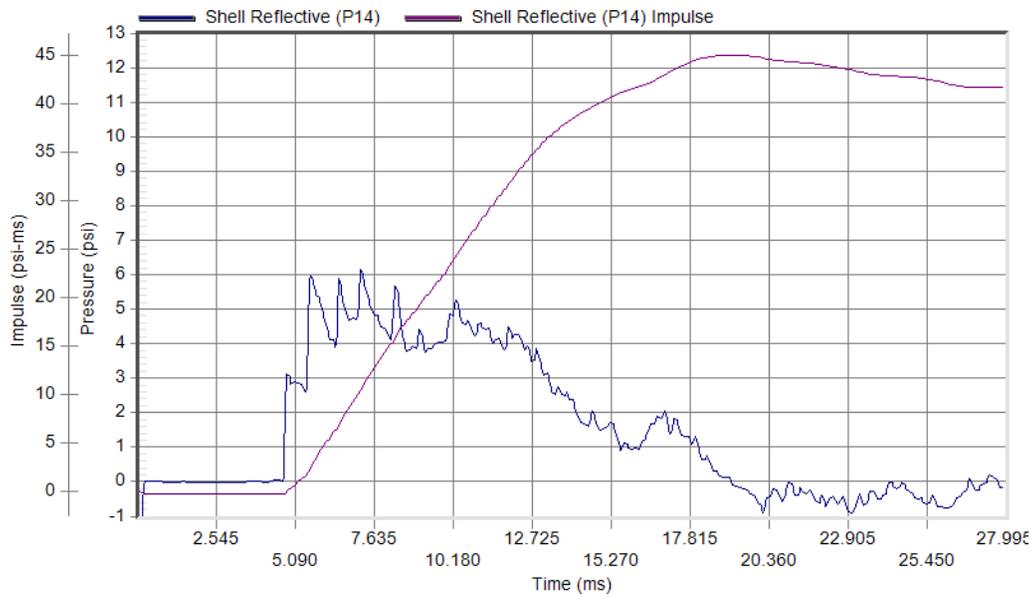
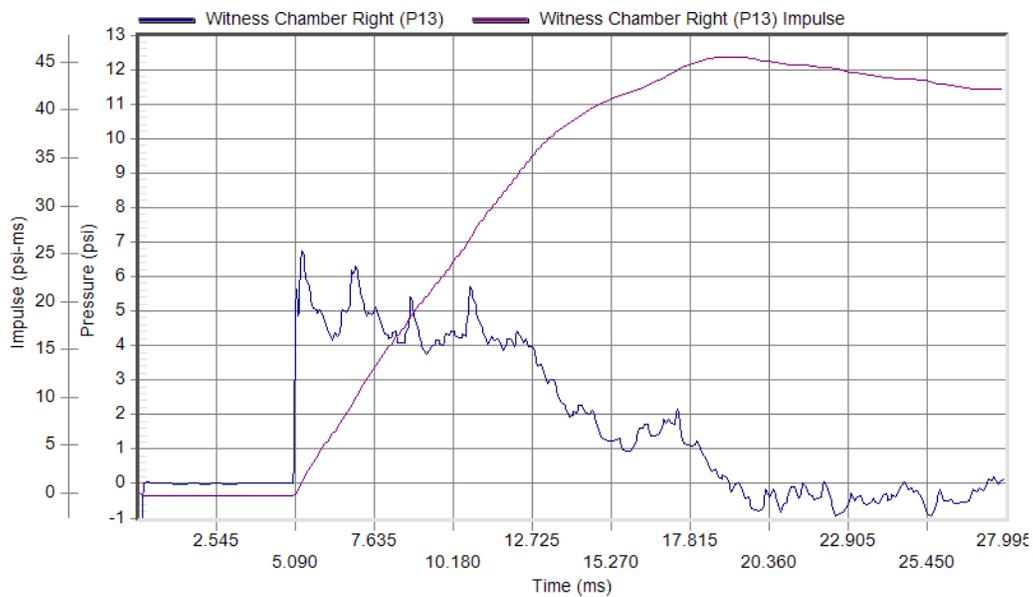
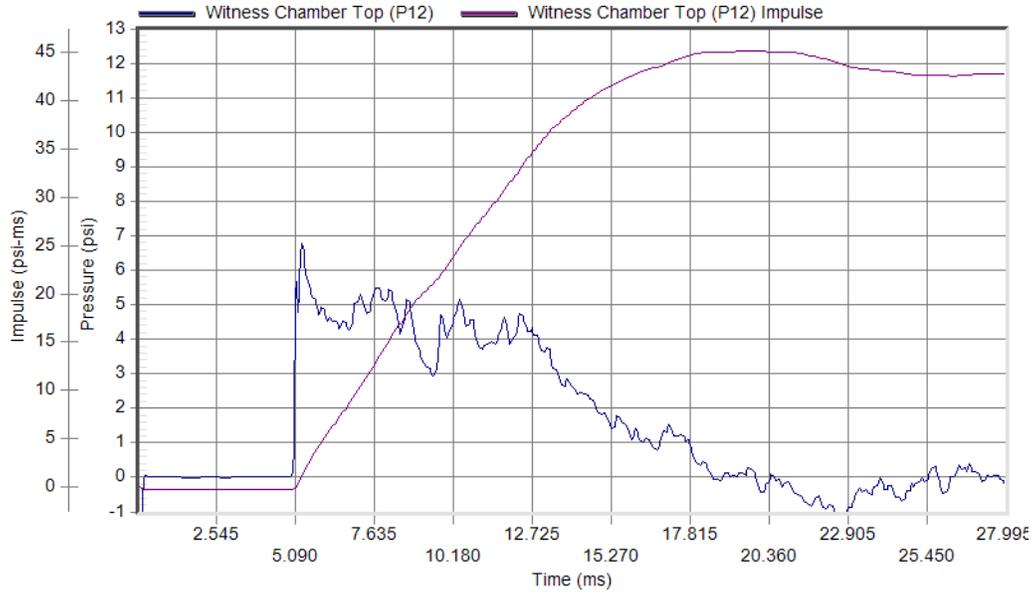
**Specimen #2**

Peak Pressure: 6.21 psi at 7.21 ms  
Duration: 11.92 ms

Peak Pressure: 6.83 psi at 5.31 ms  
Duration: 13.76 ms

Peak Pressure: 6.77 psi at 5.31 ms  
Duration: 13.20 ms

<u>Description</u>	<u>Results</u>
Ambient Temperature	63°F
Glazing Temperature	64°F
Peak Positive Pressure	
Top Pressure	6.8 psi
Right Pressure	6.8 psi
Shell Pressure	6.2 psi
Average Pressure	6.6 psi
Positive Phase Duration	
Top Duration	13 msec
Right Duration	14 msec
Shell Duration	12 msec
Average Duration	13 msec
Positive Phase Impulse	
Top Impulse	46 psi-msec
Right Impulse	45 psi-msec
Shell Impulse	45 psi-msec
Average Impulse	45 psi-msec

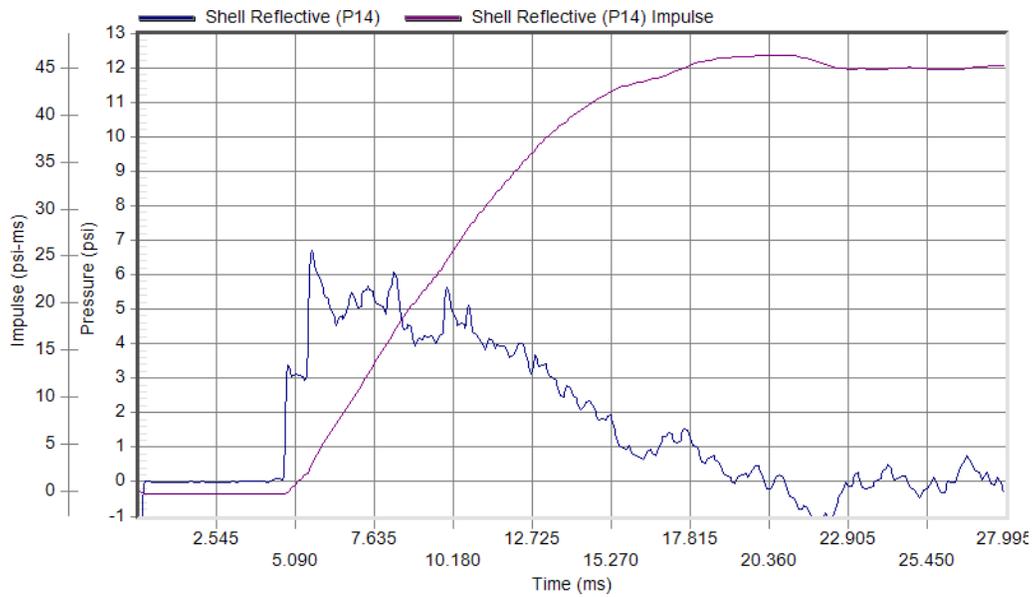
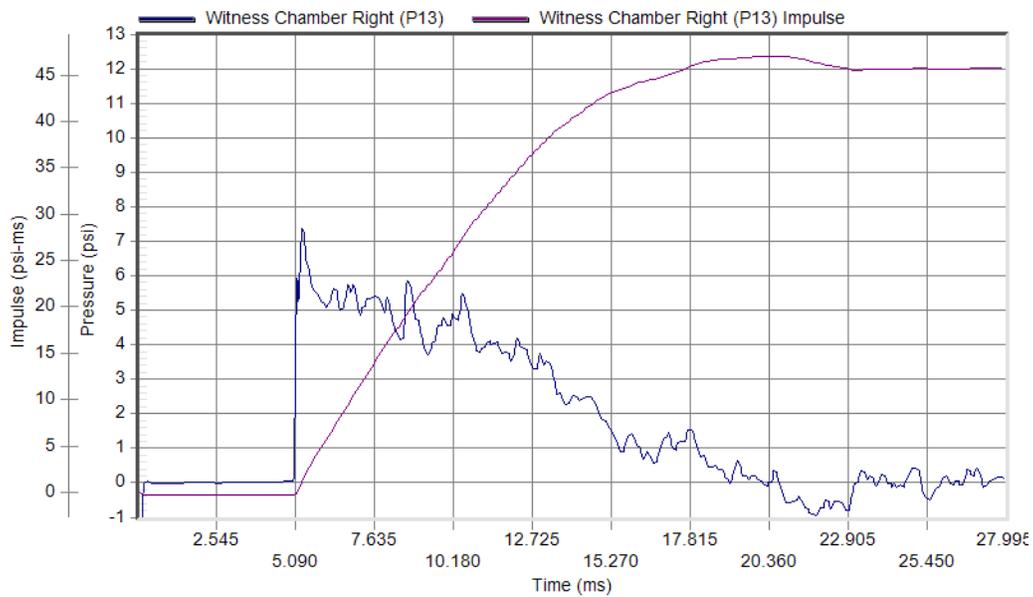
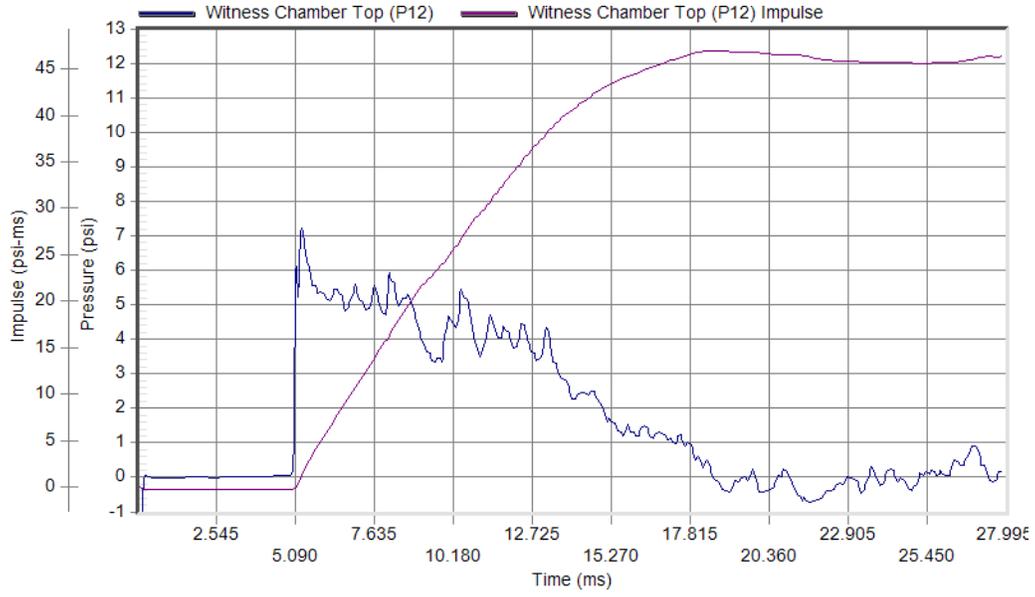
### Specimen #3

Peak Pressure: 6.70 psi at 5.61 ms  
Duration: 13.53 ms

Peak Pressure: 7.43 psi at 5.33 ms  
Duration: 13.73 ms

Peak Pressure: 7.26 psi at 5.30 ms  
Duration: 13.22 ms

<u>Description</u>	<u>Results</u>
Ambient Temperature	64°F
Glazing Temperature	64°F
Peak Positive Pressure	
Top Pressure	7.3 psi
Right Pressure	7.4 psi
Shell Pressure	6.7 psi
Average Pressure	7.1 psi
Positive Phase Duration	
Top Duration	13 msec
Right Duration	14 msec
Shell Duration	14 msec
Average Duration	14 msec
Positive Phase Impulse	
Top Impulse	47 psi-msec
Right Impulse	47 psi-msec
Shell Impulse	46 psi-msec
Average Impulse	47 psi-msec

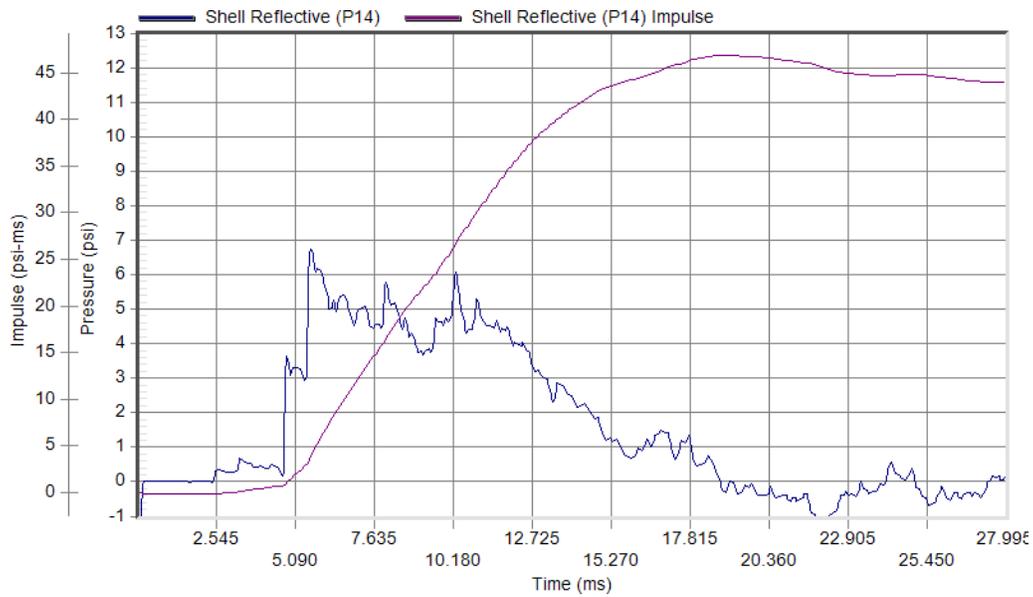
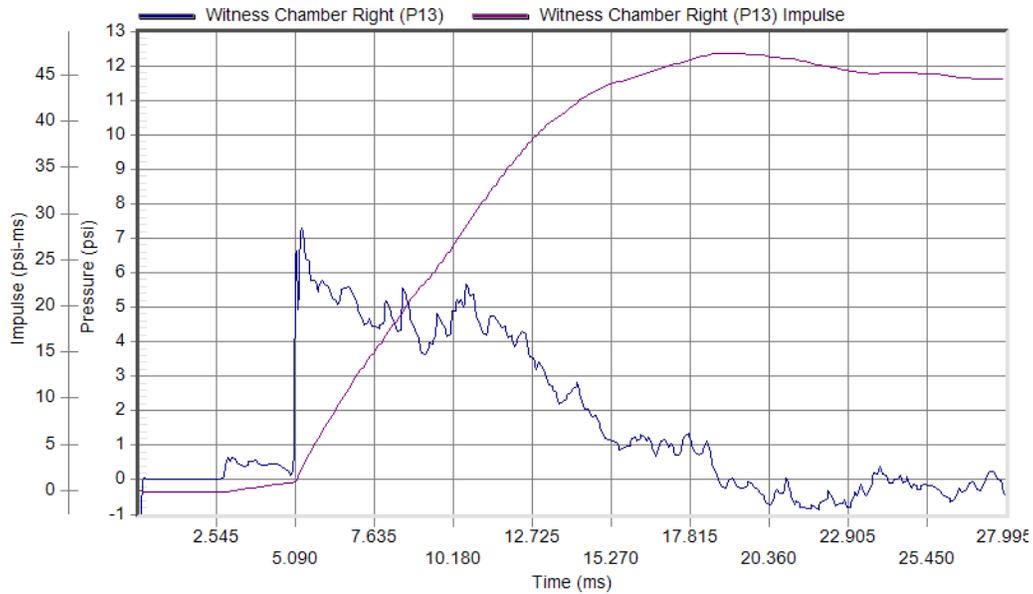
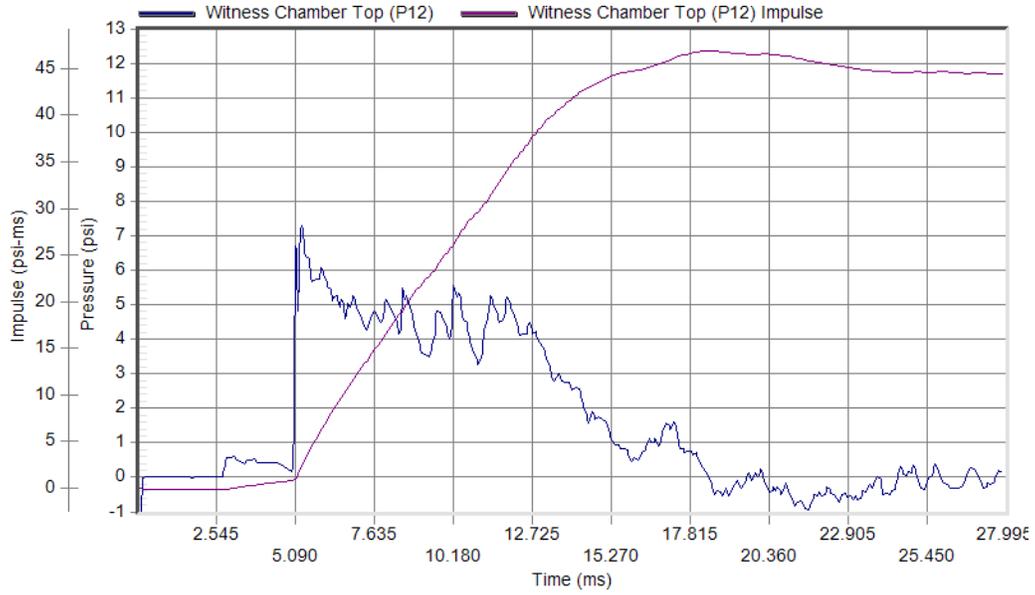
### Specimen #4

Peak Pressure: 6.76 psi at 5.58 ms  
Duration: 13.20 ms

Peak Pressure: 7.38 psi at 5.30 ms  
Duration: 13.43 ms

Peak Pressure: 7.32 psi at 5.29 ms  
Duration: 13.13 ms

<u>Description</u>	<u>Results</u>
Ambient Temperature	65°F
Glazing Temperature	67°F
Peak Positive Pressure	
Top Pressure	7.3 psi
Right Pressure	7.4 psi
Shell Pressure	6.8 psi
Average Pressure	7.2 psi
Positive Phase Duration	
Top Duration	13 msec
Right Duration	13 msec
Shell Duration	13 msec
Average Duration	13 msec
Positive Phase Impulse	
Top Impulse	46 psi-msec
Right Impulse	47 psi-msec
Shell Impulse	46 psi-msec
Average Impulse	46 psi-msec

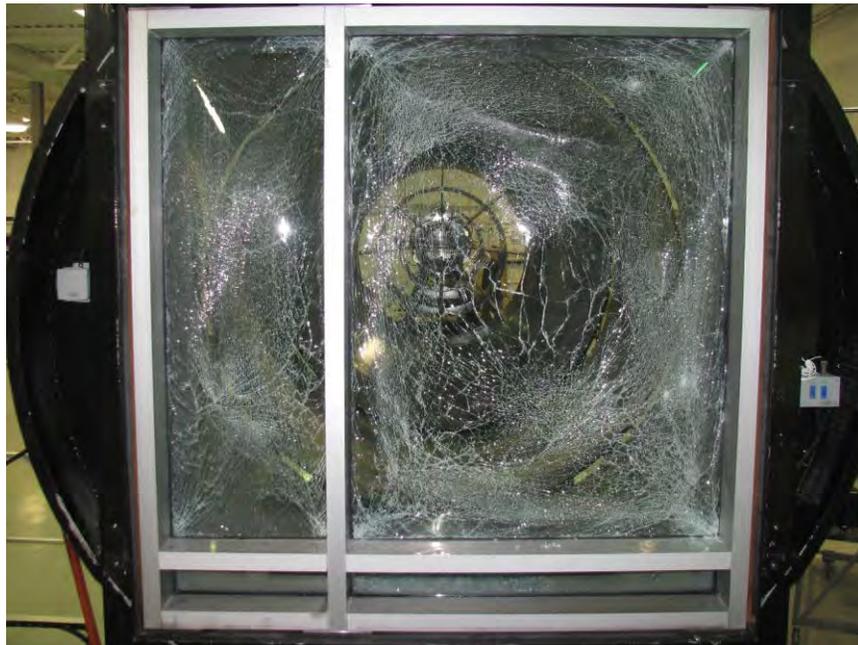
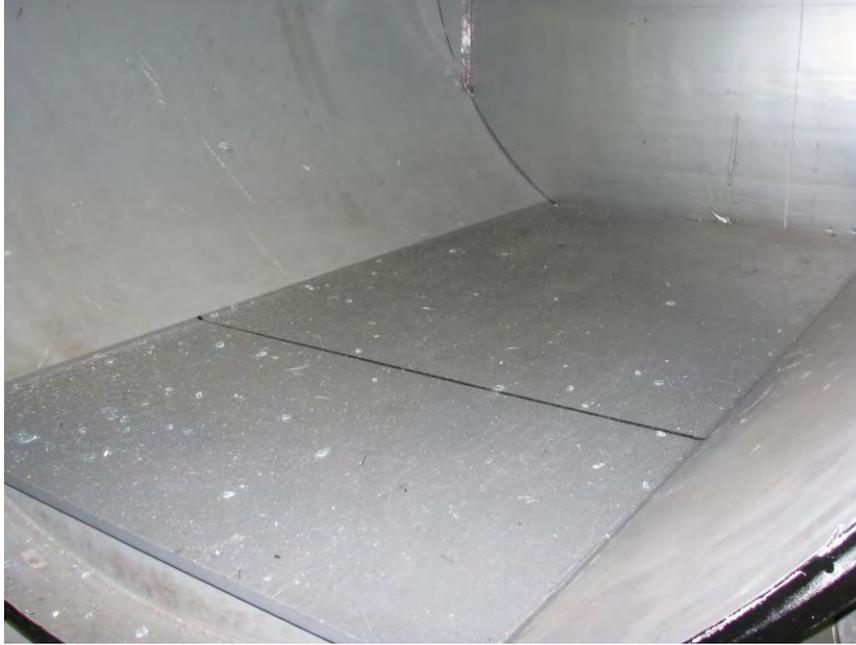
- No pressure rise was measured on the protected side of the specimen.
- Two 24" long tears in the laminate of the large lite and approximately 8" pull-out along the left jamb. One tear approximately 16" long on the large side lite. Total tears and pull-out for the large lite was greater than 20% of the sight perimeter.
- Fragments were observed in the witness area, with a sum total united dimension less than 10" in the 1m-3m area. Three impacts on the back wall were observed below the 24" line.

ASTM Hazard Rating: Very Low Hazard

GSA Performance Condition: 4

**Photo No. 2**  
Post-test Specimen #1, Interior

**Photo No. 3**  
Post-test Specimen #1, Witness Chamber

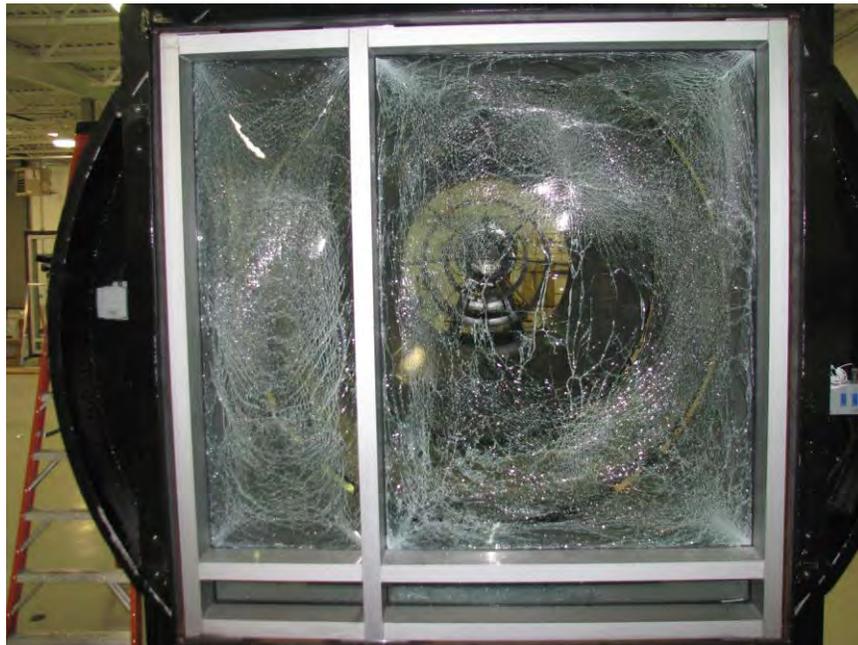
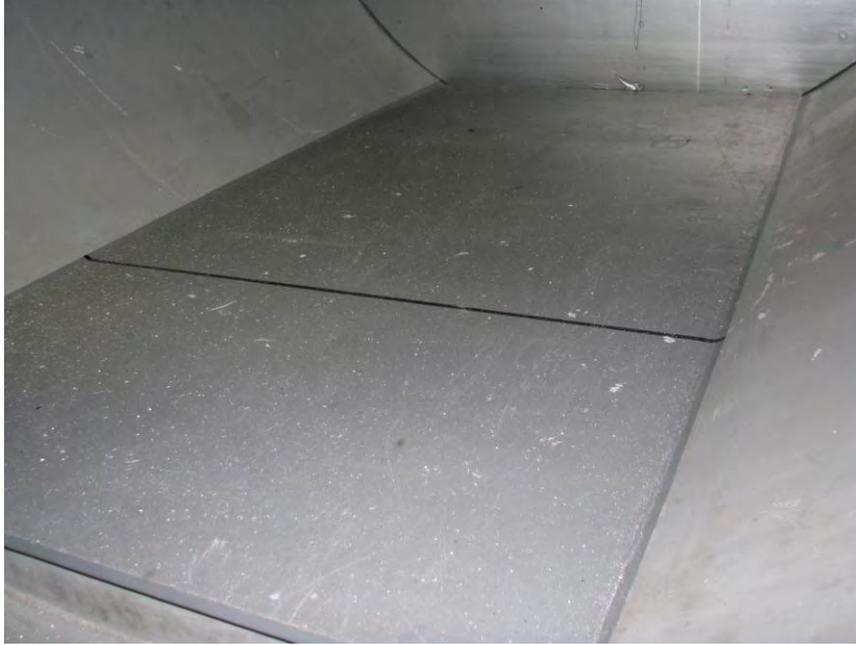
- No pressure rise was measured on the protected side of the specimen.
- A 14-1/2" tear in the laminate was observed at the top center of the large lite and 43" of pull-out was observed along the right jamb of the large lite. Total tears and pull-out for the large lite was greater than 20% of the sight perimeter.
- Dusting of glass in the witness area. No fragments or damage to the back panel was observed.

ASTM Hazard Rating: Very Low Hazard

GSA Performance Condition: 2

**Photo No. 5**  
Post-test Specimen #2, Interior

**Photo No. 6**  
Post-test Specimen #2, Witness Chamber

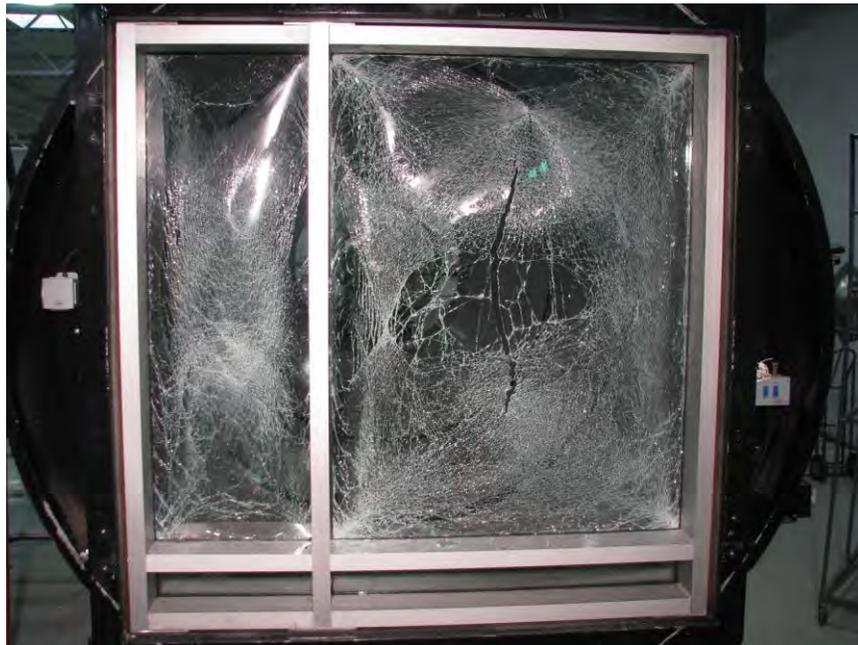
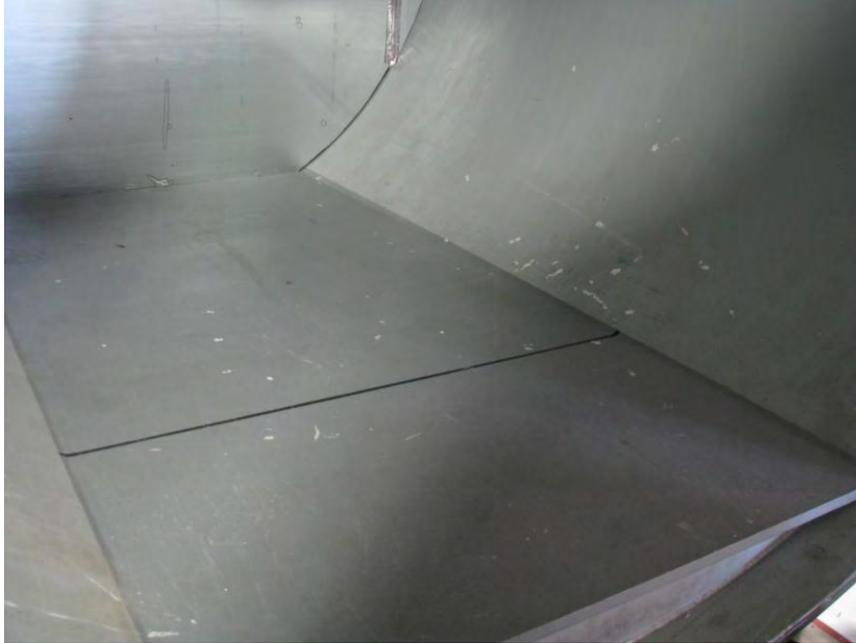
- No pressure rise was measured on the protected side of the specimen.
- A 43" long vertical tear in the laminate was observed at the center of the large lite. No pull-out was observed at the perimeter glazing.
- Multiple fragments were observed in the witness area with approximately 63" sum total united dimensions in the 1m-3m area. Thirteen indents were observed in the wall panel below the 24" line.

ASTM Hazard Rating:           Low Hazard

GSA Performance Condition:       4

**Photo No. 8**  
Post-test Specimen #3, Interior

**Photo No. 9**  
Post-test Specimen #3, Witness Chamber

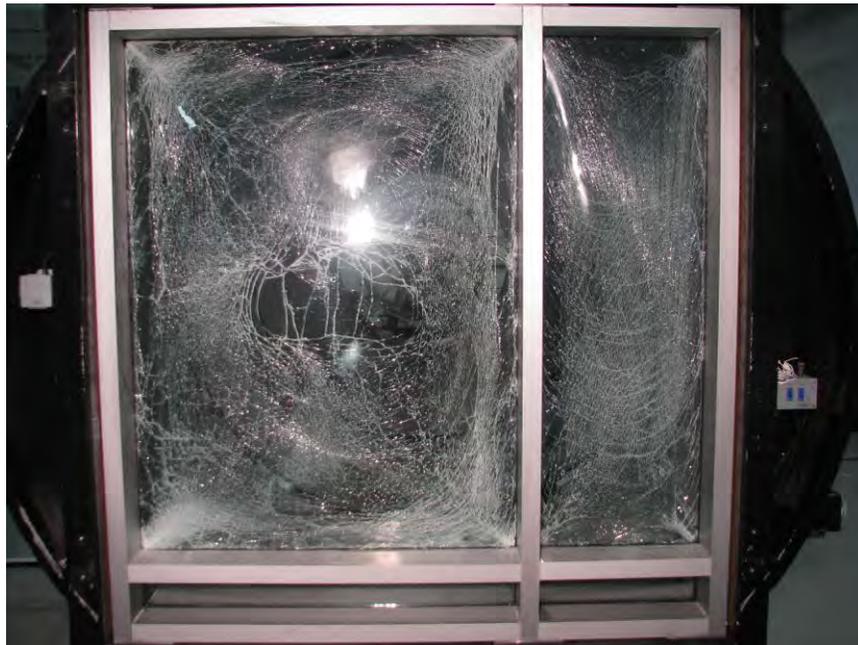
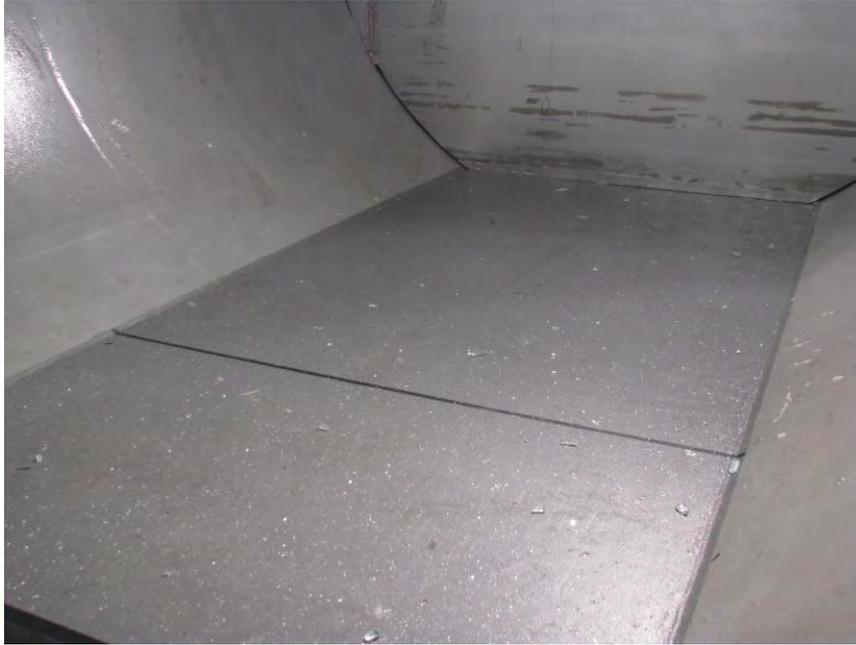
- No pressure rise was measured on the protected side of the specimen.
- A 43" horizontal tear in the laminate was observed at the center of the large lite, 39-1/2" of pull-out was observed out along the mullion and 29-1/2" pull-out was observed along the left jamb of the large lite. Total tears and pull-out for the large lite was greater than 20% of the sight perimeter.
- Multiple fragments were observed in the witness area with approximately 14" sum total united dimensions in the 1m-3m area. One fragment indent was observed on the back witness panel, 1" from the floor.

ASTM Hazard Rating:           Low Hazard

GSA Performance Condition:       4

**Photo No. 11**  
Post-test Specimen #4, Interior

**Photo No. 12**  
Post-test Specimen #4, Witness Chamber

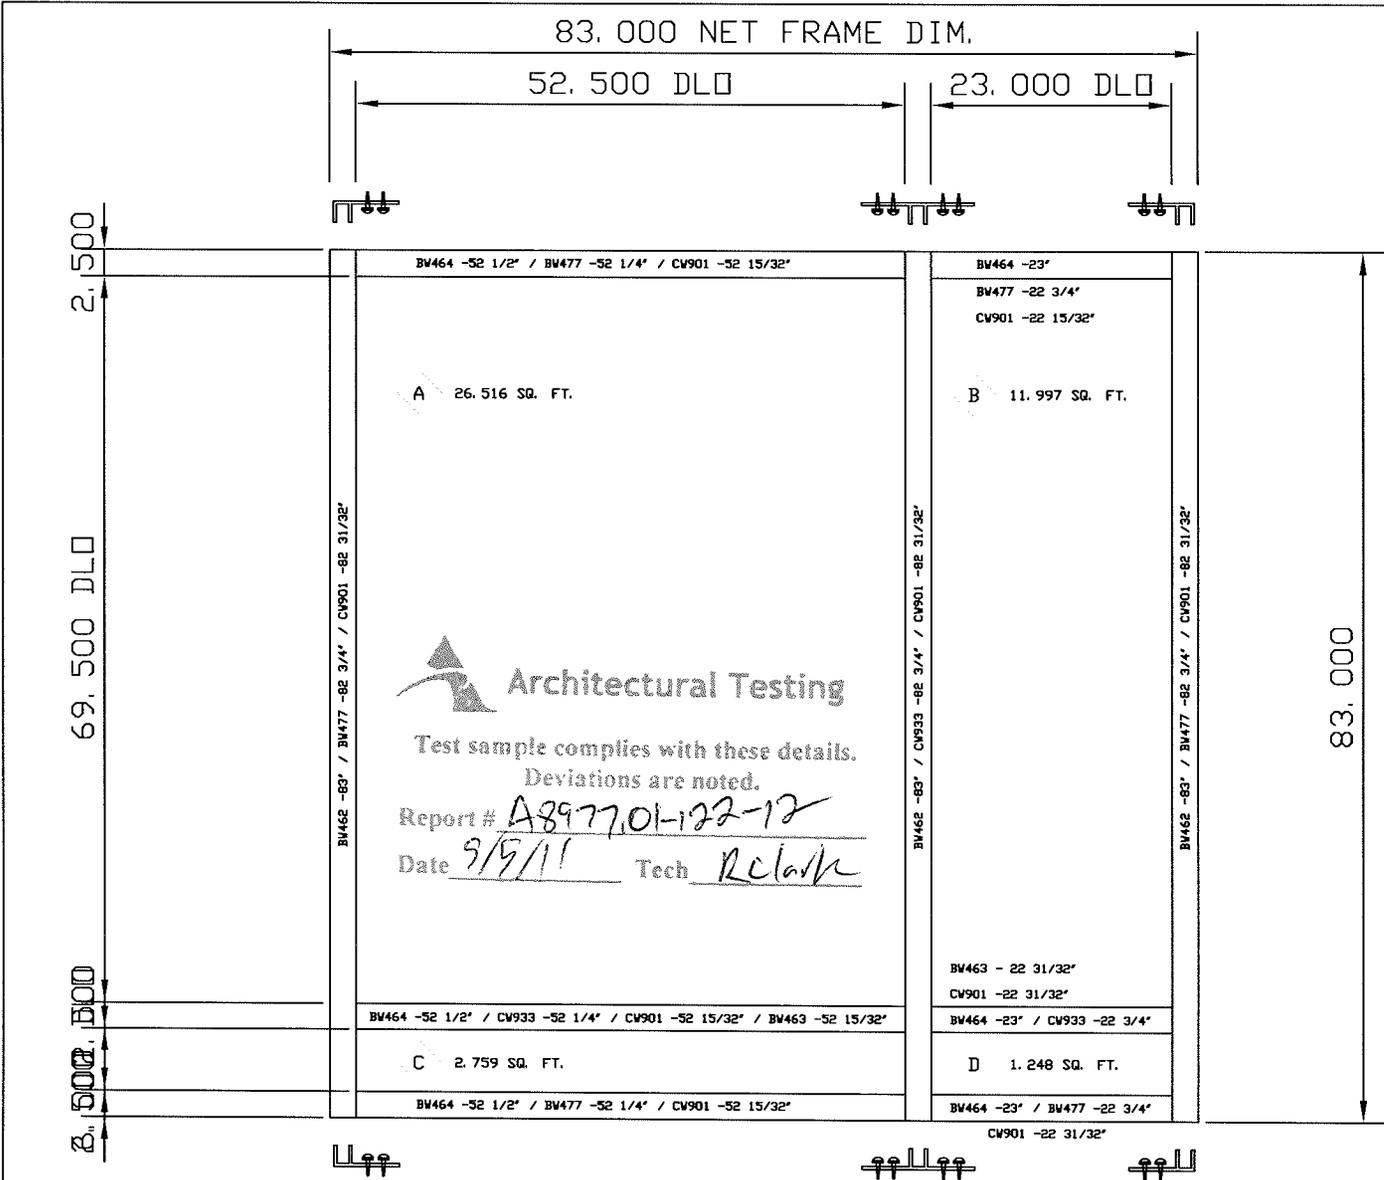
SYMBOL	DESCRIPTION	QTY
	AC462 "T" CLIP @ 5" LONG	2
	AC461 "F" CLIP @ 5" LONG	4
	1/2-13 x 1 1/2" GR5 BOLT	24
	1/2-13 x 1 1/2" GR5 BOLT	36
	1/4-20 x 3/4" FH GR2 MS	24
	1/4-20 x 3/4" FH GR2 MS	12

- 10.8 PSI FOR LESS THAN 10.8 SQ. FT.
- 4.4 PSI FOR GREATER THAN 10.8 SQ. FT. BUT LESS THAN 32 SQ. FT.

DRAWN BY J. FREY	SYSTEM SERIES BR3250
DATE 02/28/11	BLAST WALL SYSTEM FOR DoD
APPROVED BY	DESCRIPTION ELEVATION & ANCHORS
SCALE 1" = 1'0"	DRAWING NO. USA-3145
	SHEET 2 OF 20

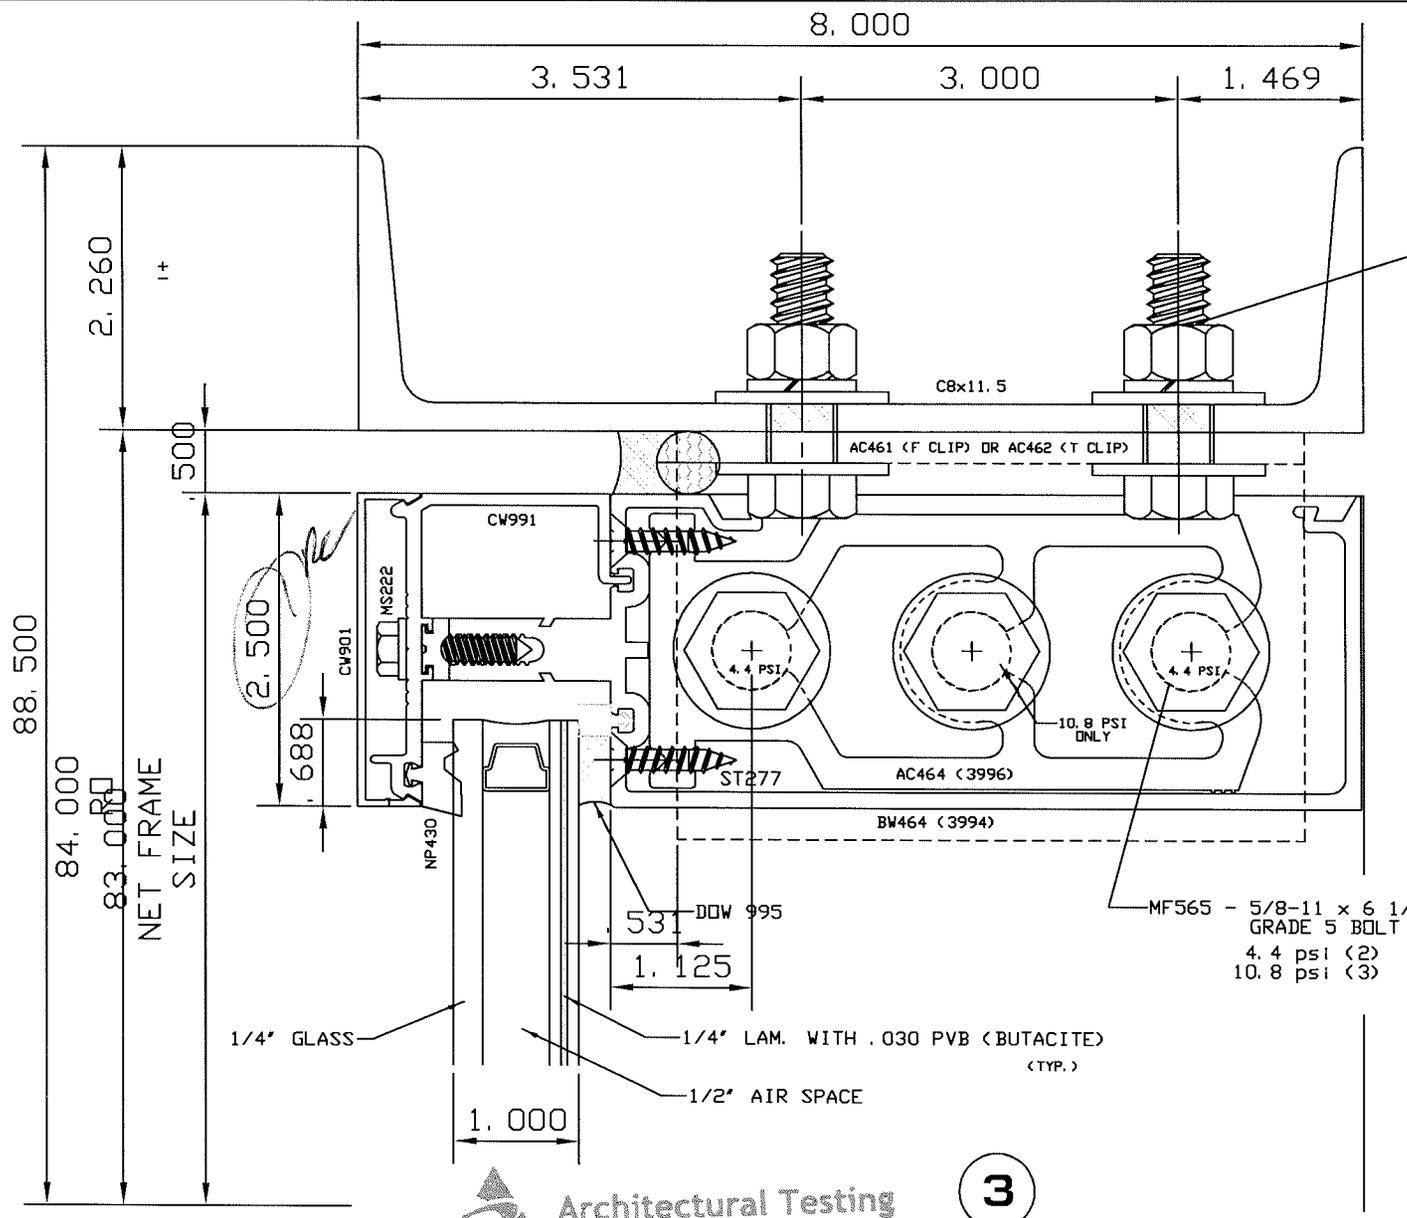
1/2-13 X 1 3/4" GRADE 5 BOLT  
FLAT WASHER + LOCK WASHER  
SEE ELEV. FOR SPACING

<b>United States Aluminum</b> • 720 Cel-River Road Rock Hill, SC 29730 • 200 Singleton Drive Waxahachie, TX 75165		
DRAWN BY J. FREY	SYSTEM SERIES BR3250 BLAST WALL SYSTEM FOR DoD	DATE 02/28/11
APPROVED BY	DESCRIPTION DETAILS (HEAD)	SCALE FULL SIZE
DRAWING NO. USA-3145	SHEET 3 OF 20

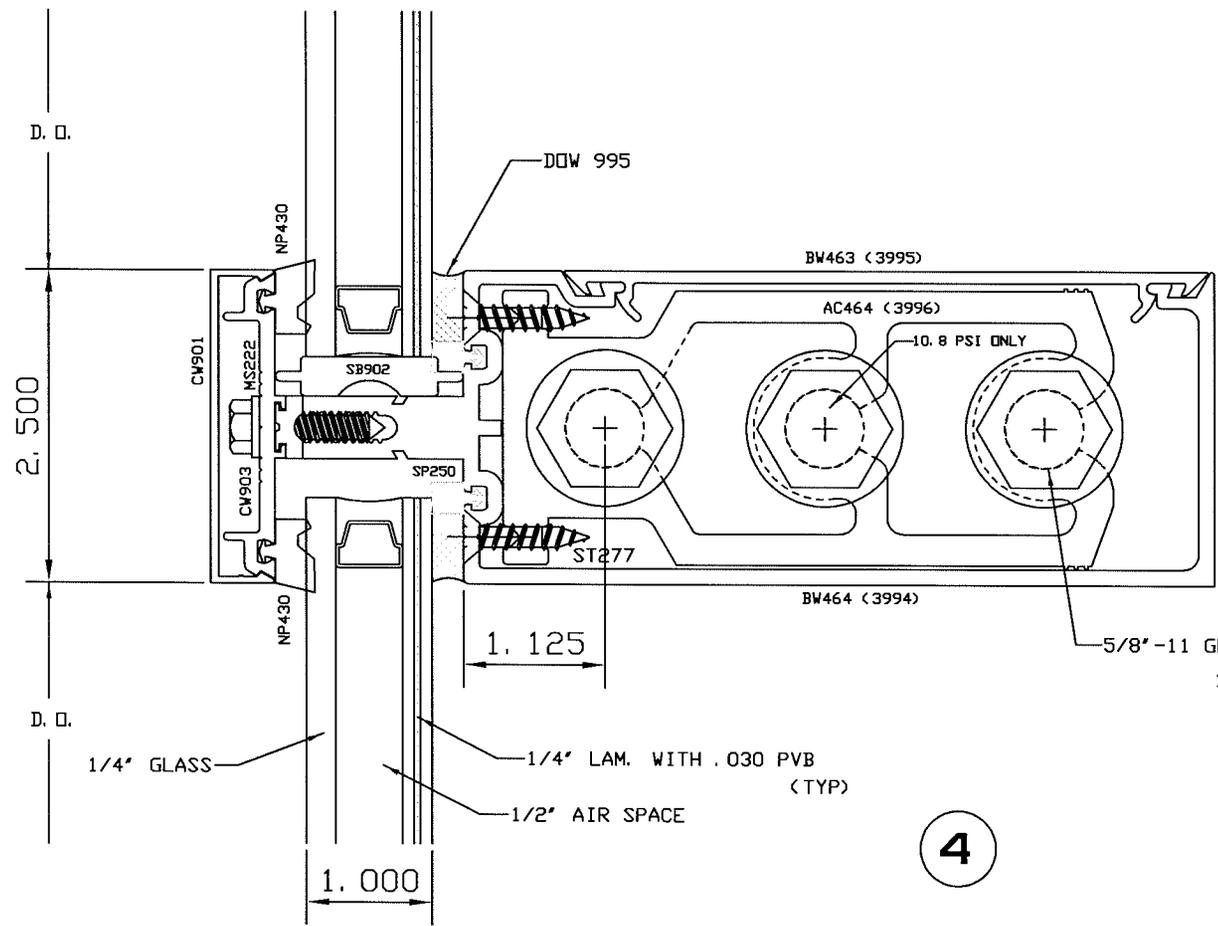
5/8" - 11 GRADE 5 BOLTS  
 4.4 psi (2)  
 10.8 psi (3)

<b>United States Aluminum</b> • 720 Cel-River Road Rock Hill, SC 29730 • 200 Singleton Drive Vauxhall, TX 75165		
DRAWN BY J FREY	SYSTEM SERIES BR3250 BLAST WALL SYSTEM FOR DoD	
DATE 3/02/11		
APPROV BY	DESCRIPTION DETAILS (HOR MULL)	
SCALE FULL SIZE	DRAWING NO. USA-3145	SHEET 4 OF 20

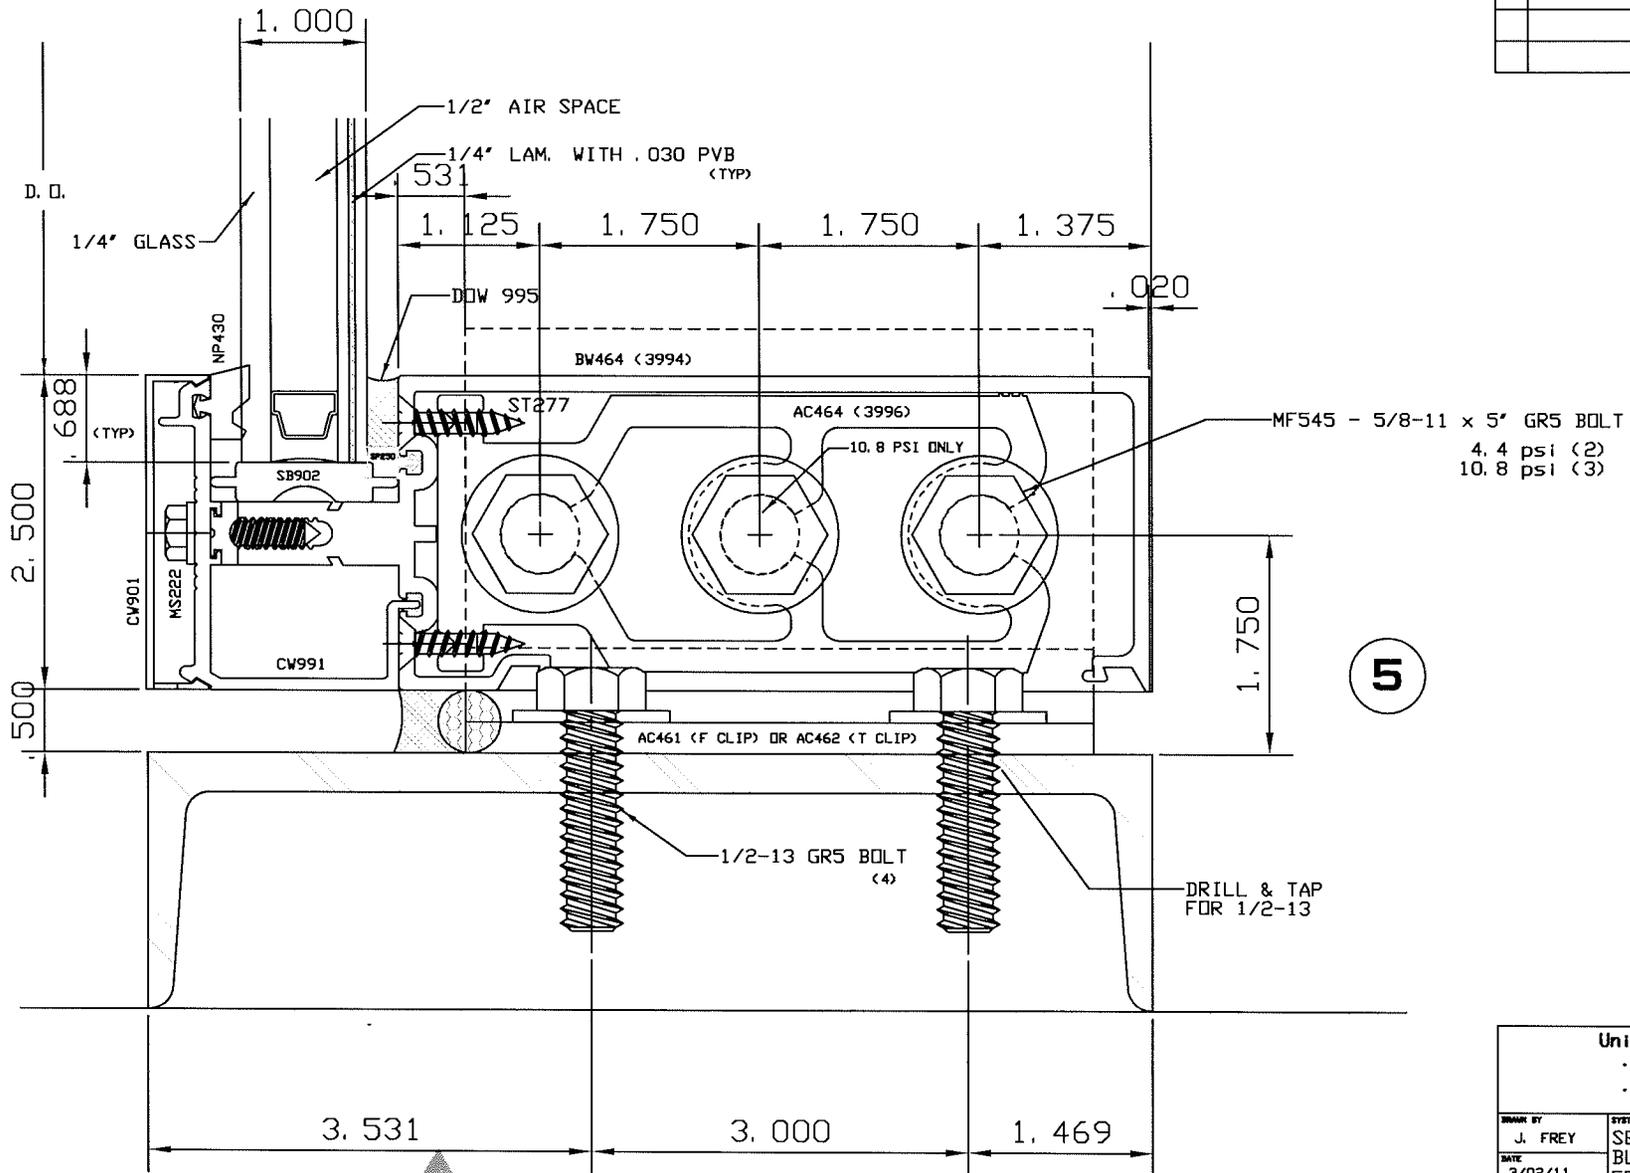
<b>United States Aluminum</b> • 720 Cel-River Road Rock Hill, SC 29730 • 200 Singleton Drive Waxahatchie, TX 75165		
DRAWN BY J. FREY	SYSTEM SERIES BR3250 BLAST WALL SYSTEM FOR DoD	
DATE 3/02/11		
APPROVED BY	DESCRIPTION DETAILS (SILL)	
SCALE FULL SIZE	DRAWING NO. USA-3145	SHEET 5 OF 20
