**ASTM F 1642-04/GSA TS01  
TEST REPORT**

**UNITED STATES ALUMINUM**

**SERIES/MODEL: BW3250**

**PRODUCT TYPE: Aluminum Combination Fixed Window**

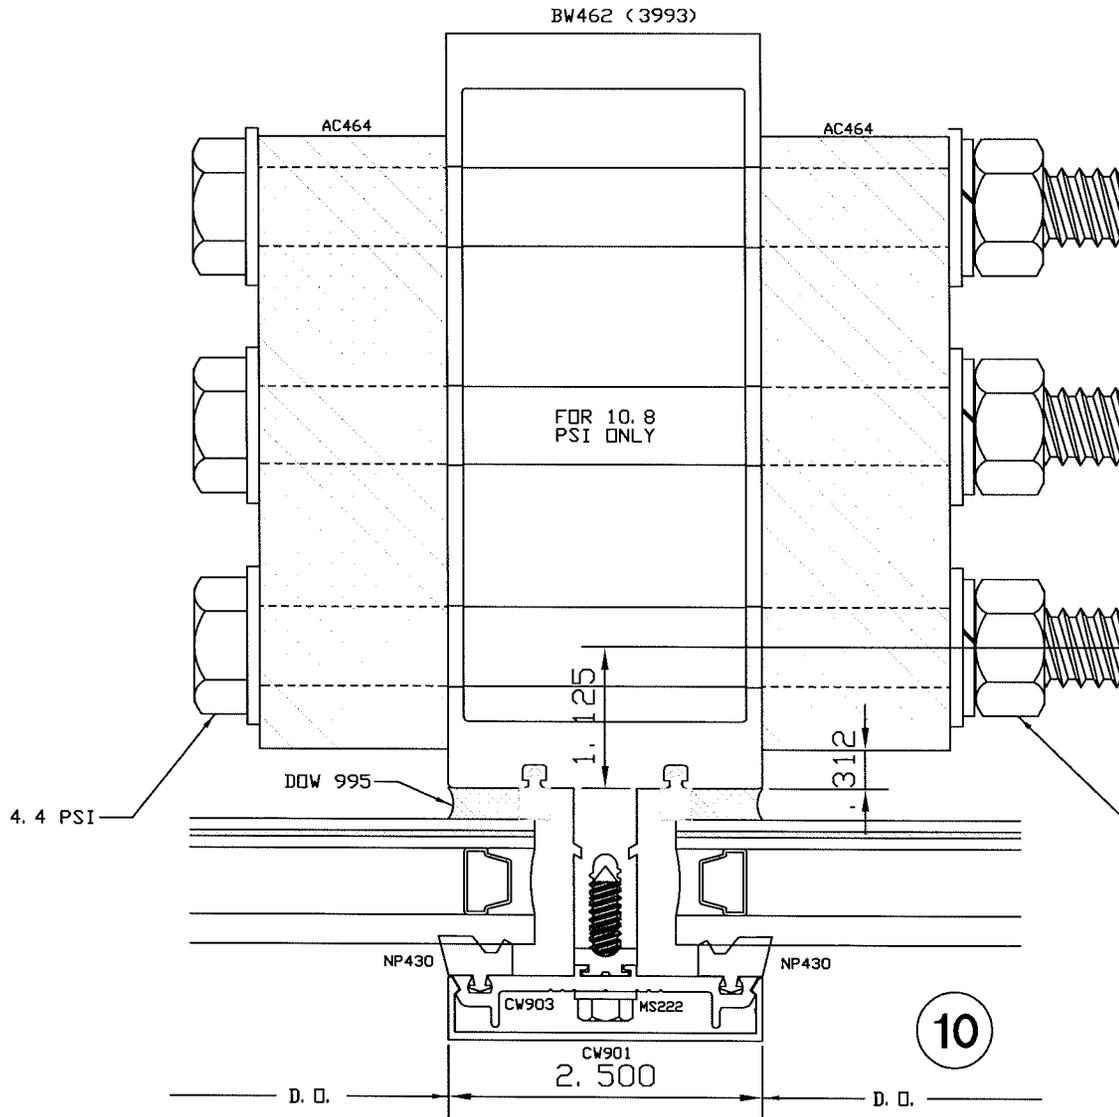
- MF565 - 5/8-11 X 7" GR5 BOLT  
4.4 psi (2)  
10.8 psi (3)
- MF255 - 5/8 NARROW FLAT WASHER  
4.4 psi (4)  
10.8 psi (6)
- MF256 - 5/8 LOCK WASHER, SPLIT  
4.4 psi (2)  
10.8 psi (3)
- MF219 - 5/8-11 HEX NUT, NYLOC  
4.4 psi (2)  
10.8 psi (3)

DESIGNED BY J. FREY	SYSTEM SERIES BR3250 BLAST WALL SYSTEM FOR DoD
DATE 3/02/11	
APPROVED BY	DESCRIPTION DETAILS SHEAR BLOCK AT VERTICAL
SCALE FULL SIZE	DRAWING NO. USA-3145 SHEET 10 of 20

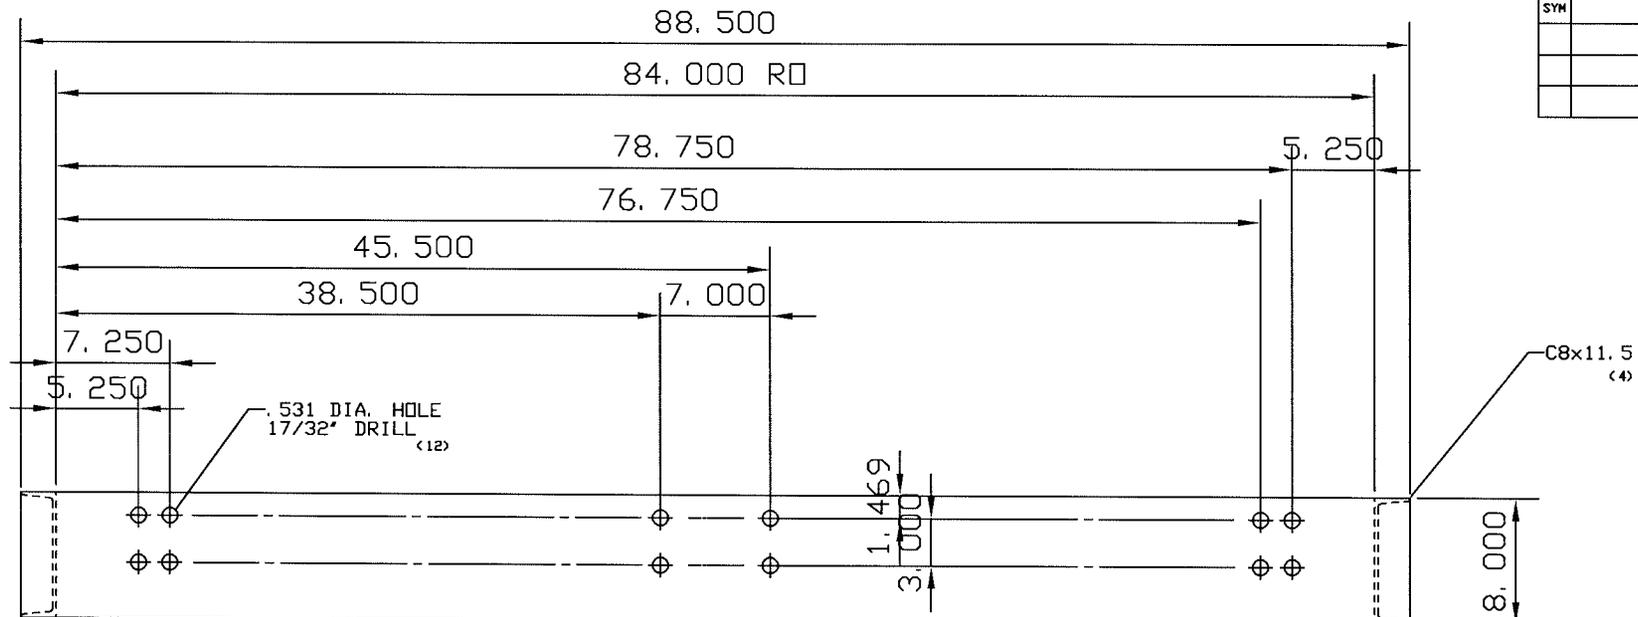
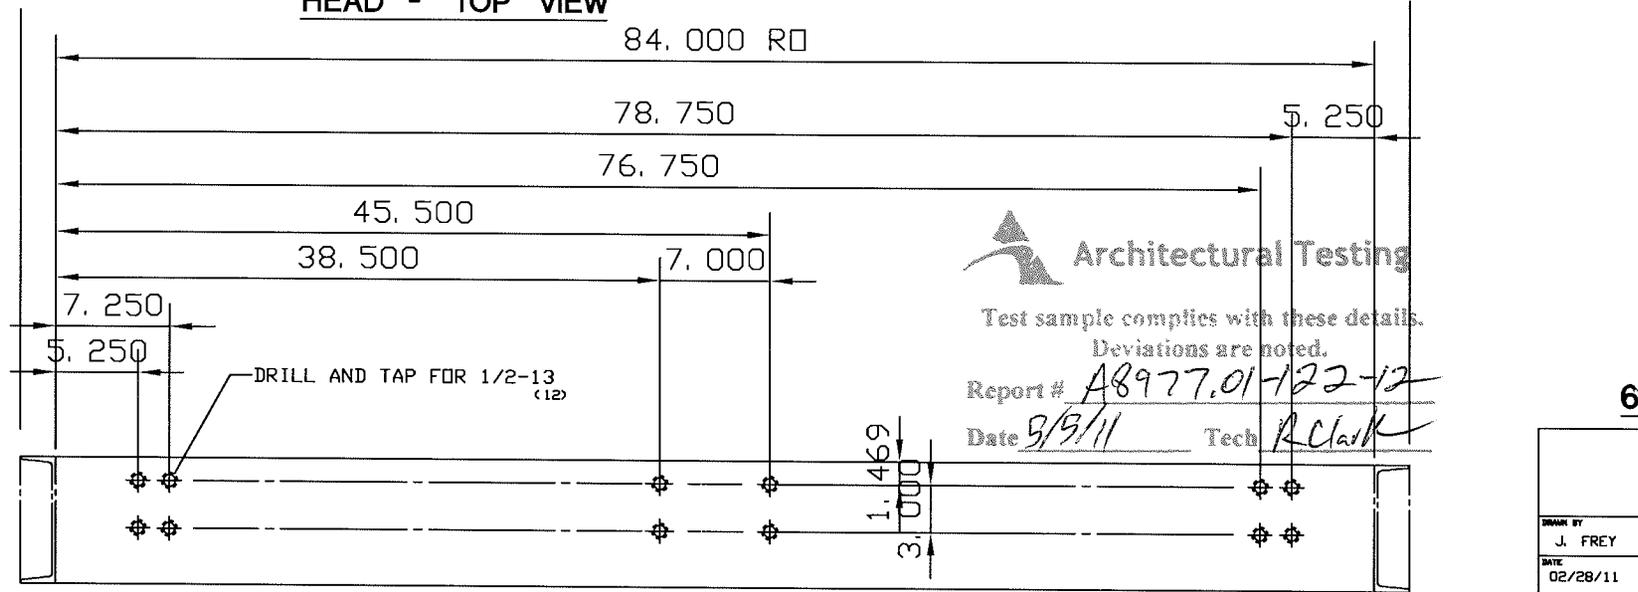
**HEAD - TOP VIEW**

**SILL - TOP VIEW**
