CR LAURENCE CO. INC.

ACOUSTICAL PERFORMANCE TEST REPORT

ASTM E90 SOUND TRANSMISSION LOSS TESTING ON A PALISADES S100, SLIDING GLASS DOOR

L8956.04-303-11-R0

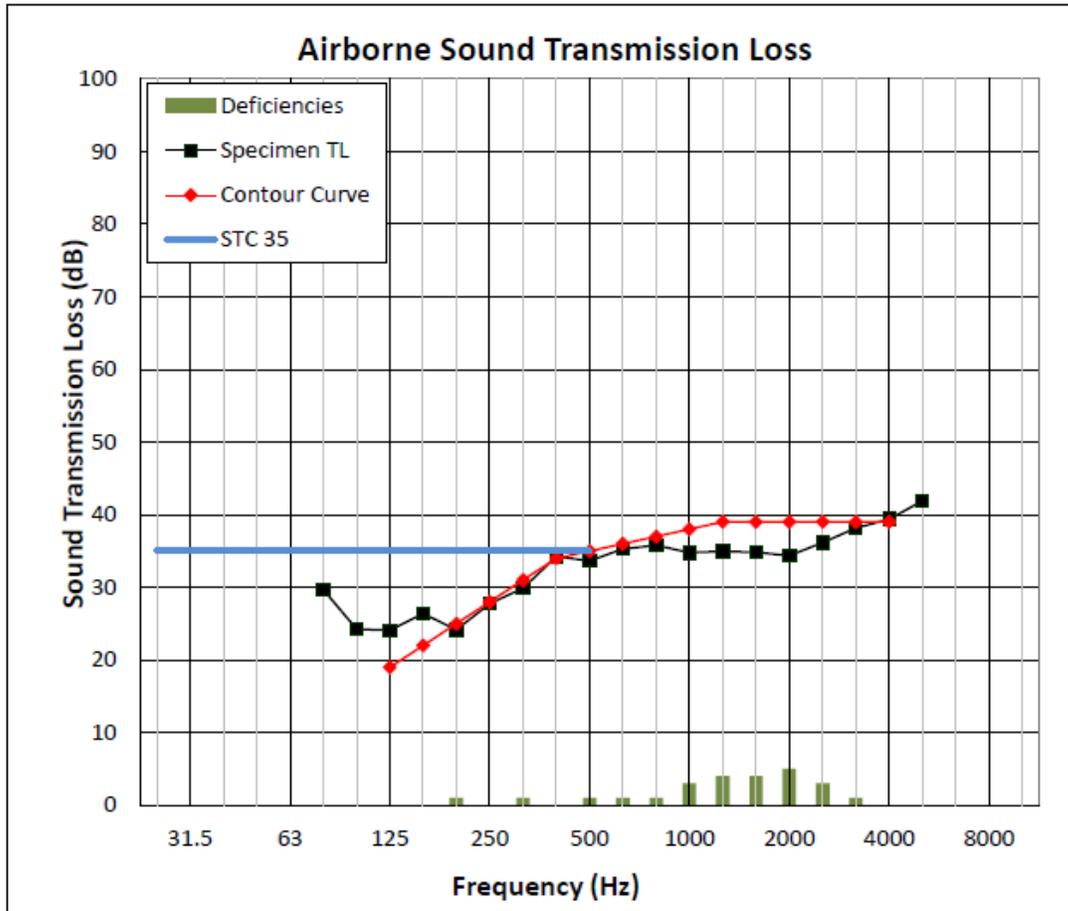
ASTM E90 AIRBORNE SOUND TRANSMISSION LOSS

TEST DATE	03/02/21				
DATA FILE NO.	L8956.01C				
CLIENT	CR Laurence Co. Inc.				
DESCRIPTION	Series/Model: Palisades S100, Sliding Glass Door with 1" IG (1/4" Tempered Exterior, 3/8" Air Space, 3/8" Tempered Interior)				
SPECIMEN AREA	4.03 m ²	RECEIVE TEMP.	18.8 °C	SOURCE TEMP	18.8 °C
TECHNICIAN	Eric T Rueda	RECEIVE HUMIDITY	32%	SOURCE HUMIDIT	31%

FREQ (Hz)	BACKGROUND SPL (dB)	ABSORPTION (m ²)	SOURCE SPL (dB)	RECEIVE SPL (dB)	SPECIMEN TL (dB)	95% CONFIDENCE LIMIT	NUMBER OF DEFICIENCIES
80	35.3	4.4	104	74	30	1.98	-
100	30.9	4.3	102	78	24	0.87	-
125	38.7	4.8	102	78	24	0.73	0
160	43.9	5.1	102	75	26	1.21	0
200	38.4	6.4	106	80	24	0.78	1
250	33.0	7.1	106	76	28	0.41	0
315	36.1	7.2	106	74	30	0.39	1
400	41.2	6.4	105	69	34	0.42	0
500	24.8	5.5	106	71	34	0.70	1
630	21.4	6.0	106	69	35	0.36	1
800	24.2	6.1	105	68	36	0.23	1
1000	16.3	6.2	107	70	35	0.18	3
1250	14.3	6.5	105	68	35	0.18	4
1600	6.6	7.3	103	65	35	0.27	4
2000	4.3	8.9	101	63	34	0.20	5
2500	3.8	10.4	100	60	36	0.19	3
3150	4.1	12.6	100	57	38	0.26	1
4000	4.7	16.3	96	50	39	0.32	0
5000	5.5	21.6	92	42	42	0.43	-
STC RATING	35 (Sound Transmission Class)						
DEFICIENCIES	25 (Sum of Deficiencies)						
OITC RATING	31 (Outdoor-Indoor Transmission Class)

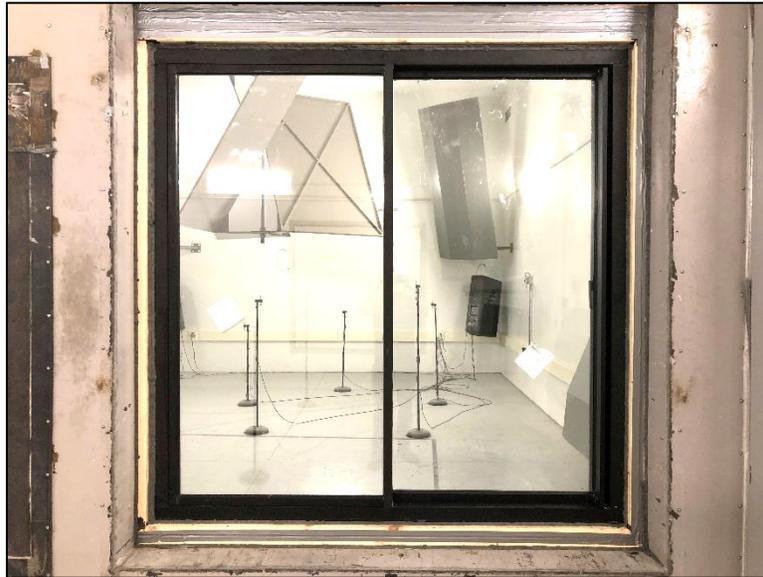
Photo No. 1
Source Room View of Test Specimen

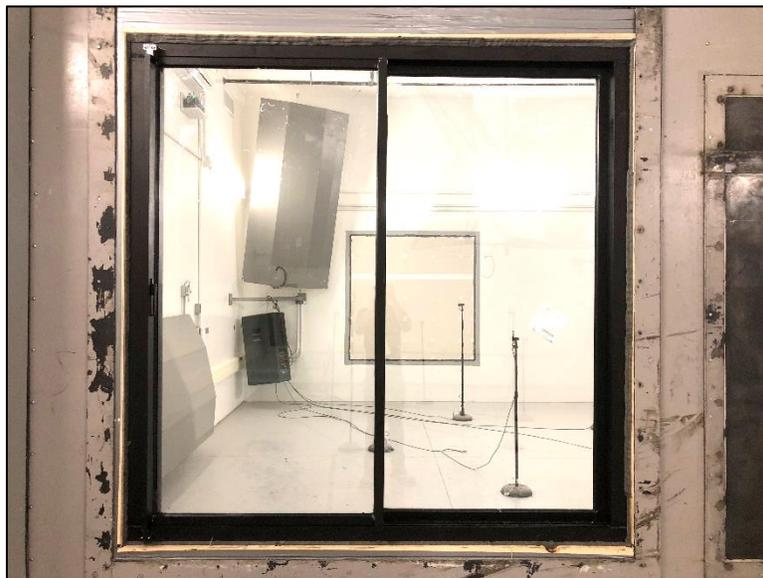
Photo No. 2
Receive Room View of Test Specimen

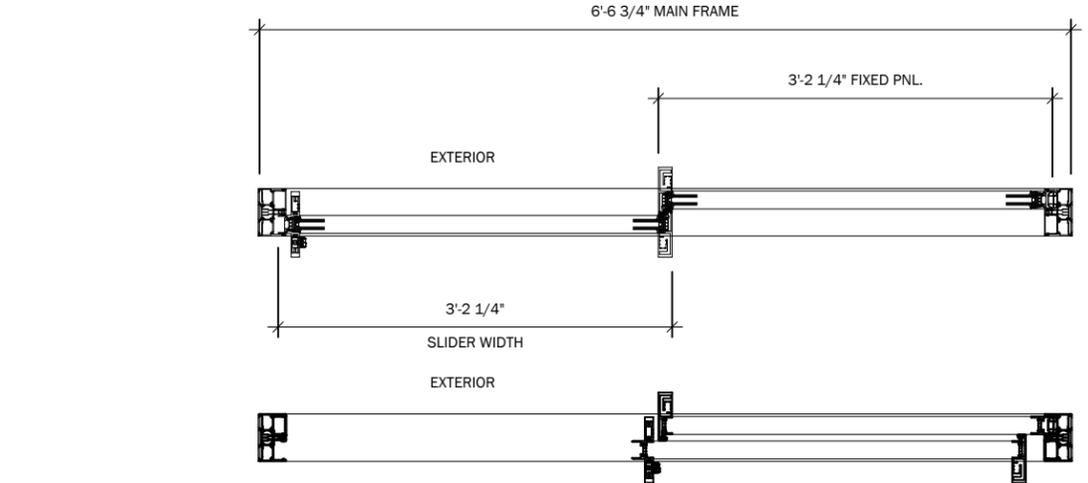
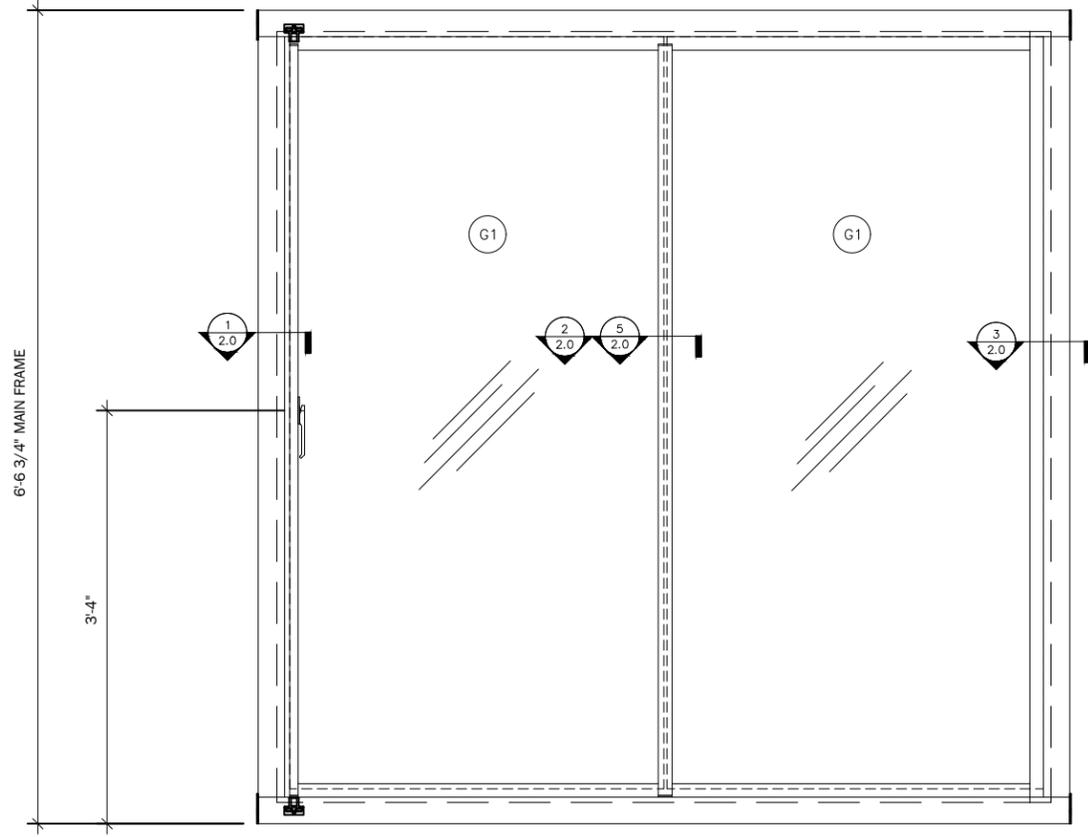
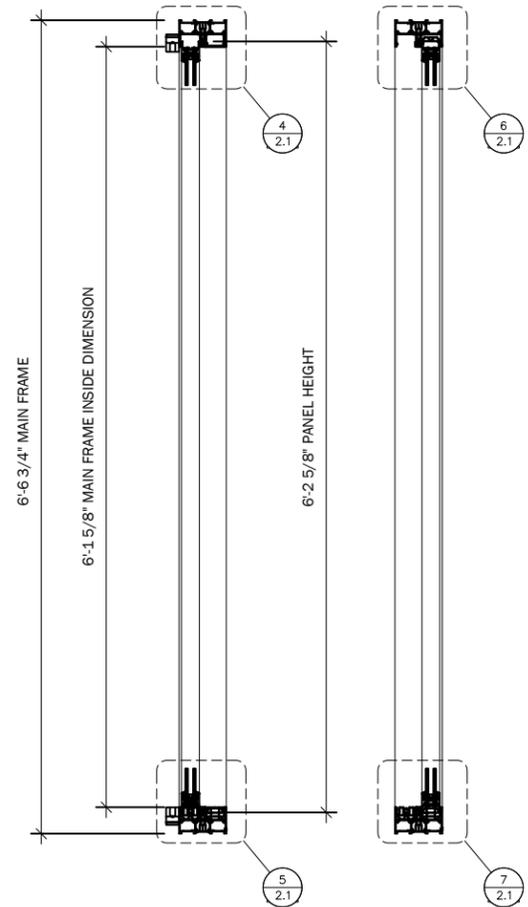
Sheet No.
1.0

PALISADES S100 SLIDER CONFIGURATION	
PTC #	1011117 - ACOUSTIC
CUSTOMER PO #	CR Laurence Co., Inc
SYSTEM:	S100
FRAME & PANEL FINISH:	DARK BRONZE ANODIZE - CLASS 1
HARDWARE FINISH:	BLACK
SILL:	RAISED
CONFIGURATION:	XO
GLAZING:	1" INSULATED
QTY:	1 (ONE) THUS

① ELEVATION-EXTERIOR
ARCH REF: NONE

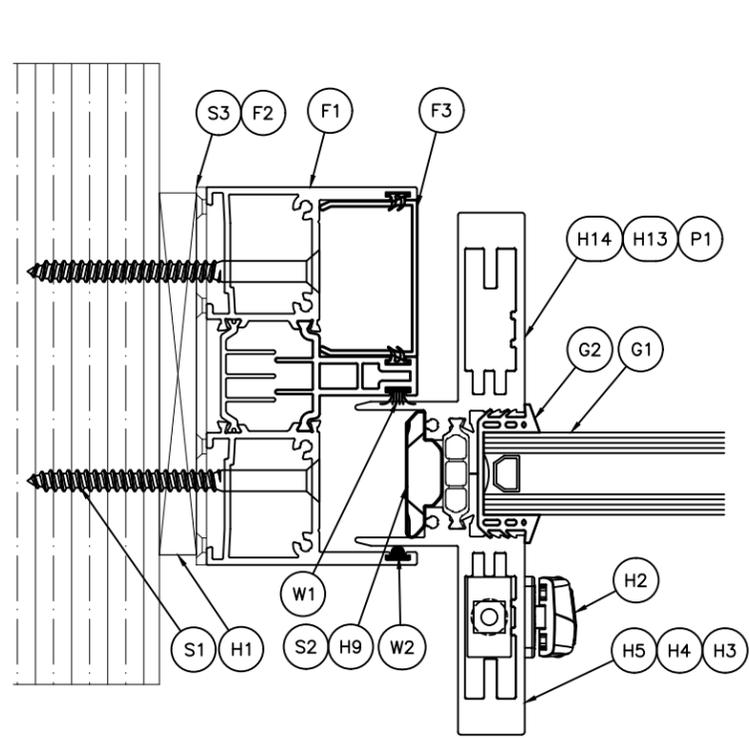
① SLIDER JAMB DETAIL

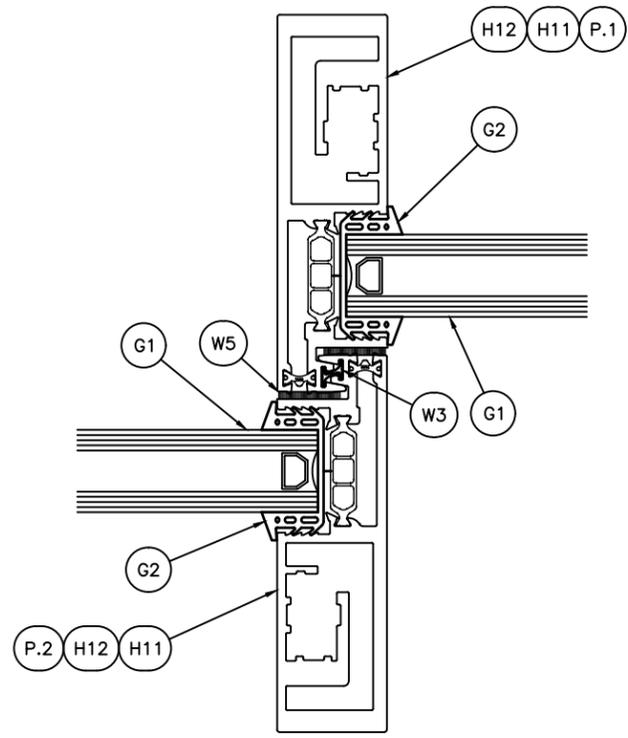
② INTERLOCK DETAIL (LARGE)

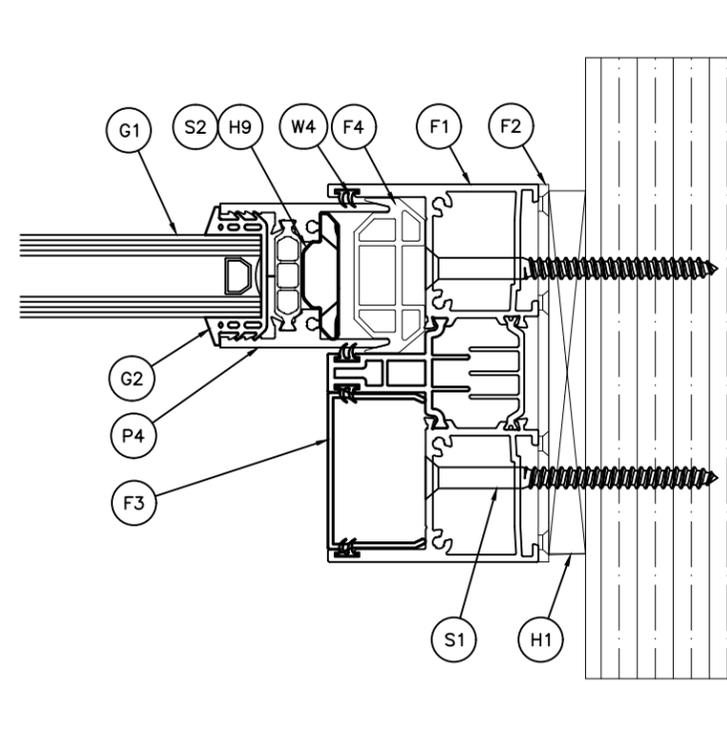
③ FIXED JAMB DETAIL

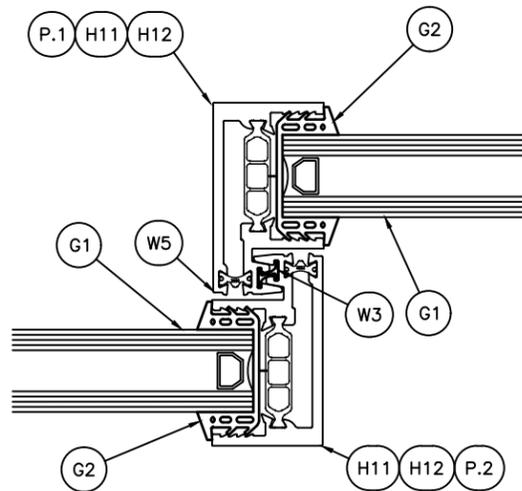
② INTERLOCK DETAIL (SMALL)

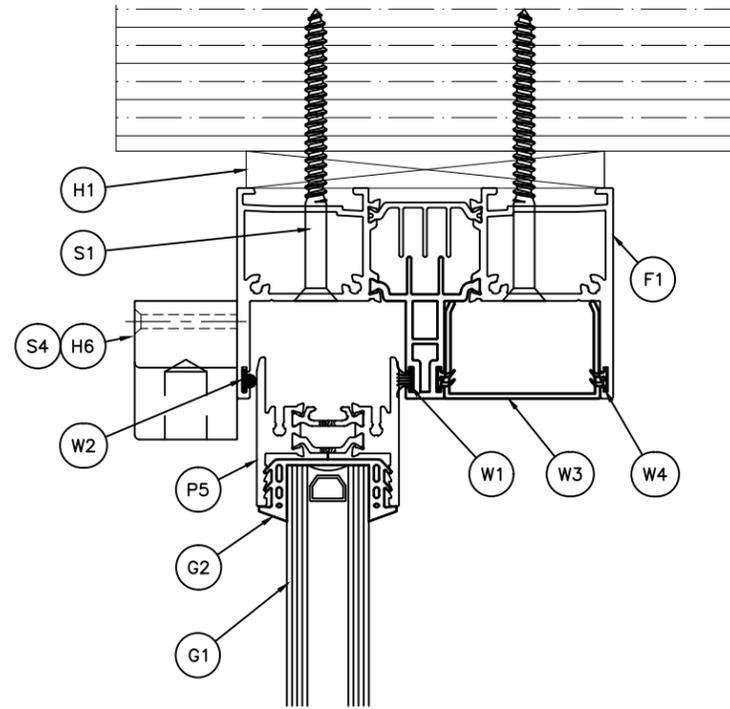
④ HEAD DETAIL @ SLIDER

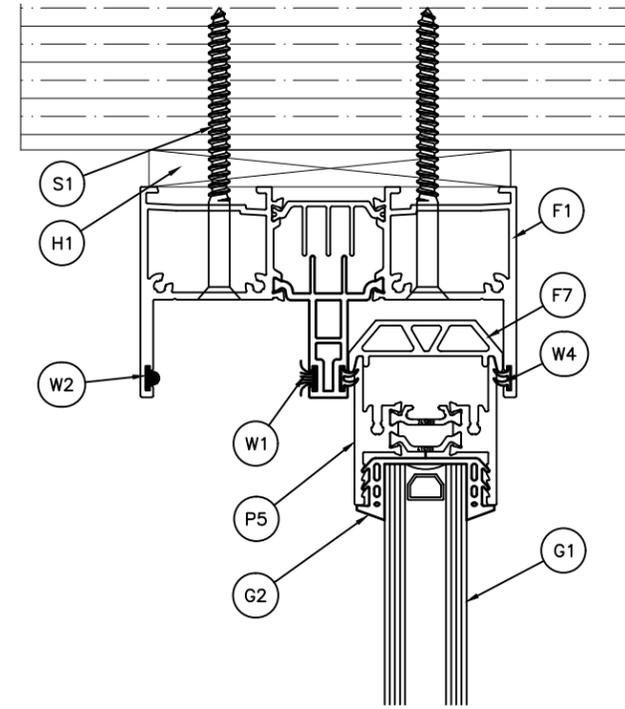
⑥ HEAD DETAIL @ FIXED PANEL

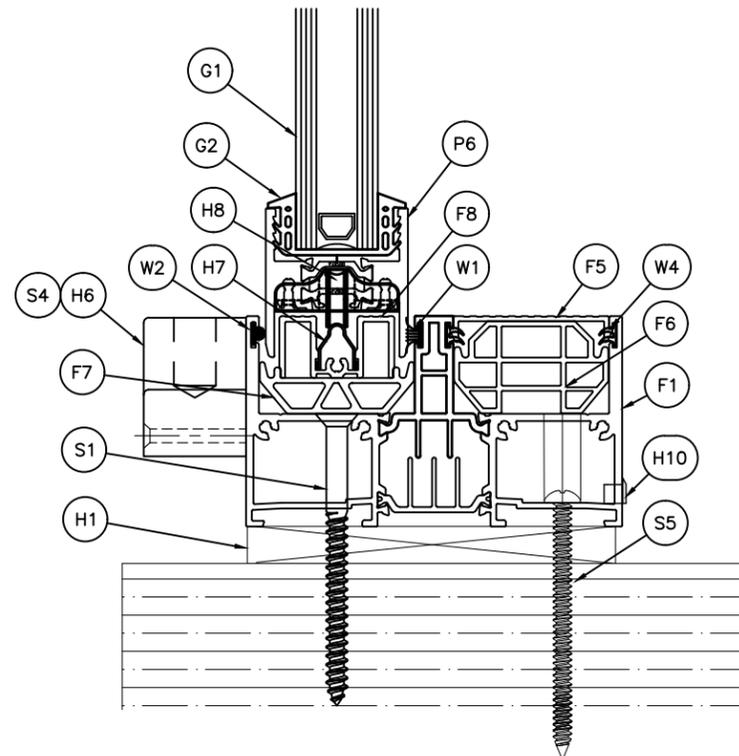
⑤ SILL DETAIL @ SLIDER

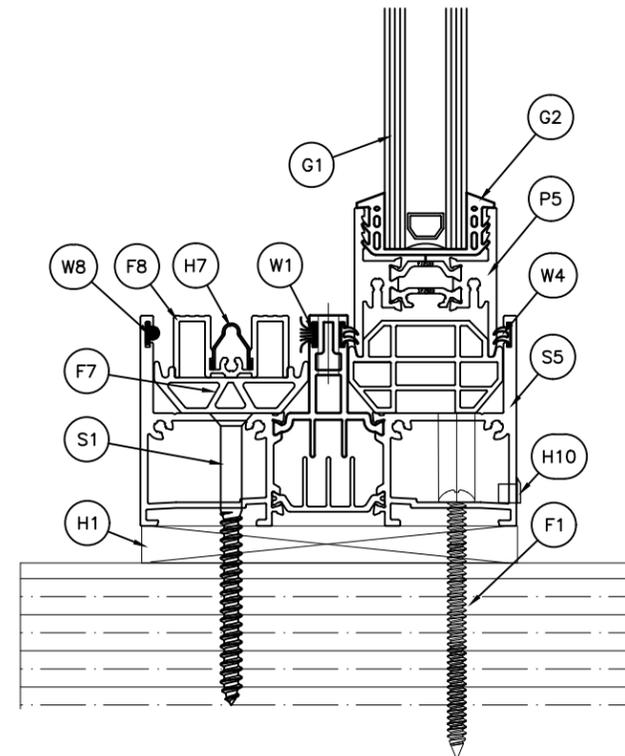
⑦ SILL DETAIL @ FIXED PANEL
