**H0258.01-303-11-R2
ACOUSTICAL PERFORMANCE TEST REPORT
ASTM E90**

Series/Model: 487-AR

Type: Office Partition

Acoustical Performance Test Report

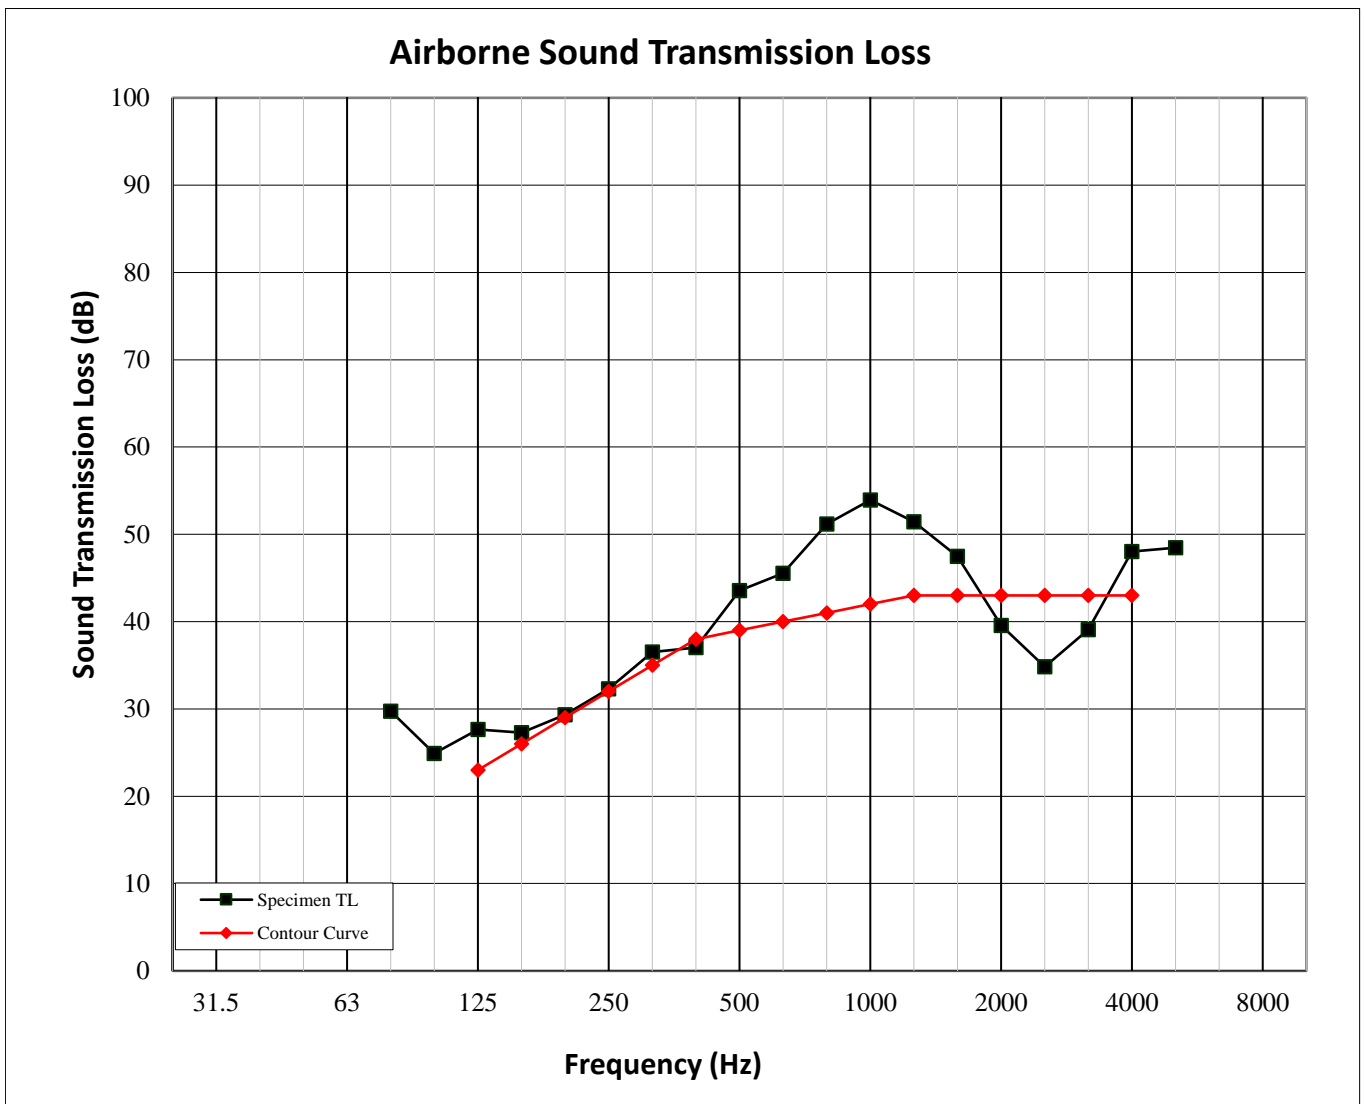
AIRBORNE SOUND TRANSMISSION LOSS
ASTM E 90

Test Date	04/19/17					
Data File No.	H0258.01					
Client	CR Laurence Co., Inc.					
Description	Series/Model: 487-AR Aluminum Office Wall with 1/4" tempered, 3-1/2" air space, 1/4" tempered					
Specimen Area	4.12 m ²	Receive Temp.	22.8 °C		Source Temp.	22.2 °C
Technician	Bradlay Hunt	Receive Humidity	54%		Source Humidity	56%

STC Rating **39** *(Sound Transmission Class)*
Deficiencies **16** *(Sum of Deficiencies)*
OITC Rating **35** *(Outdoor-Indoor Transmission Class)*
