#### **TEST REPORT**

**Report No.**: D6387.01-301-47

CR LAURENCE CO., INC. Vernon, California

**PRODUCT TYPE**: Architectural Terrace Door (In-Swing) **SERIES/MODEL**: 900

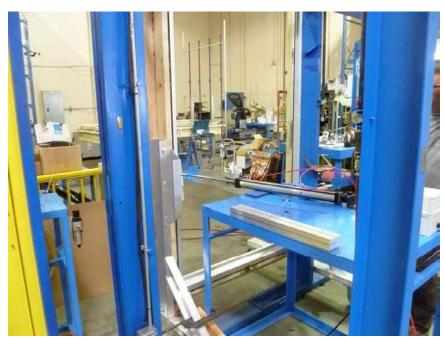
Photo No. 1 Door Cycling Set-up – Interior

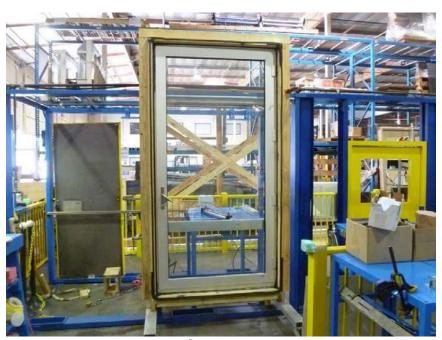
Photo No. 2 Door Cycling Set-up – Exterior

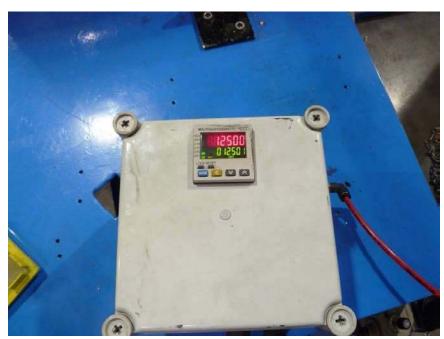
**Photo No. 3**Door Cycling – Completion of First Half

40.0 N (9.0 lbf)	Report Only			
Air Leakage,					
Infiltration per ASTM E 283	0.5 L/s/m <sup>2</sup>	0.5 L/s/m <sup>2</sup>			
at 300 Pa (6.27 psf)	$(0.10 \text{ cfm/ft}^2)$	$(0.10 \text{ cfm/ft}^2) \text{ max.}$	1		
Water Penetration,		, ,			
per ASTM E 547 and ASTM E 331					
at 390 Pa (8.15 psf)	Pass	No leakage			
I	i <b>fe Cycle</b> per AAMA 910				
Door Leaf Cycling,					
(First half)					
per AAMA 910					
12,500 cycles	Pass	No damage			
Locking Hardware Cycling,					
(First half)					
per AAMA 910					
2000 cycles	Pass	No damage			
	use Testing per AAMA 9	910	1		
Door Leaf Vertical Load	D	NT 1			
at 890 N (200 lbf)	Pass	No damage			
Door Leaf Corner Block	D	Ma danaa			
at 334 N (75 lbf)	Pass	No damage			
Life Cycle per AAMA 910					
Door Leaf Cycling,					
(Second half) per AAMA 910					
12,500 cycles	Pass	No damage			
Locking Hardware Cycling,	г dSS	ivo udiliage			
(Second half)					
per AAMA 910					
2000 cycles	Pass	No damage

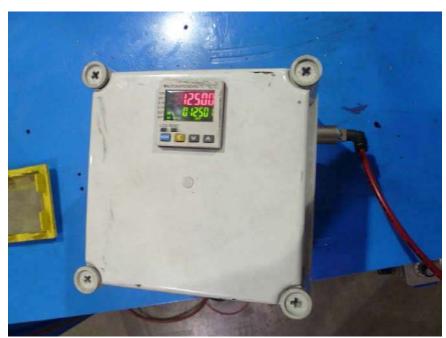
**Photo No. 4**Door Cycling – Completion of Second Half

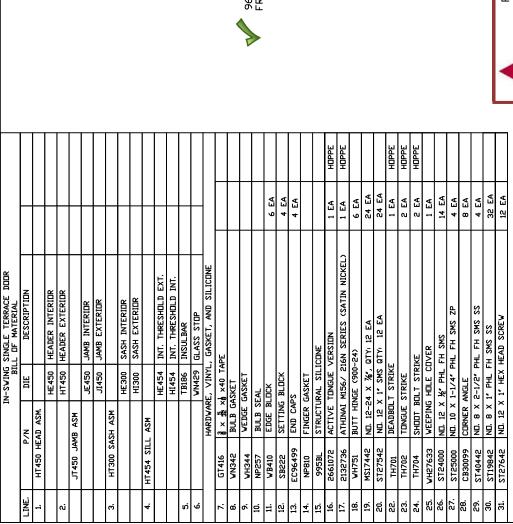
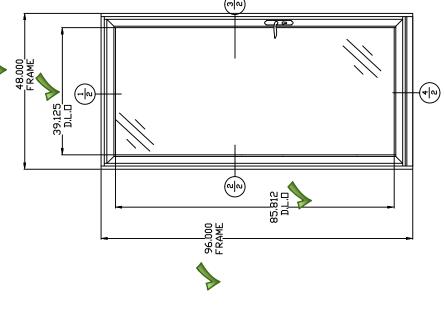
900 IN-SWING SINGLE TERRACE DOOR MACK-UP DRAWING

SYMBOL KEY	DESCRIPTION	1. INSULATED GLASS 1. 1/4. CLEAR TEMPERED GLASS 2. 1/4. ALUMINUM SPACER 3. 1/4. CLEAR TEMPERED 4. GLASS SIZE: 40.125' × 86.812'
	SYMBOL	ਓ
