TEST REPORT

Report No.: G5257.02-301-47

CR LAURENCE CO., INC. Vernon, California

$\textbf{PRODUCT TYPE}: \ \ \text{Dual Side Hinged Door - Outswing}$

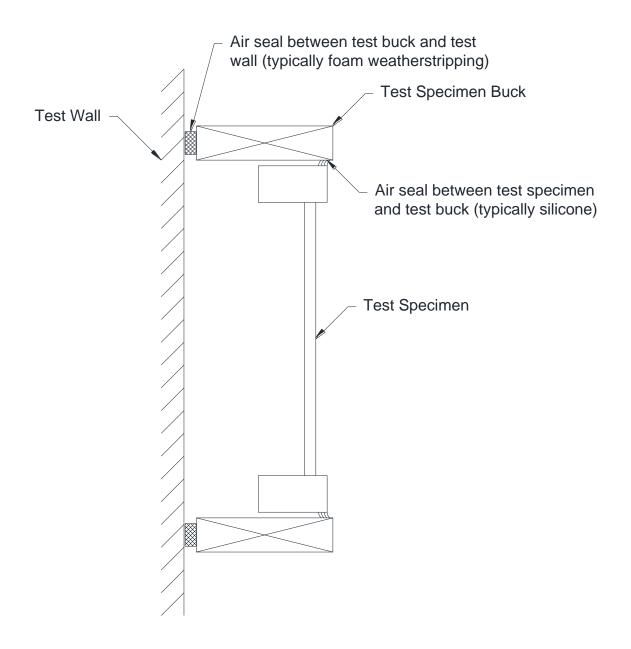
Appendix A

Location of Air Seal: The air seal between the test specimen and the test wall is detailed below. The seal is made of foam weatherstripping and is attached to the edge of the test specimen buck. The test specimen buck is placed against the test wall and clamped in place, compressing the weatherstripping and creating a seal.
