**H0258.02-303-11-R1  
ACOUSTICAL PERFORMANCE TEST REPORT  
ASTM E90**

**CR LAURENCE CO., INC.**

**Series/Model: 487-AR**

**Type: Office Partition**

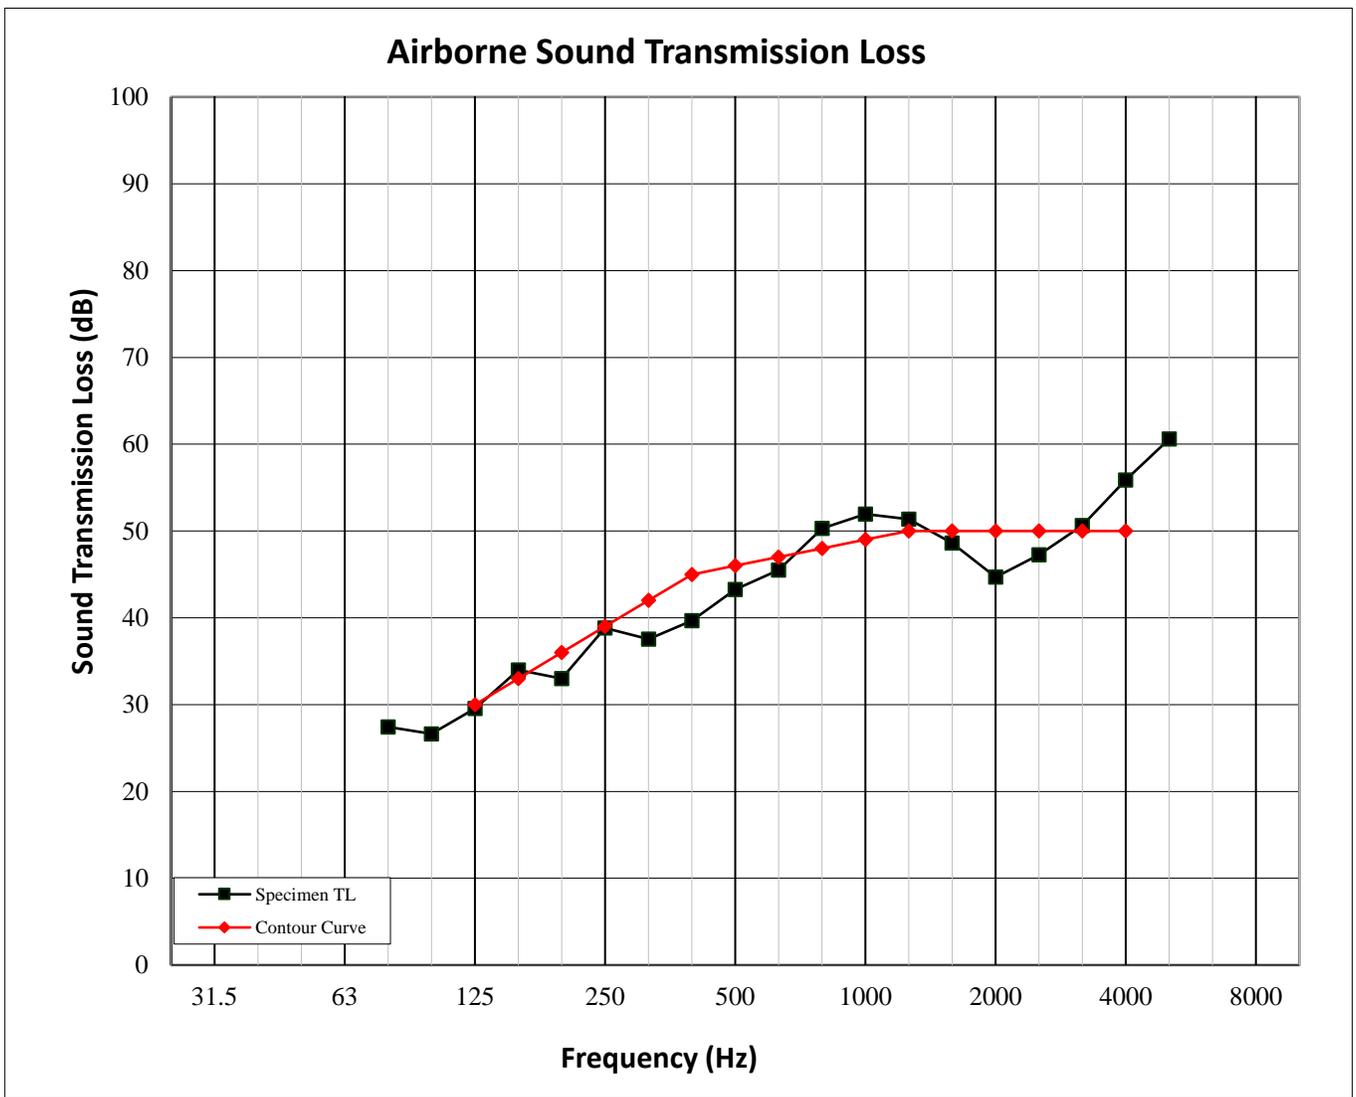
**AIRBORNE SOUND TRANSMISSION LOSS**  
ASTM E 90

**STC Rating**      **46**      *(Sound Transmission Class)*  
**Deficiencies**      **25**      *(Sum of Deficiencies)*  
**OITC Rating**      **38**      *(Outdoor-Indoor Transmission Class)*

<b>Test Date</b>	04/19/17					
<b>Data File No.</b>	H0258.02					
<b>Client</b>	CR Laurence Co., Inc.					
<b>Description</b>	Series/Model: 487-AR Aluminum Office Wall with 1/4" laminate, 3-1/2" air space, 1/4" laminate					
<b>Specimen Area</b>	4.12 m <sup>2</sup>	Receive Temp.	22.8 °C		Source Temp.	22.2 °C
<b>Technician</b>	Bradlay Hunt	Receive Humidity	54%		Source Humidity	56%

Freq (Hz)	Background SPL (dB)	Absorption (m <sup>2</sup> )	Source SPL (dB)	Receive SPL (dB)	Specimen TL (dB)	95% Confidence Limit	Number of Deficiencies
80	37.6	4.4	104	78	27.4	1.94	-
100	32.3	4.7	106	80	26.6	1.64	-
125	38.8	5.4	105	75	29.5	0.99	0
160	42.6	5.2	103	69	34.0	1.00	0
200	35.7	6.2	105	71	33.0	0.82	3
250	21.8	7.0	106	65	38.8	0.74	0
315	18.3	6.9	106	67	37.5	0.34	4
400	18.9	6.0	107	66	39.7	0.55	5
500	20.3	5.4	108	63	43.3	0.69	3
630	18.8	5.7	106	59	45.5	0.42	1
800	19.6	5.9	106	54	50.3	0.37	0
1000	16.0	6.0	107	54	51.9	0.53	0
1250	14.6	6.3	106	53	51.4	0.19	0
1600	14.3	6.9	103	53	48.6	0.24	1
2000	12.9	8.1	102	54	44.7	0.20	5
2500	12.5	8.8	101	51	47.3	0.12	3
3150	10.1	10.0	101	46	50.6	0.19	0
4000	8.0	12.0	99	39	55.9	0.28	0
5000	9.6	15.5	99	32	60.6	0.24	-

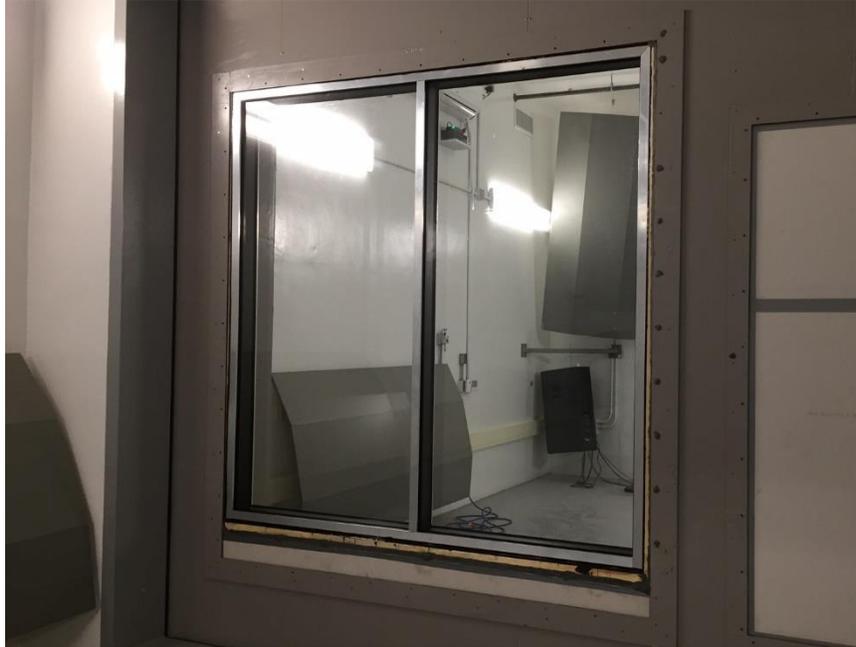
**Receive Room View of Installed Specimen**

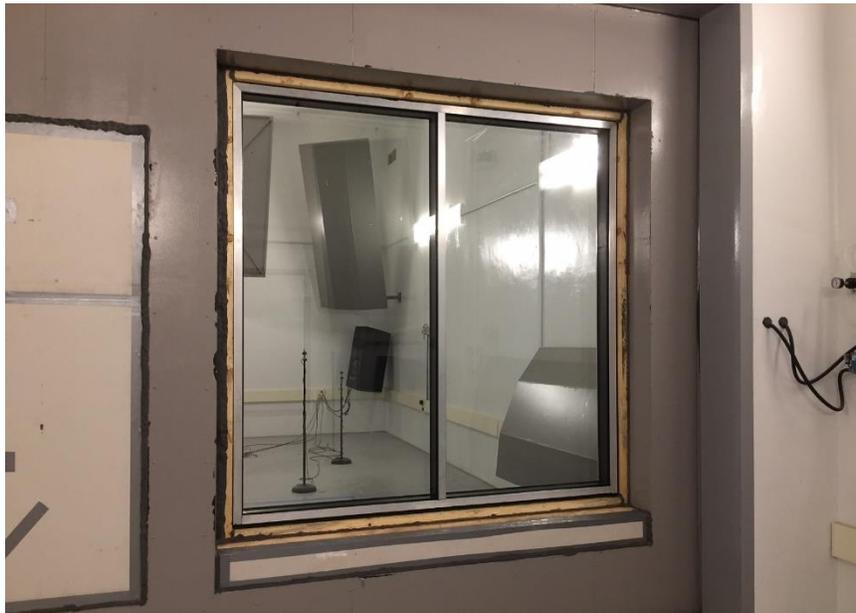
**Source Room View of Installed Specimen**

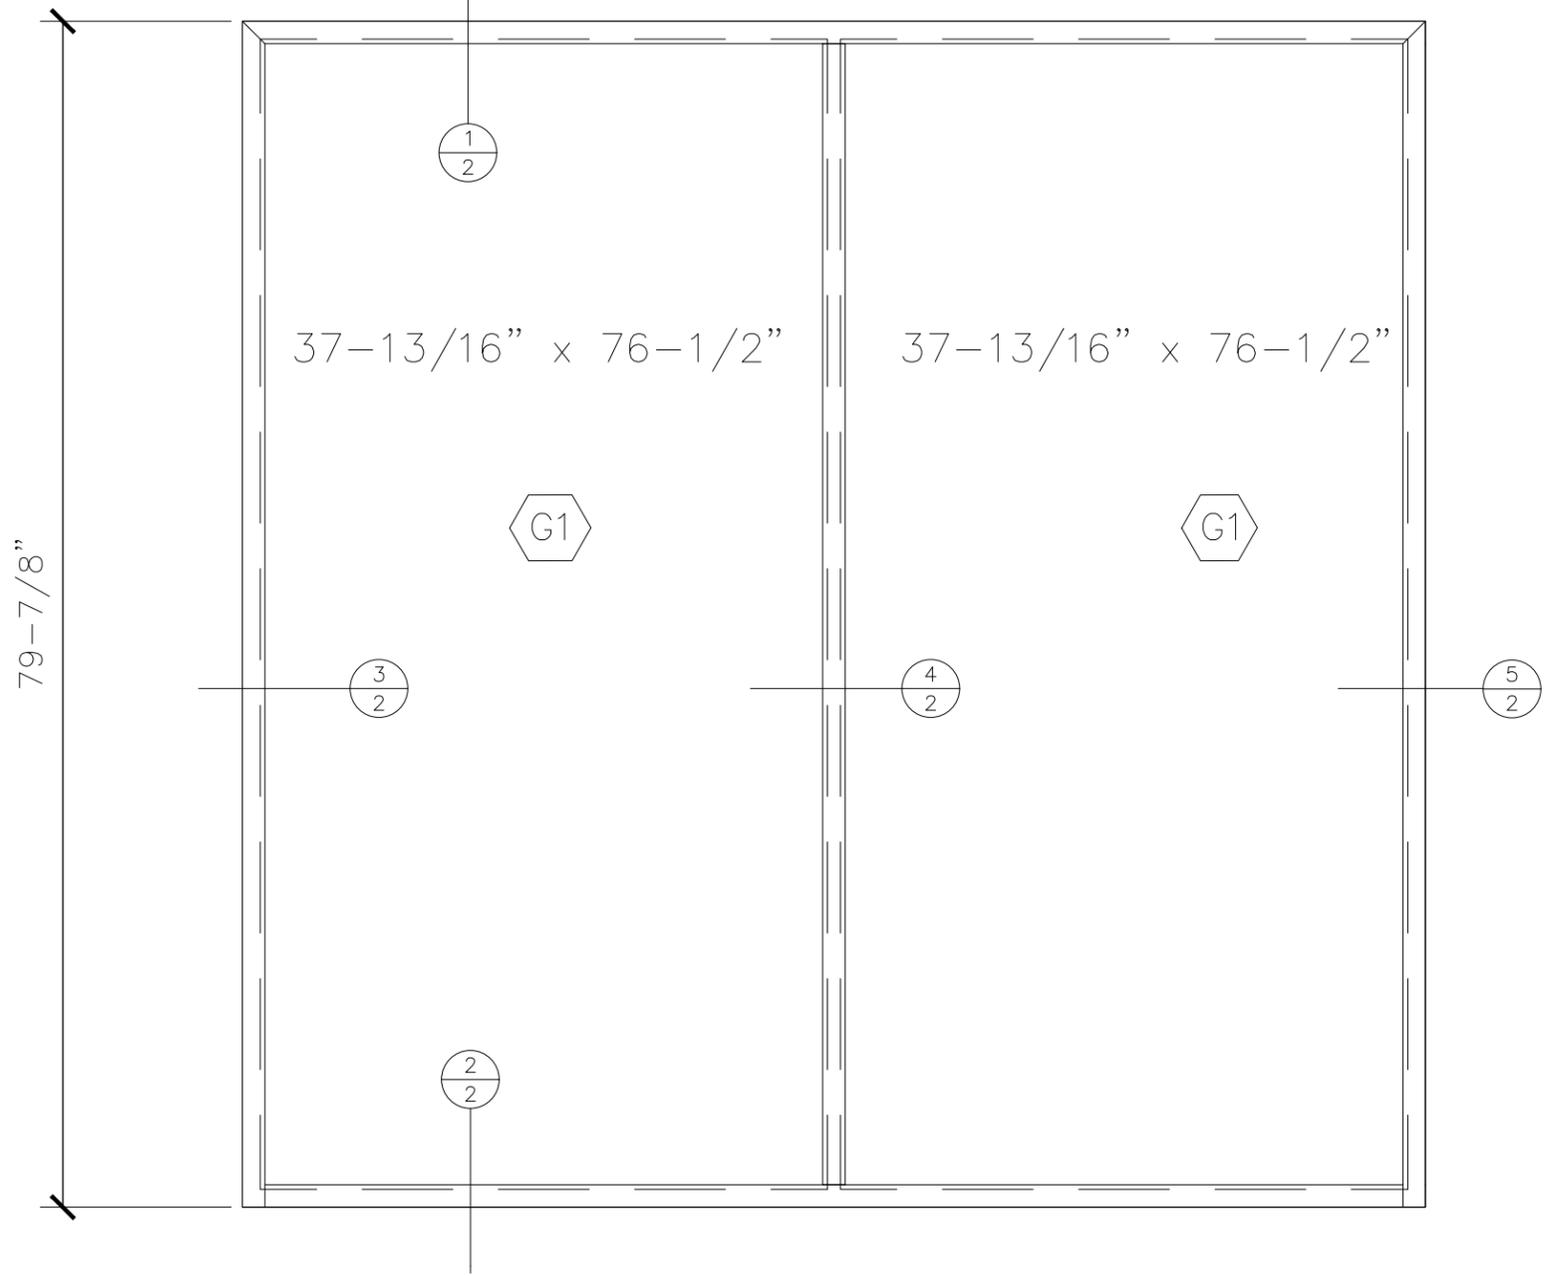
C1	FRAME	487X201	487 HEAD, JAMB, SILL MULLIONS
C2		487X203	487 VERTICAL/HORIZONTAL MULLIONS
C3		487X202	487 FLOOR TRACK
C4		487X215	487 FACE CAP- 1-1/2"
C6		487X214	487 GLAZING ADAPTOR
F1	FASTENERS	20061601	# 6-20X1/2 P.H.P. TEK SCREWS
F2		-----	# 8 X 2-1/2 DRY WALL SCREWS
W1	WTHR STRIP	NP718	INTERIOR SPONGE GASKET
W2		NP225	VINYL GLAZING GASKET
G1	GLASS		1/4" LAMINATED GLASS
G2		SB514	NEOPRENE SETTING BLOCK
H1	HARDWARE	487C1	487 SERIES 90 DEG. CLIP
H2		487C2	487 SERIES "T" CLIP
H3		TCI-93170X330	TREMCO ACOUSTICAL CURTAINWALL SEALANT

A drawing of the test specimen is included in Appendix D. The specimen was returned per the client's request.
