**ASTM E 90 SOUND TRANSMISSION LOSS  
TEST REPORT**

**UNITED STATES ALUMINUM**

**SERIES/MODEL: 900 SERIES**

**TYPE: Out Swing Single Terrace Door**

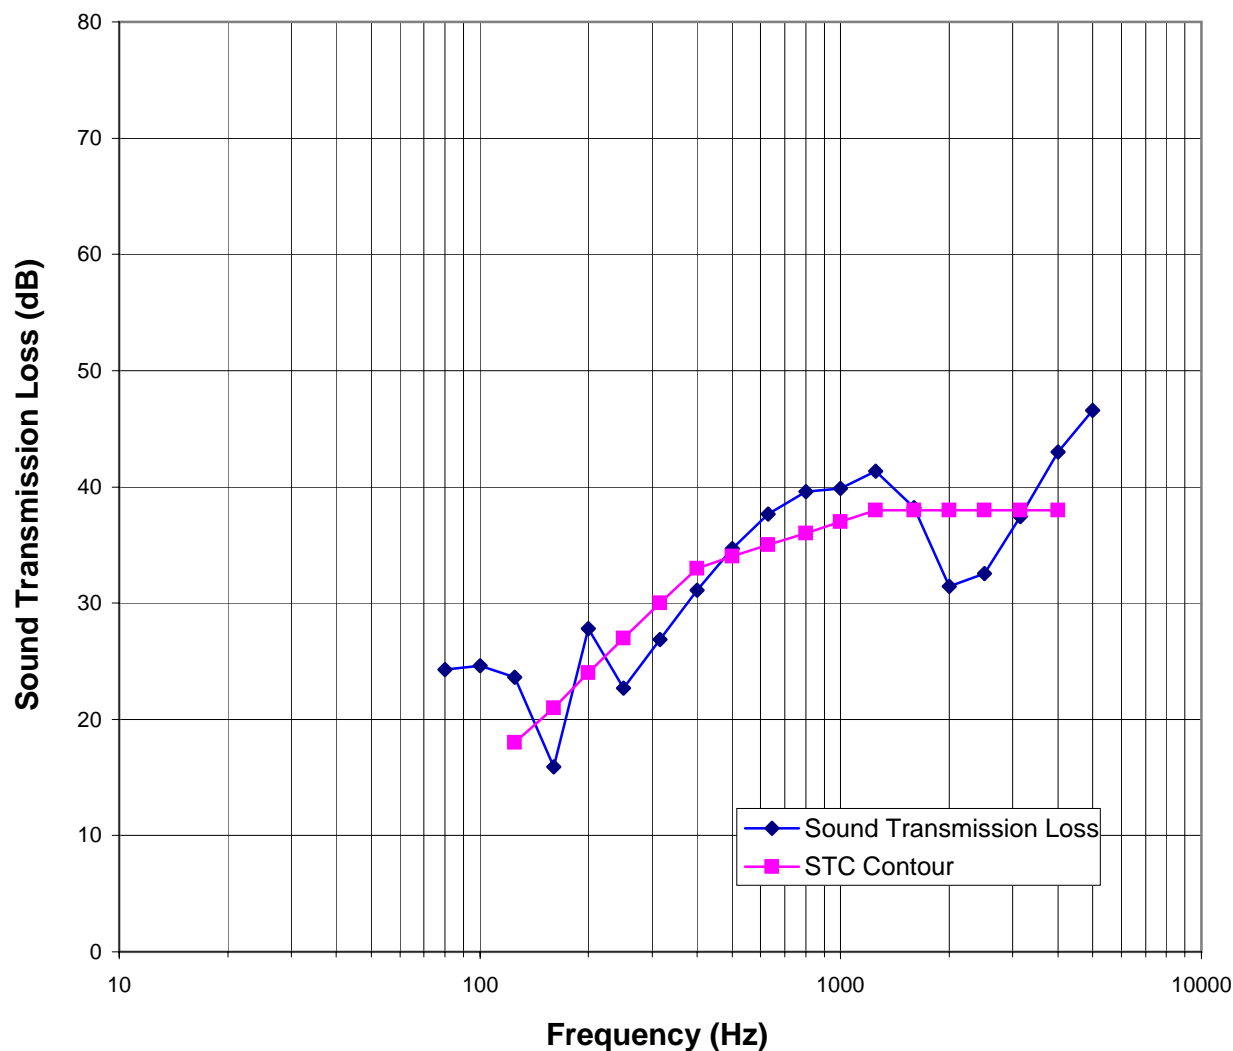
### Sound Transmission Loss

ATI No. 63137.01 Date 03/15/06  
Client United States Aluminum  
Specimen Series/Model: 900 Series, out swing single terrace door, 1" IG(1/4" tempered, 1/2" airspace, 1/4" tempered)  
Specimen Area 22.69 Sq Ft  
Filler Area 117.31 Sq Ft  
Operator Ned A. Leppo

**STC Rating =** 34 *(Sound Transmission Class)*  
**Deficiencies =** 27 *(Number of deficiencies versus contour curve)*  
**OITC Rating =** 28 *(Outdoor/Indoor Transmission Class)*

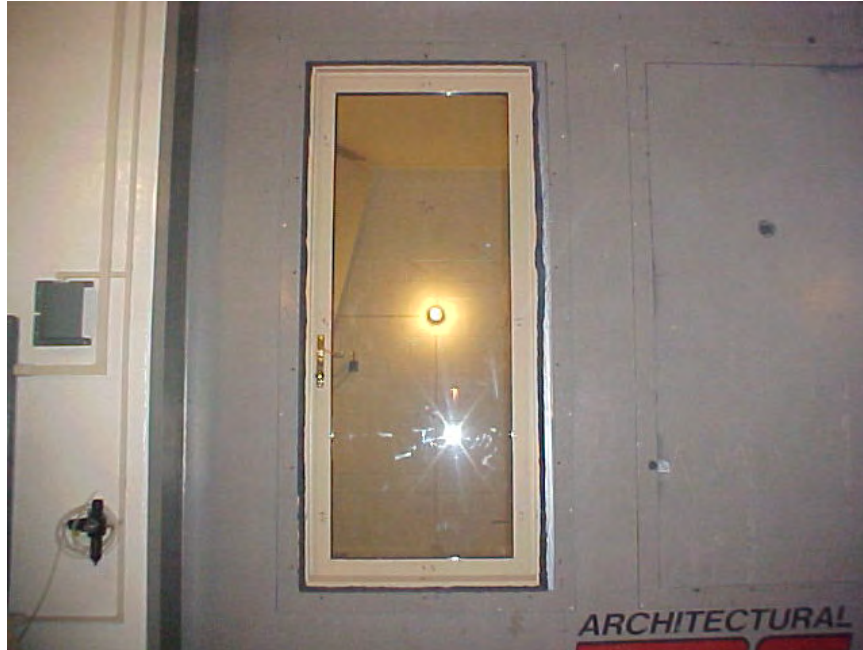
**Interior View of Specimen**

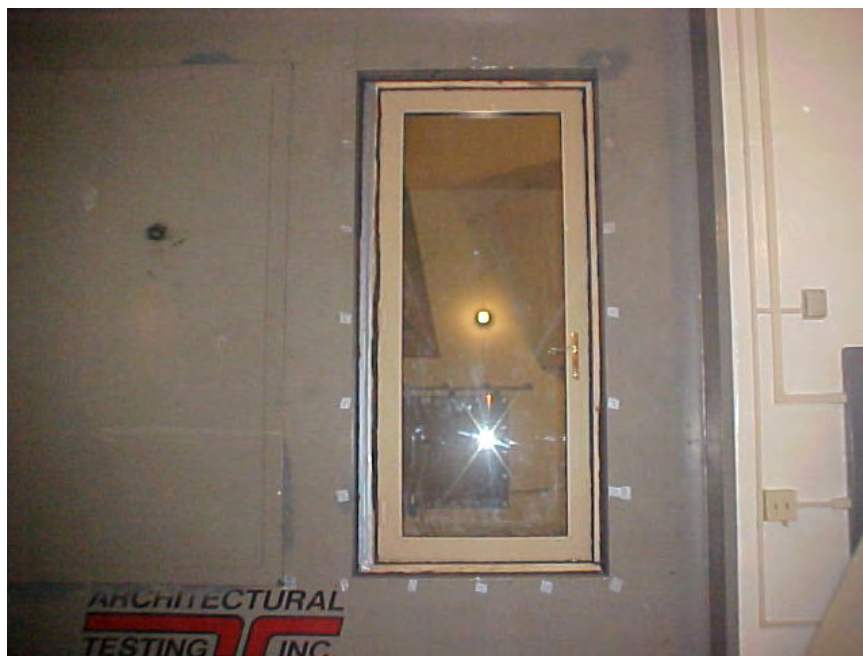
**Exterior View of Specimen**
