**E4888.01-113-11-R0**  
**ACOUSTICAL PERFORMANCE TEST REPORT**  
**ASTM E90**

**C.R. LAURENCE CO., INC.**

**Series/Model: 3000**

**Type: Sliding Glass Door**

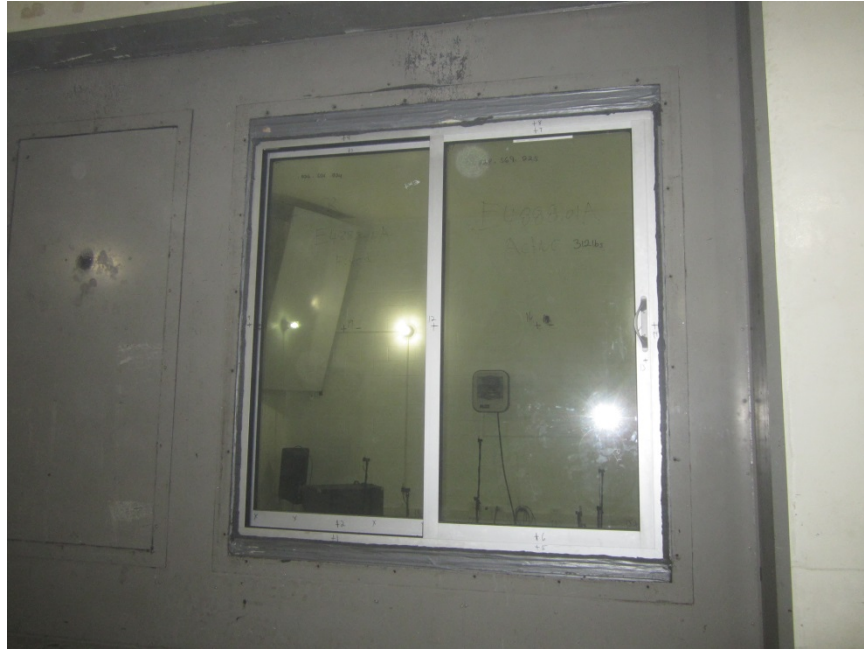
**Receive Room View of an Installed Test Specimen**

The specimen plug was removed from the filler wall assembly. The specimen was placed on a foam isolation pad in the test opening. Duct seal was used to seal the perimeter of the specimen to the test opening on both sides. The interior side of the specimen frame, when installed, was approximately 1/4" from being flush with the receive room side of the filler wall. A stethoscope was used to check for any abnormal air leaks around the test specimen prior to testing. Operable portions of the test specimen, if any, were cycled at least five times prior to testing.

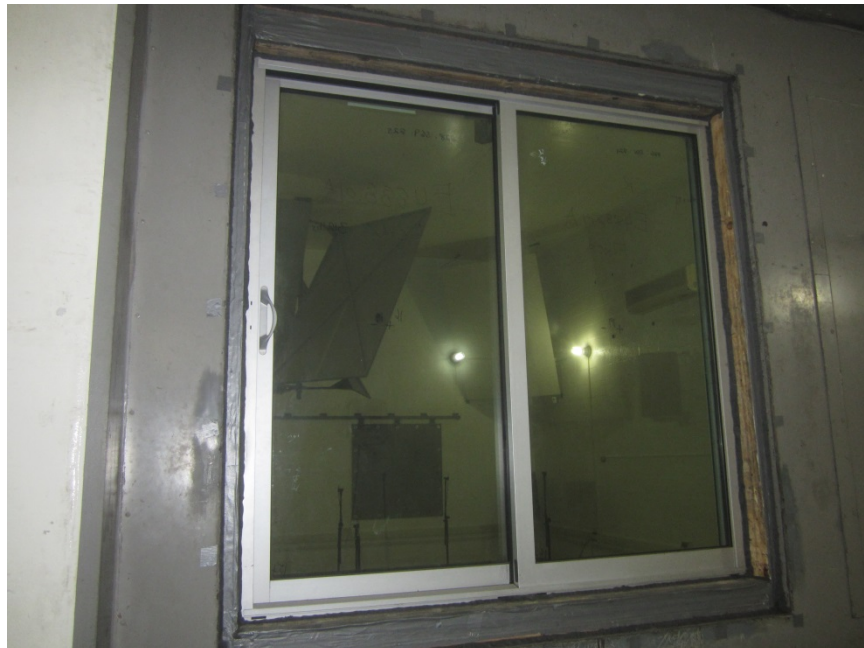
**Source Room View of an Installed Test Specimen**
