ACOUSTICAL PERFORMANCE TEST REPORT

ASTM E90 SOUND TRANSMISSION LOSS TESTING ON A PALISADES S100, SLIDING GLASS DOOR

L8956.02-303-11-R0

TEST REPORT FOR CR LAURENCE CO. INC.

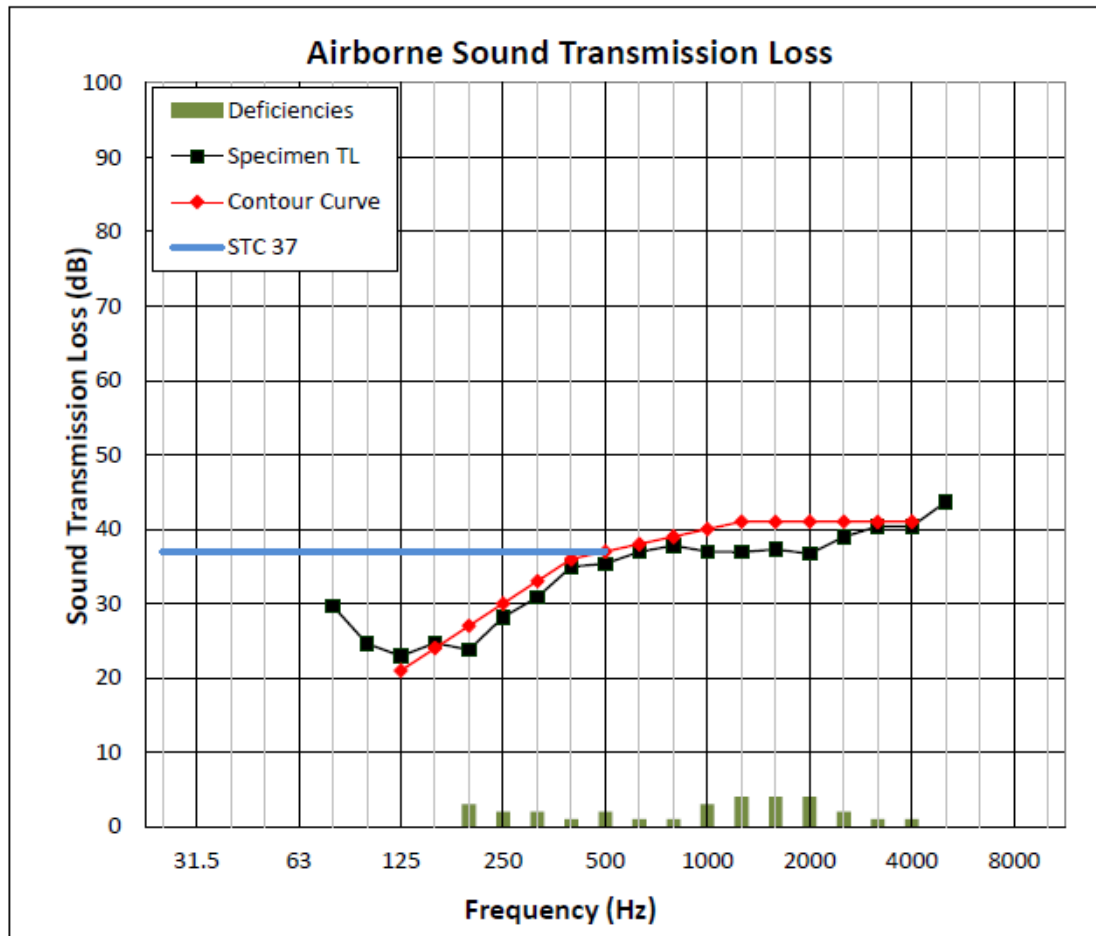
ASTM E90 AIRBORNE SOUND TRANSMISSION LOSS

DATA FILE NO.	L8956.01A1					
CLIENT	CR Laurence Co. Inc.					
DESCRIPTION	Series/Model: Palisades S100, Sliding Glass Door With 1" IG (1/4" Tempered Exterior, 3/8" Air Space, 3/8" Laminated Interior) Glass Temperature 75F * changed meeting stile*					
SPECIMEN AREA	4.03 m ²	RECEIVE TEMP.	18.5 °C	SOURCE TEMP	18.3 °C	
TECHNICIAN	Marco T Sant	RECEIVE HUMIDITY	30%	SOURCE HUMIDITY	33%

FREQ (Hz)	BACKGROUND SPL (dB)	ABSORPTION (m ²)	SOURCE SPL (dB)	RECEIVE SPL (dB)	SPECIMEN TL (dB)	95% CONFIDENCE LIMIT	NUMBER OF DEFICIENCIES
80	40.8	4.6	104	74	30	1.85	-
100	35.3	4.6	102	78	25	1.01	-
125	42.1	5.0	103	79	23	0.80	0
160	44.6	5.4	103	77	25	1.20	0
200	38.4	6.7	106	80	24	0.77	3
250	30.9	7.1	107	76	28	0.47	2
315	33.5	7.2	106	73	31	0.39	2
400	38.4	6.2	106	69	35	0.31	1
500	24.2	5.5	106	70	35	0.65	2
630	21.2	5.9	107	68	37	0.32	1
800	24.4	6.0	105	66	38	0.23	1
1000	17.8	6.3	107	68	37	0.27	3
1250	16.3	6.6	105	66	37	0.22	4
1600	6.6	7.4	103	63	37	0.30	4
2000	4.2	9.0	101	60	37	0.27	4
2500	3.8	10.8	100	57	39	0.21	2
3150	4.1	13.0	100	54	40	0.30	1
4000	4.7	16.9	96	49	40	0.41	1
5000	5.5	22.6	92	41	44	0.47	-
STC RATING	37 (Sound Transmission Class)						
DEFICIENCIES	31 (Sum of Deficiencies)						
OITC RATING	31 (Outdoor-Indoor Transmission Class)

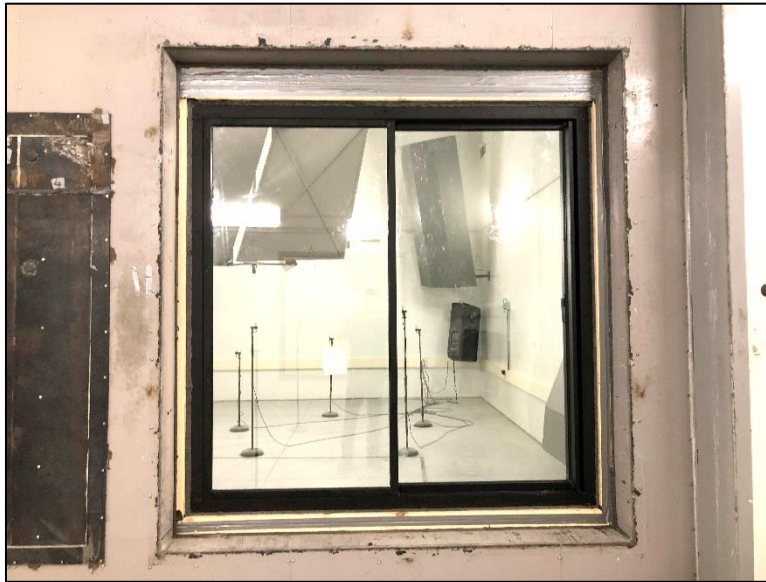
Photo No. 1
Source Room View of Test Specimen

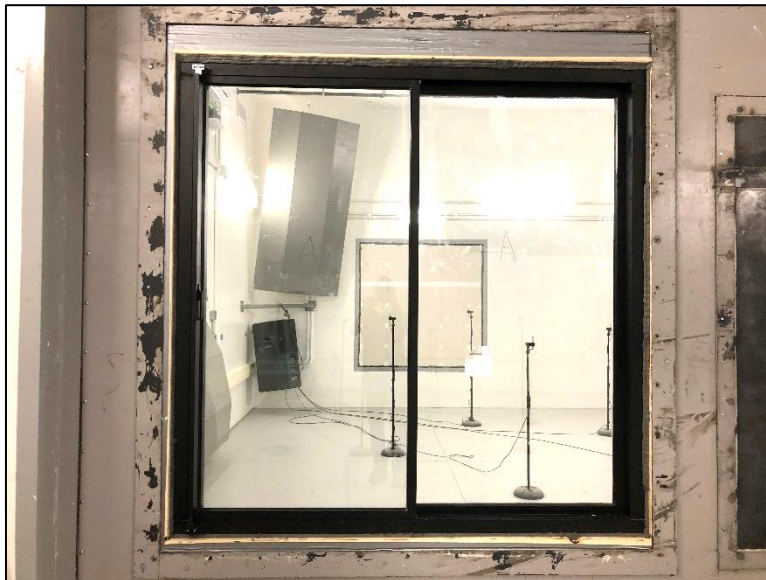
Photo No. 2
Receive Room View of Test Specimen
