**ASTM E 90 SOUND TRANSMISSION LOSS  
TEST REPORT**

**C.R. LAURENCE CO., INC.**

**SERIES/MODEL: 7500**

**TYPE: Concealed Vent Window**

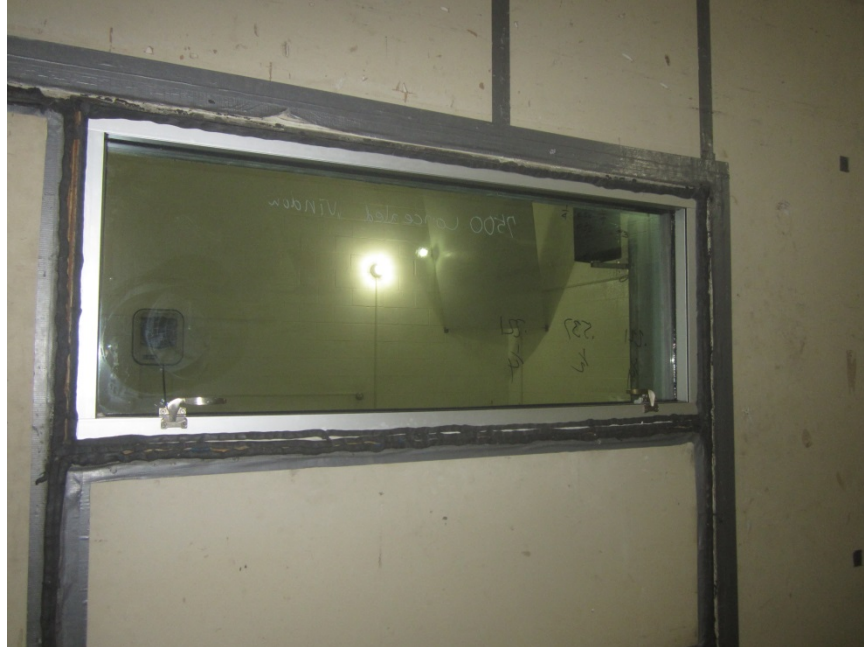
**Receive Room View of Installed Specimen**

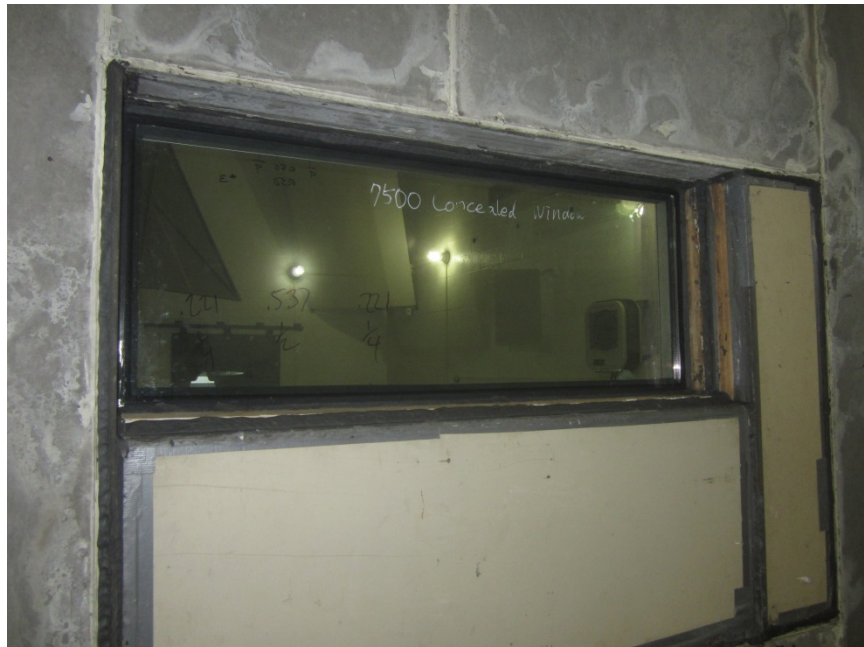
**Source Room View of Installed Specimen**
