TEST REPORT

Performed on: 3 x Panel Glass Balustrade
Client: C.R Laurence

BALUSTRADE TEST REPORT

Model No. / Name: 3 x Panel Glass Balustrade (round hand rail)

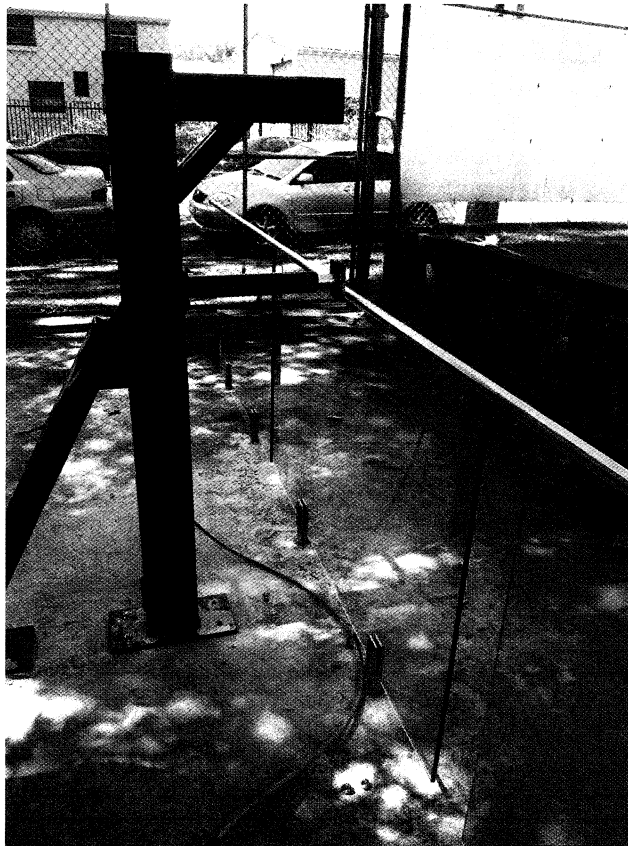
Top edge- 0.6kN test: Inward, outward or downward.

- (a) Securely fix the balustrade sample as per normal installation.
 - (b) Record a datum measurement.
 - (c) Apply the various loads as per the standard to the sample for period of 1 minute.
 - (d) Remove the load.
 - (e) Measure any permanent deflection sustained by the sample and inspect for structural failure.
- Please see photos for further detail.

Load (in kN)	Datum (in mm)	Deflection under load (in mm)	Reading after load removed (in mm)	Permanent deflection (in mm)	PASS/FAIL
Inward 0.6	-	-	-	-	PASS
Outward 0.6	-	-	-	-	PASS
Downward 0.6	-	-	-	-	PASS

Remarks: Test superceded by forces achieved in AS1657 Test.

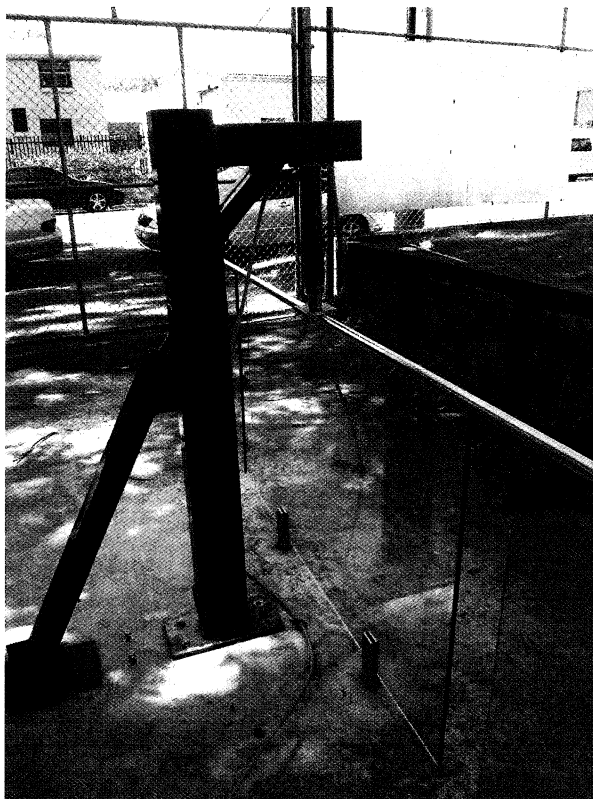
Top edge- Vertical 3.6 kN load (applied to centre of handrail)

- (a) Securely fix the balustrade sample as per normal installation.
 - (b) Record a datum measurement
 - (c) Apply the load as per the standard to the sample for period of 1 minute.
 - (d) Remove the load.
 - (e) Measure any permanent deflection sustained by the sample and inspect for structural failure.
- Please see photos for further detail.

Load (in kN) (kN/m x span in m)	Deflection under load (in mm)	Reading after load removed (in mm)	Permanent deflection (in mm)
Datum measurement	-	410	-
0.22 = 1.056	410	410	0
0.35 = 1.68	410	410	0
0.75 = 3.6	410	410	0

Permanent deflection: 0

Structural failure: Nil

Pass/Fail: PASS

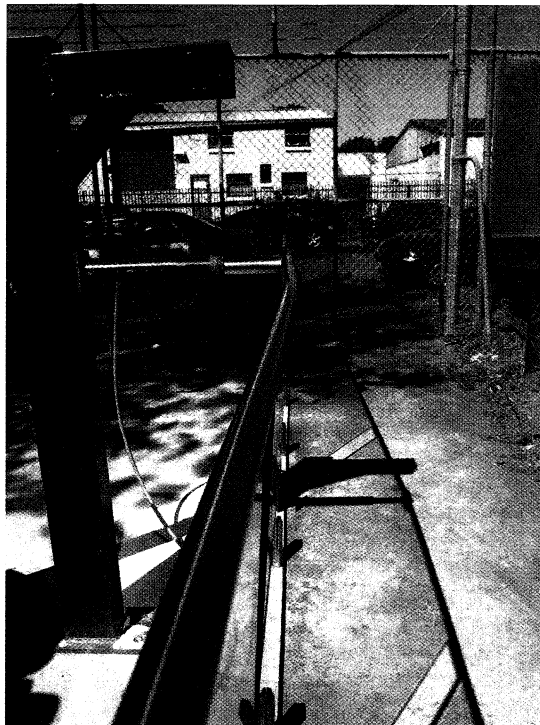
Top edge- Horizontal 3.6 kN load (applied to centre of handrail)

- (a) Securely fix the balustrade sample as per normal installation.
- (b) Record a datum measurement
- (c) Apply the various loads as per the standard to the sample for period of 1 minute.
- (d) Remove the load.
- (e) Measure any permanent deflection sustained by the sample and inspect for structural failure.
- (f) Repeat steps (c) to (e) for remaining levels in standard.

Load (in kN) (kN/m x span in m)	Deflection under load (in mm)	Reading after load removed (in mm)	Permanent deflection (in mm)
Datum measurement	-	430	-
0.22 = 1.056	452	432	2
0.35 = 1.68	462	432	2
0.75 = 3.6	508	438	8

Permanent deflection: 8mm

Max allowable (h/60 + 1/240): 37mm

Structural failure: Nil

Pass/Fail: PASS

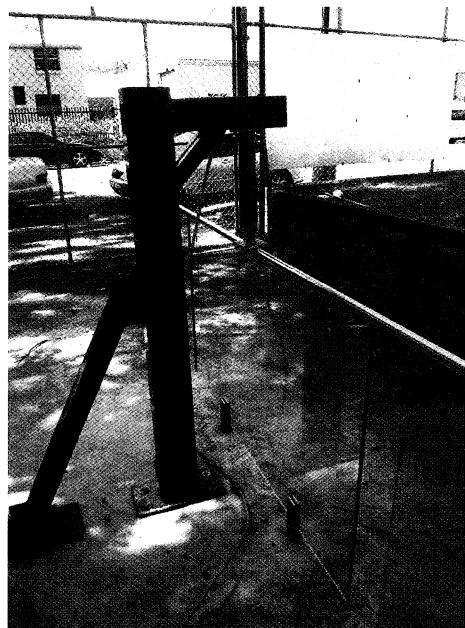
Top edge- Vertical 1.584 kN (applied to centre of handrail)

- (a) Securely fix the balustrade sample as per normal installation.
- (b) Record a datum measurement
- (c) Apply the load as per the standard to the sample for period of 1 minute.
- (d) Remove the load.
- (e) Measure any permanent deflection sustained by the sample.

Load applied: 1.584kN

Datum Measurement: 409mm

Reading after load removed: 409mm

Permanent deflection: 0mm

Max allowable (1/90 span between supports): 53mm

Structural failure: Nil

Pass/Fail: PASS

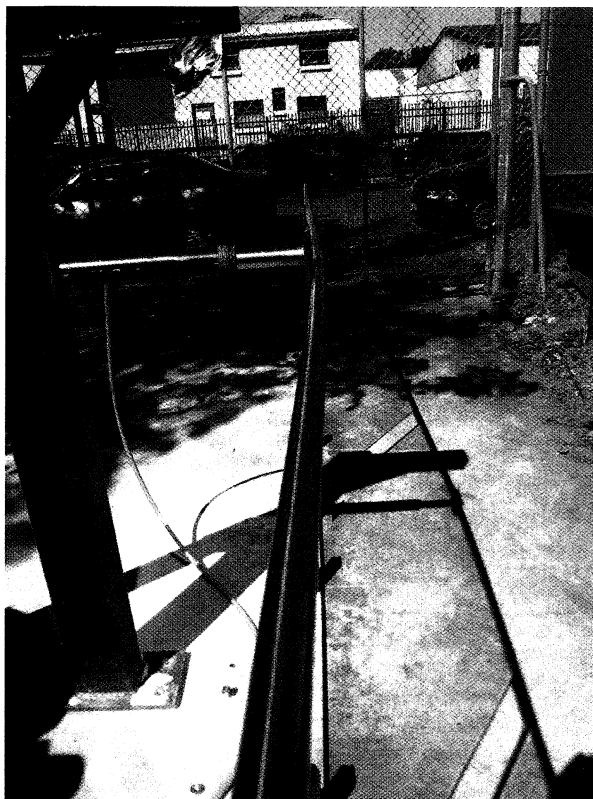
Top edge- Horizontal 1.584 kN (applied to centre of handrail)

- (a) Securely fix the balustrade sample as per normal installation.
- (b) Record a datum measurement
- (c) Apply the load as per the standard to the sample for period of 1 minute.
- (d) Remove the load.
- (e) Measure any permanent deflection sustained by the sample.

Load applied: 1.584kN

Datum Measurement: 430mm

Reading after load removed: 431mm

Permanent deflection: 1mm

Max allowable (1/90 span between supports): 53mm

Structural failure: Nil

Pass/Fail: PASS

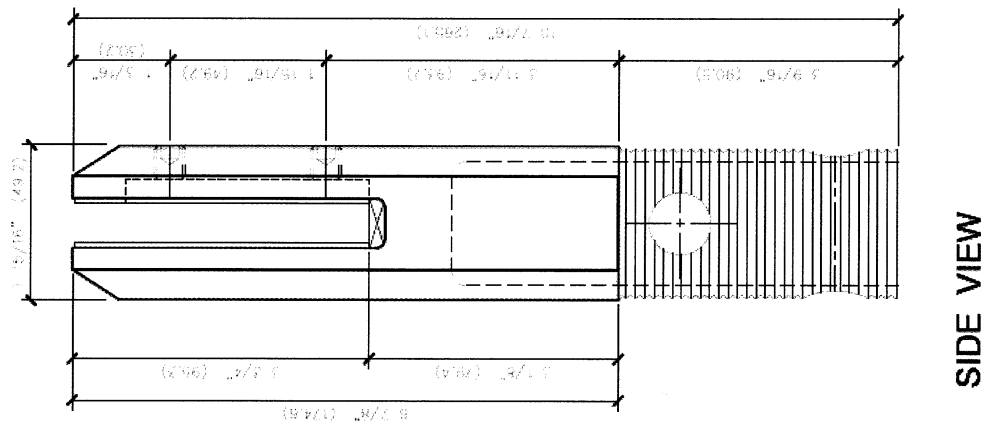
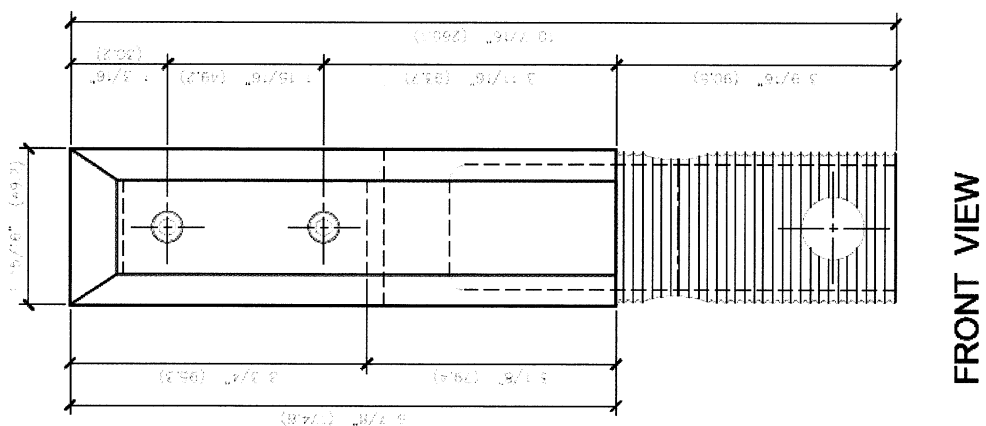
FWCS10 SPIGGOT DETAIL DRAWINGS

NO GLASS FABRICATION
REQUIRED

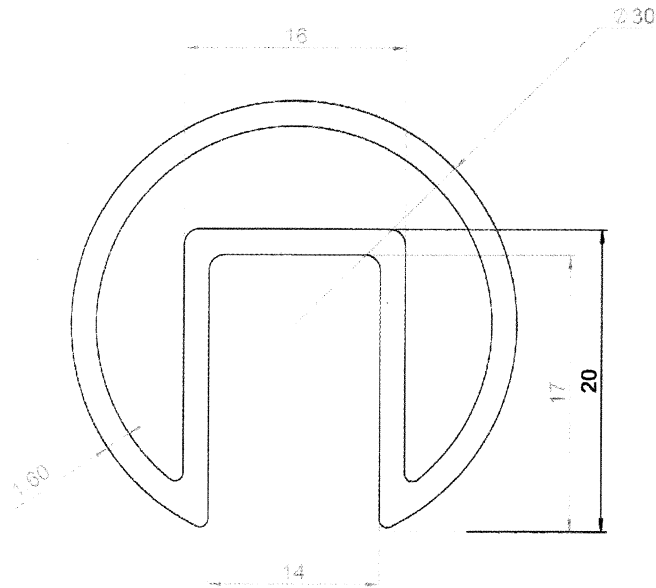
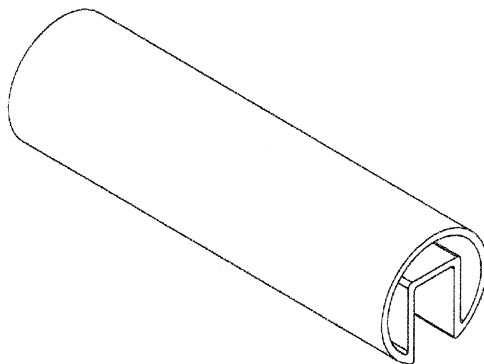
CROSS SECTION OF Ø30mm TOP RAIL

TOP RAIL
