**ASTM E 90 SOUND TRANSMISSION LOSS
TEST REPORT**

C.R. LAURENCE CO., INC.

SERIES/MODEL: 7200

TYPE: Project In Window

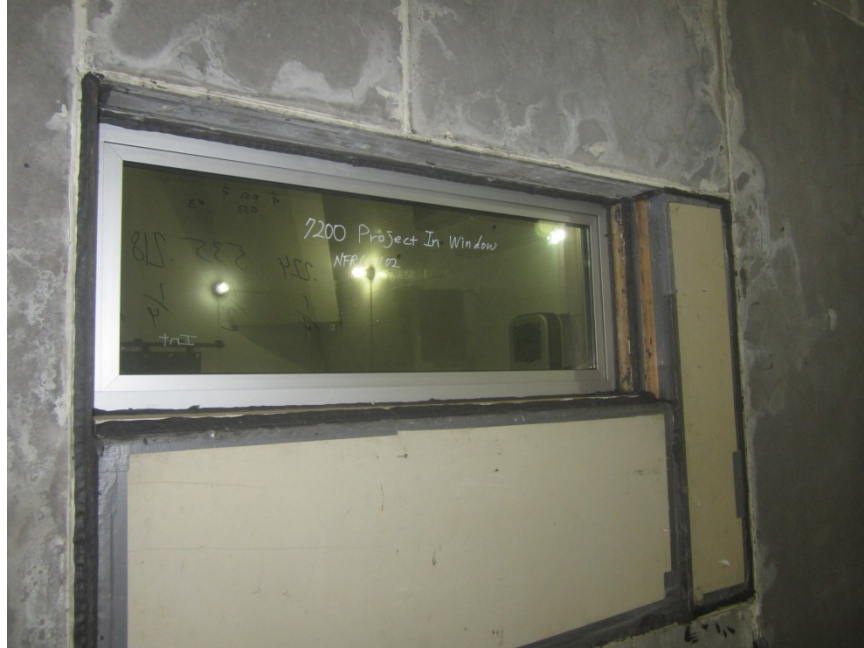
Receive Room View of Installed Specimen

Sample Installation: A double stud filler wall was constructed with 2-1/2" steel studs and 3-1/2" steel studs spaced 24" on center. Five layers of 5/8" Type "X" gypsum board were fastened to the receive side of the filler wall. Three layers of 1/2" cement board were fastened to the source side of the filler wall. The cavity was filled with two layers of R-13 fiberglass insulation. The perimeter and seams were sealed with acoustical sealant. A sound transmission loss test was then conducted on the filler wall. The filler wall achieved an STC rating of 71. The 60-1/2" by 48-1/2" filler wall plug was removed.

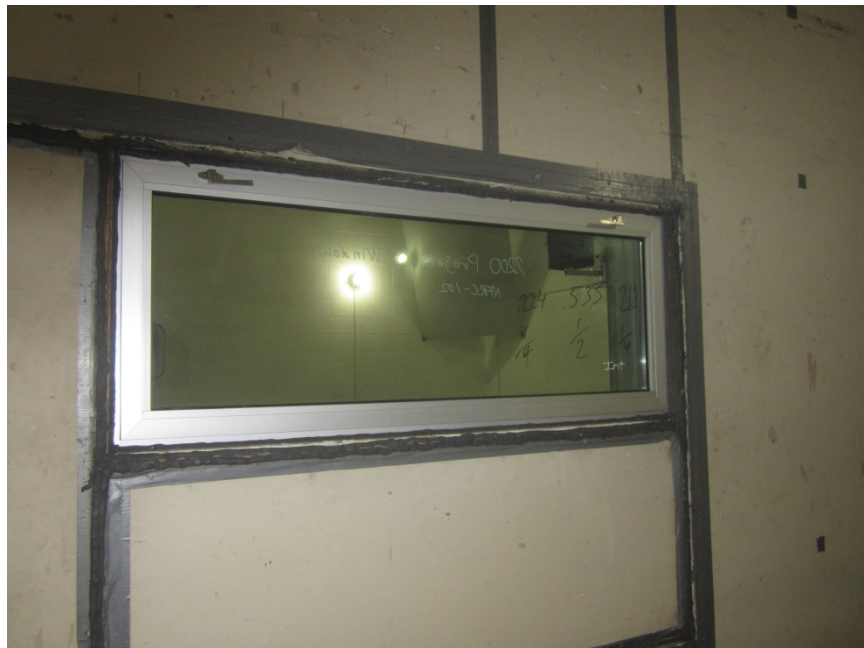
Source Room View of Installed Specimen
