# CR LAURENCE CO, INC.

## ACOUSTICAL PERFORMANCE TEST REPORT

AAMA 1801 TESTING ON IT451, STOREFRONT WINDOW

H7645.02-303-11 R0

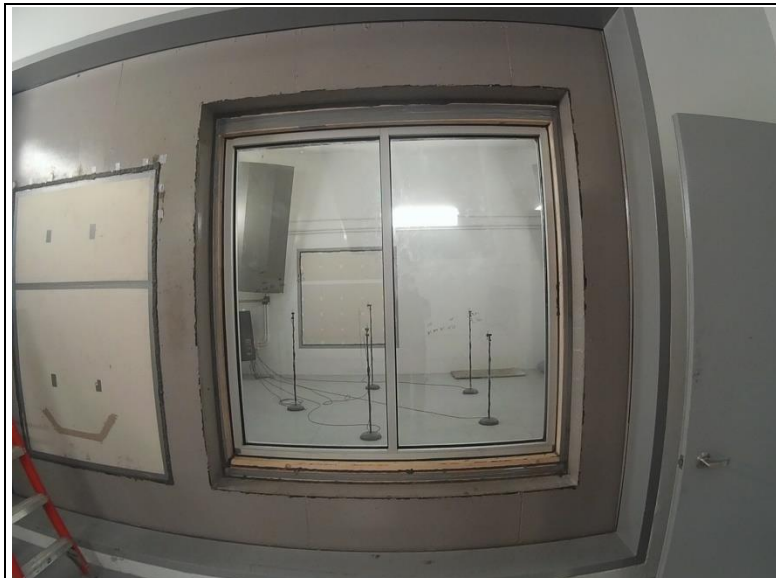
Receive Room View of Test Specimen

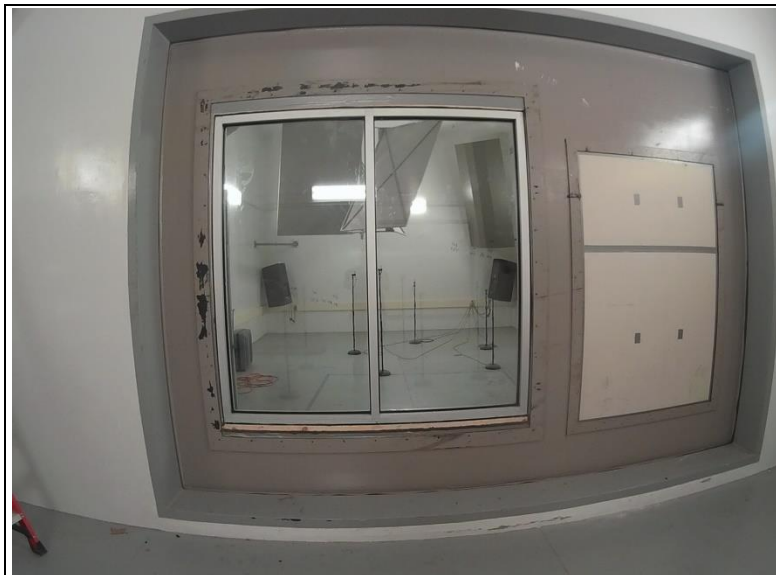
Source Room View of Test Specimen
