US ALUMINUM
4500/4500SG CURTAIN WALL SYSTEM
REPORT # CCLI-99-014

**CURTAIN WALL MOCK-UP TESTING REPORT
4500/4500SG CURTAIN WALL SYSTEM
REPORT # CCLI-99-014**

<u>Project:</u>	4500/4500SG Curtain Wall System Mock-Up Performance Testing
<u>Test Completion:</u>	September 29, 1999
<u>Tested For:</u>	United States Aluminum Corporation 200 Singleton Drive Waxahachie, TX 75165

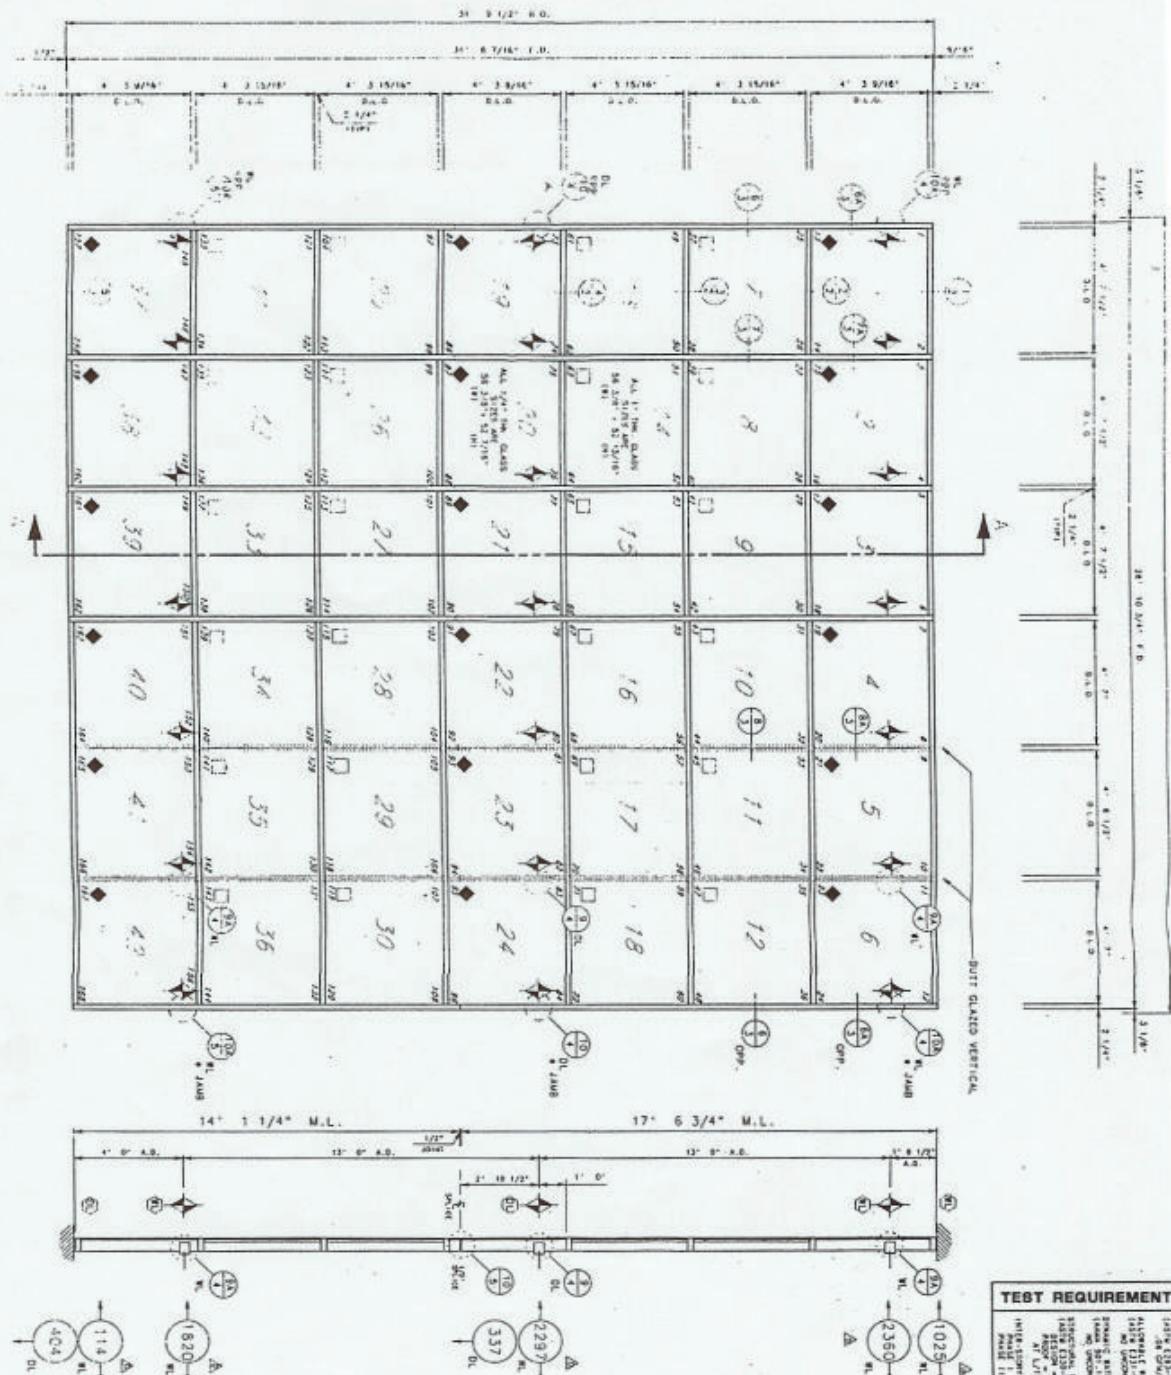
ELEVATION VIEW FROM EXTERIOR

The mock-up test specimen was identified as a combined specimen 4500/4500SG Curtain Wall. The combined mock-up specimen was approximately 29'-5" wide x 39'-1½" high, (Photograph 1).
