OFFICIAL TEST REPORT

For CRL's 9/16" (13.52mm) Laminated Glass Railing System

Specifications: ASTM-E330, ASTM-E1996 (Impacts Only)

MANUFACTURER: C.R. Laurence C.O. Inc.

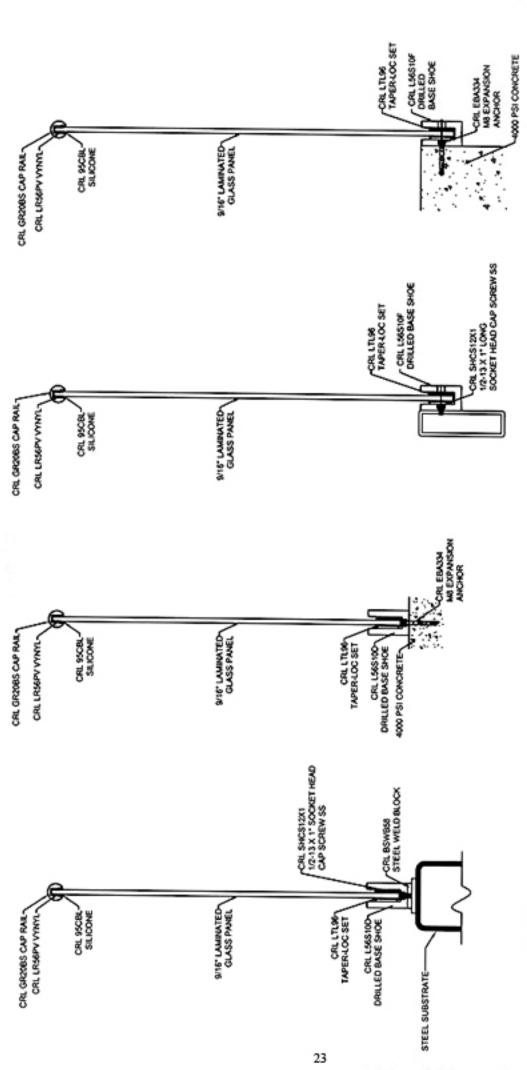
TEST C-1

CRL 9/16" LAMINATED GLASS RAIL SYSTEM #L56S10F 9/16" FASCIA MNT BASE SHOE ATTACHED TO STEEL

CRL 9/16" LAMINATED GLASS RAIL SYSTEM #L56S10D 9/16" SURFACE MNT BASE SHOE ATTACHED TO CONCRETE

TEST B-1

TEST D-1

CRL 9/16" LAMINATED GLASS RAIL SYSTEM #L56S10F 9/16" FASCIA MNT BASE SHOE ATTACHED TO CONCRETE

TEST A-1

CRL 9/16" LAMINATED GLASS RAIL SYSTEM #L56\$10D 9/16" SURFACE MNT BASE SHOE ATTACHED TO STEEL WELD BLOCK

The shoe base was fastened to the steel weld block part number **BSWB5 with a single row of number 1/2-13 by 3/4" long stainless steel socket head cap screws located 6 1/2" from each end and remaining on 12" center, the weld block was welded to a steel test fixture.

The shoe base was fastened to concrete test slab with a single row of No. 1/2 by 3 3/4" Hilti expansion bolt located 6" from each end and remainder on 6" centers.

The shoe base was fastened to the steel tube with a single row of number 1/2-13 by 3/4" long stainless steel socket head cap screws located 6 1/2" from each end and remaining on 12" center, the steel tube was welded to a steel test fixture.

The shoe base was fastened to concrete test slab with a single row of No. 1/2 by 3 3/4" Hilti expansion bolt located 6 1/2" from each end and remainder on 6" centers.
