TEST REPORT

Report No.: E9580.01-301-47

CR LAURENCE CO., INC.
Vernon, California

PRODUCT TYPE: Out-Swing Aluminum Bi-Fold Door
SERIES/MODEL: Monterey S80

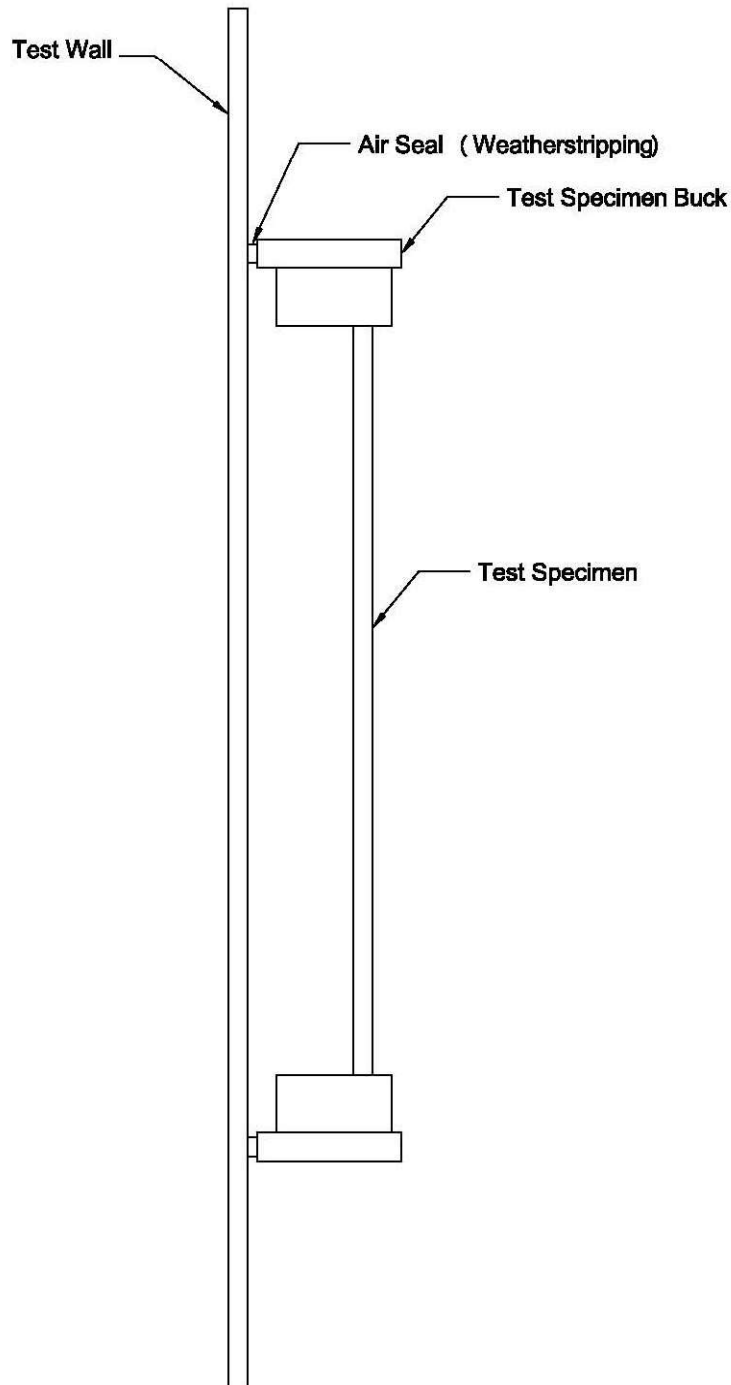
Location of Air Seal: The air seal between the test specimen and the test wall is detailed below. The seal is made of foam weatherstripping and is attached to the edge of the test specimen buck. The test specimen buck is placed against the test wall and clamped in place, compressing the weatherstripping and creating a seal.
