**AAMA 1503-09 THERMAL PERFORMANCE
TEST REPORT**

CR LAURENCE CO., INC.

SERIES/MODEL: Impact Resistant Storefront

Report Number: G1018.02-301-46
Test Date: 10/11/16
Report Date: 11/09/16

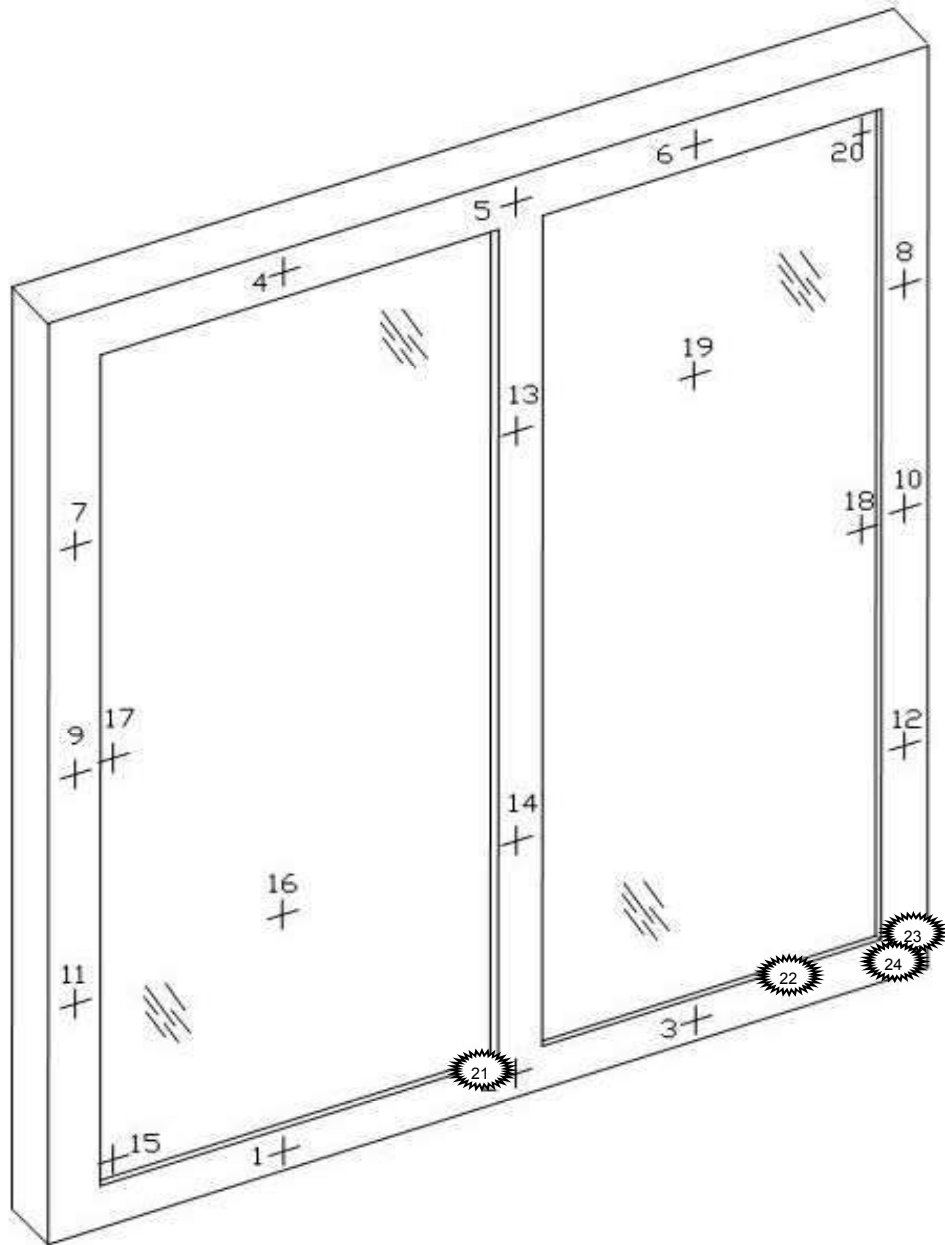
Thermocouple Location Diagram

Cold Point Locations

21. 20.35

22. 19.80

23. 19.73

24. 19.28

The CRF number was determined to be 34 (on the size as reported). When reviewing this test data, it should be noted that the frame temperature (FT) was colder than the glass temperature (GT) therefore controlling the CRF number. Refer to the 'CRF Report' page and the 'Thermocouple Location Diagram' page of this report.

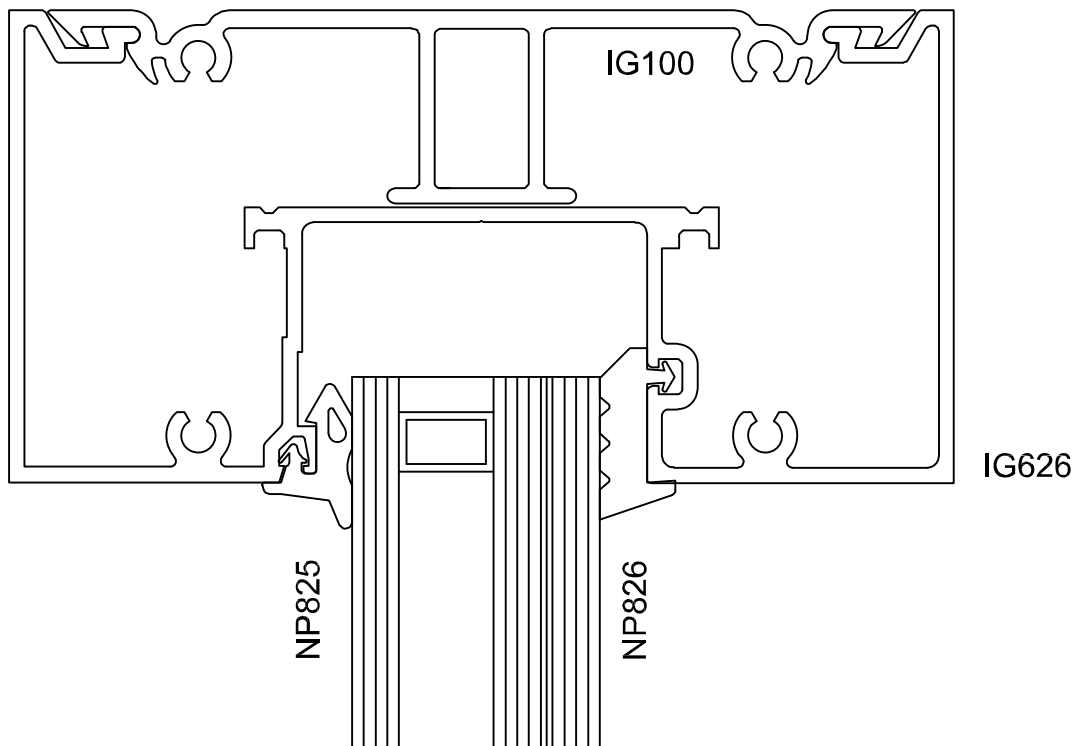
IG626 / IG100

IG600 HURRICANE RESISTANT STOREFRONT HEAD

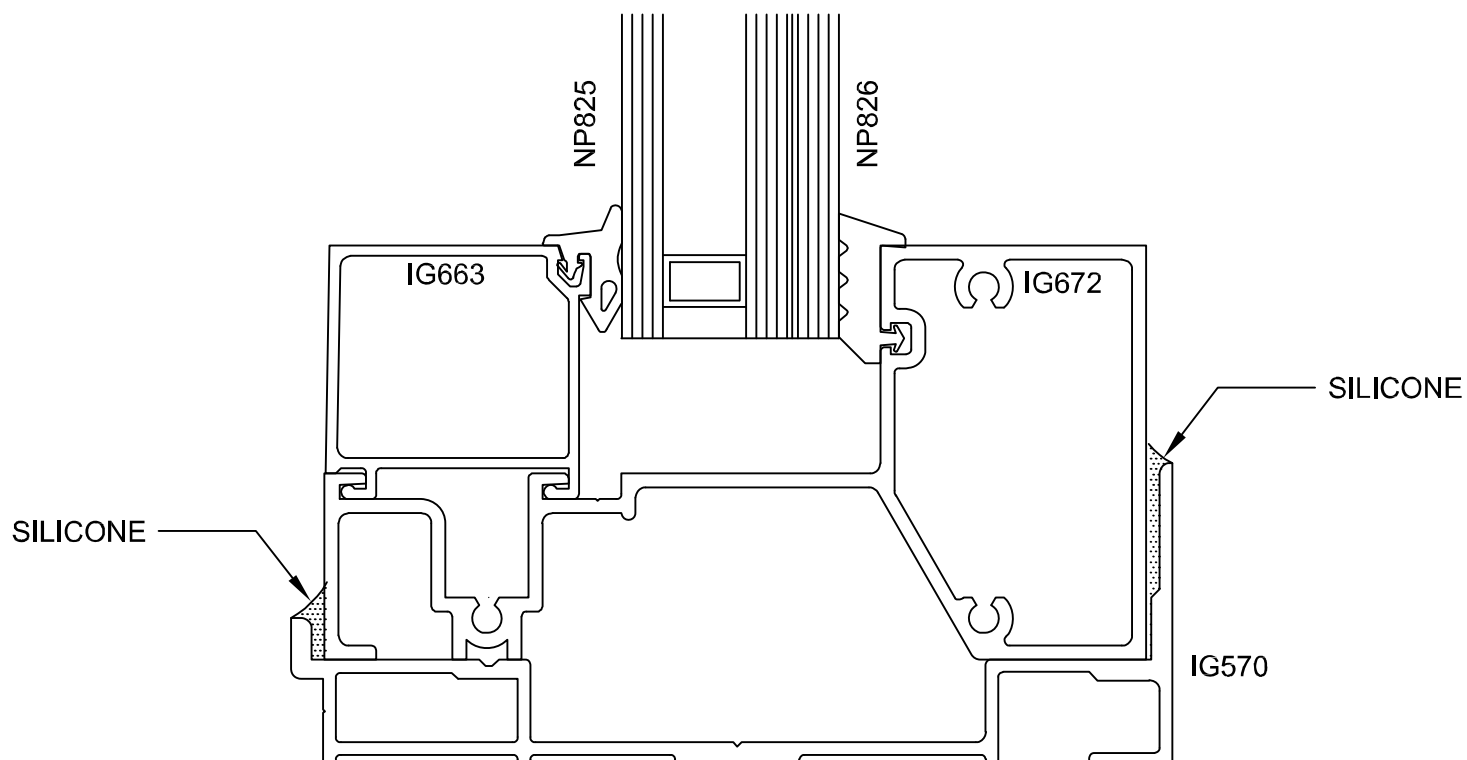
IG672 / IG663 / IG570

IG600 HURRICANE RESISTANT STOREFRONT SILL

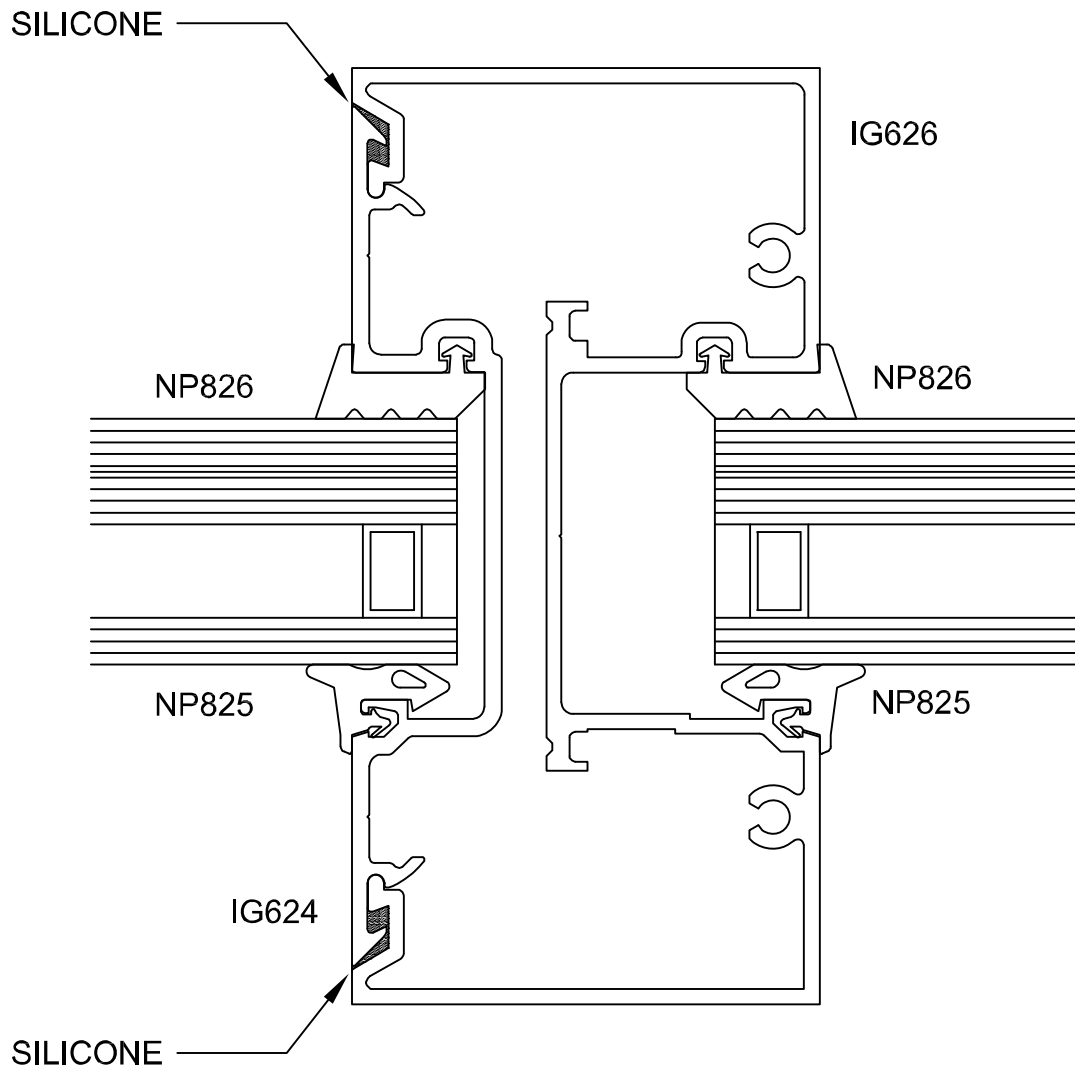
IG626 / IG624 / SS852

IG600 HURRICANE RESISTANT STOREFRONT VERT. MULLION
