**NFRC 102-2010 THERMAL PERFORMANCE  
TEST REPORT**

**CR LAURENCE CO., INC.**

**SERIES/MODEL: 7500 Concealed Vent**

Report Number: D9549.01-116-46  
Test Date: 01/09/15  
Report Date: 01/16/15

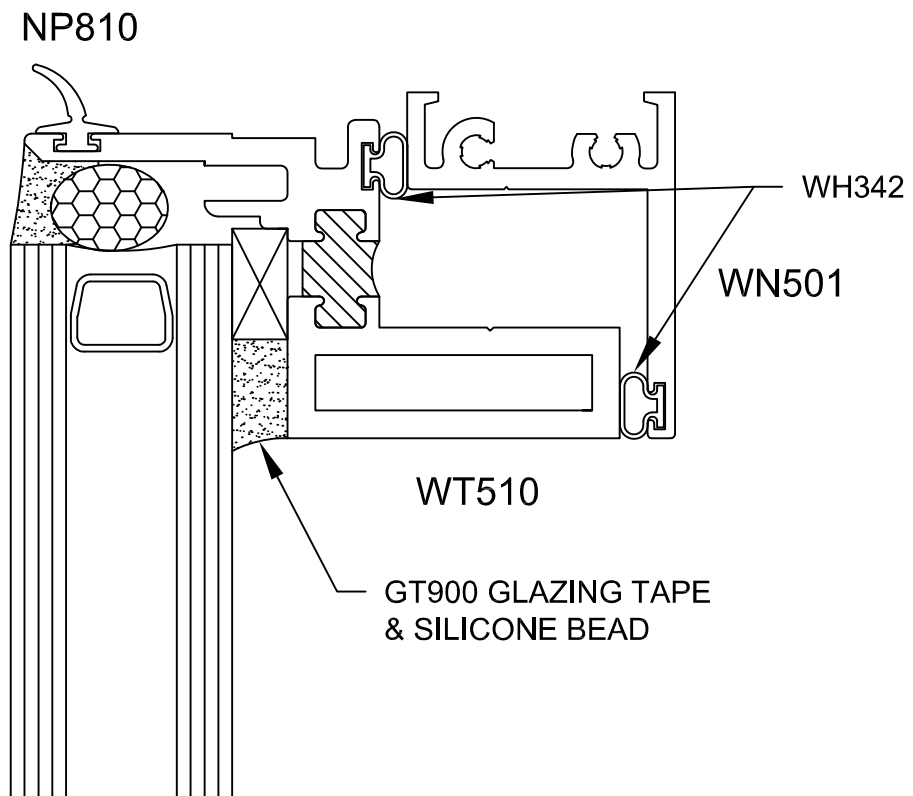
# 7500 WINDOWS HEAD

## WN501 / WT510

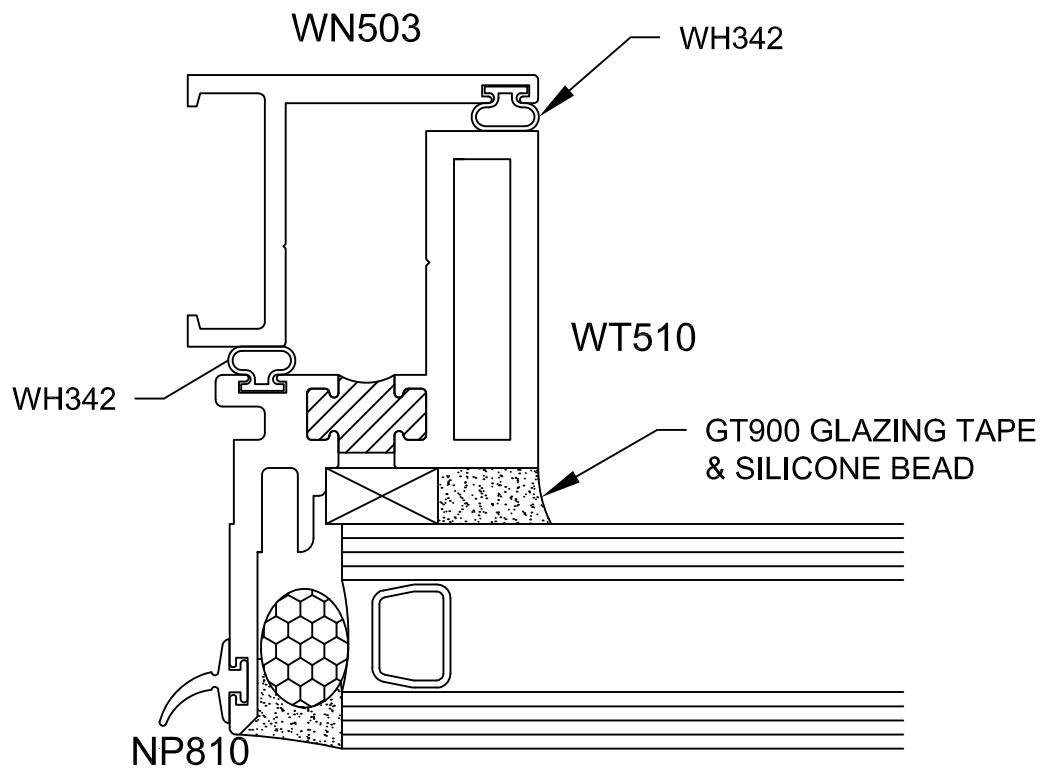
# 7500 WINDOWS JAMB

## WN503 / WT510

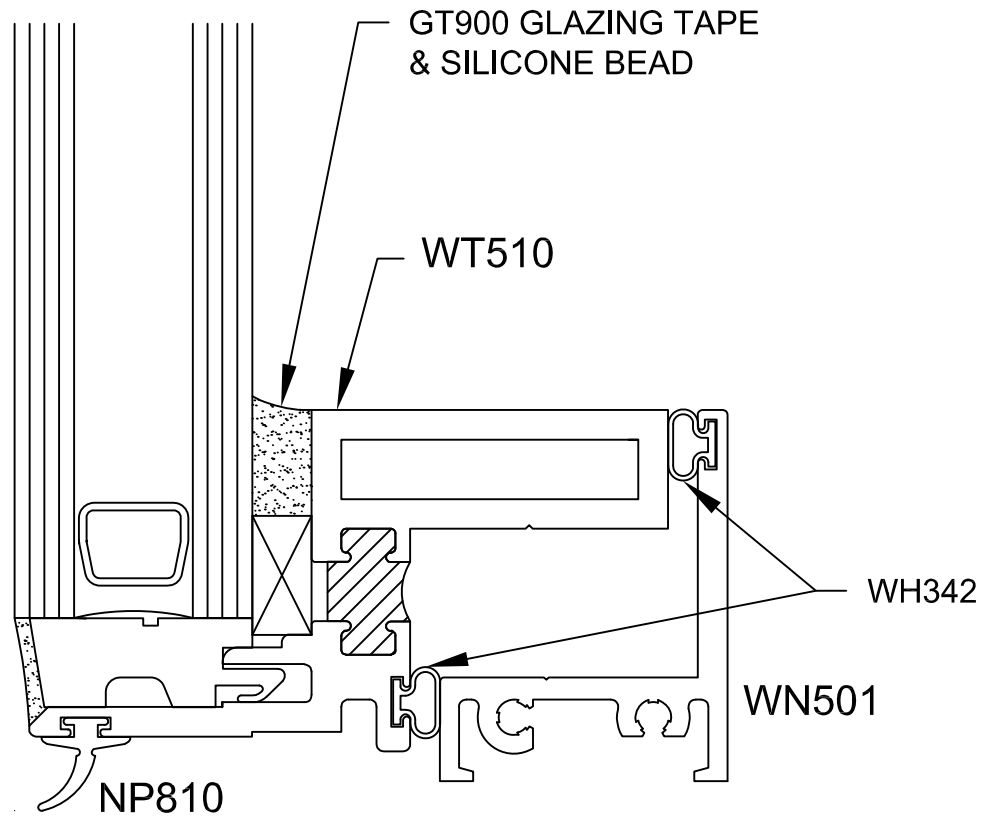
# 7500 WINDOWS SILL

## WN501 / WT510
