#### **TEST REPORT**

**Report No.**: D6386.01-301-47

**SERIES/MODEL**: 900

**PRODUCT TYPE**: Double Architectural Terrace Door (In-Swing)

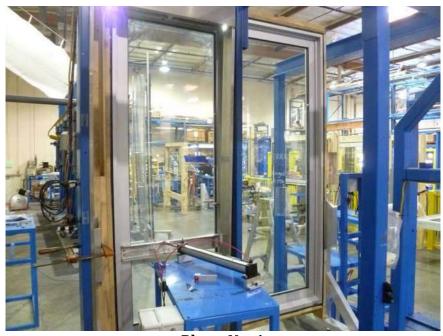
Photo No. 1 Door Cycling Set-up – Exterior

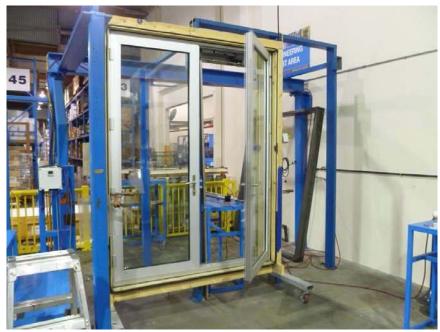
Photo No. 2 Door Cycling Set-up - Interior

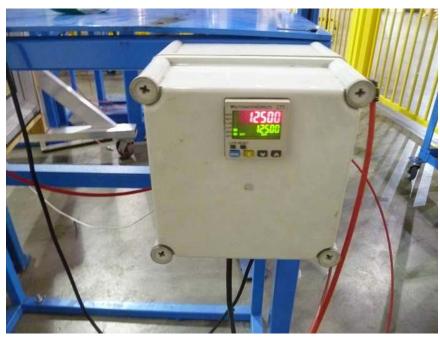
Photo No. 3 Door Cycling - Completion of First Half

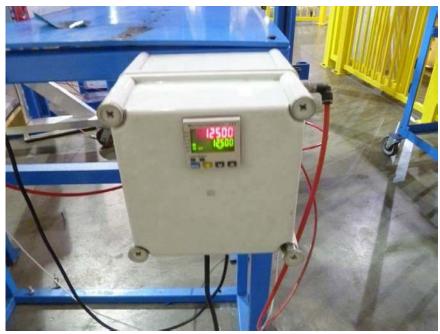
Photo No. 4
Door Cycling - Completion of Second Half

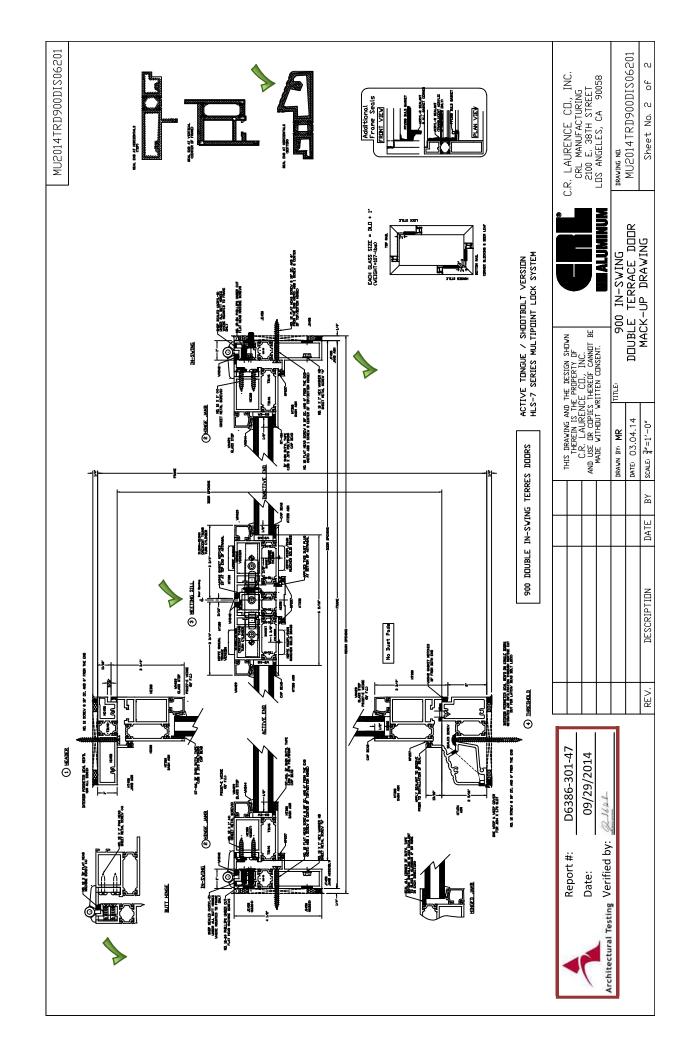
DRAWING ND. MU2014TRD900DIS06201

IN-SWIN	IN-SWING DOUBLE TERRACE DOOR BILL OF MATERIAL			MU2014TRD900DIS06201
DIE	DESCRIPTION	QTY:		
HEAD				
HE450	0 HEADER INTERIOR			
HI450	HEADER EXTERIOR			
			•	
JE45(	JE450 JAMB INTERIOR			
JI450	JAMB EXTERIOR		•	
			72,000	
HE300	D SASH INTERIOR		FRAME	
HI300	SASH EXTERIOR		017.70	
-HOLDER				
HE454	4 HEADER INTERIOR			
HI454	† DUTSWING THRESHOLD		2)	
AI350	) EXTERIOR ASTRAGAL			
AE350	INTERIOR ASTRAGAL			
TB186	INSULBAR			
VN42	WN429 GLASS STDP			
ARE, VIN	HARDWARE, VINYL, GASKET, AND SILICONE			
3×表水40 TAPE	TAPE			
BULB GASKET				
VEDGE GASKET				•

1. INSULATED GLASS
1. ½' CLEAR TEMPERED GLASS
2. ½' ALUMINUM SPACER
3. ½' CLEAR TEMPERED
4. GLASS SIZE: 28.6875' × 86.812'
